# Seismic Stabilization of Historic Adobe Structures

**Final Report of the Getty Seismic Adobe Project**

**E. Leroy Tolles**

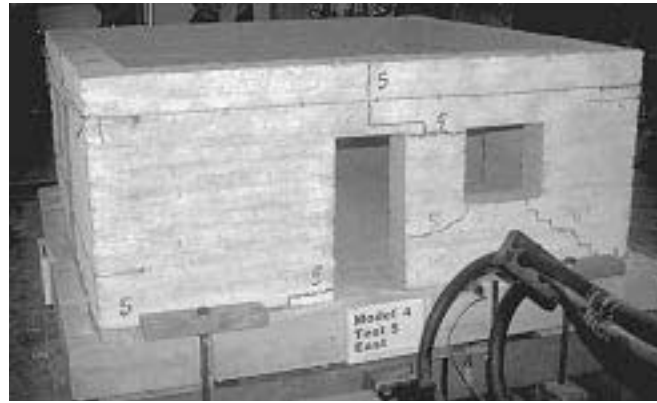
Model 4, test level IV, showing (a) east wall (out of plane); (b) north wall (in plane); (c) west wall (out of plane); and (d) south wall (in plane). Crack initiation occurred, with crack pattern in walls showing little differentiation between in-plane and out-of-plane directions. Cracks in the in-plane walls (north and south) started at the corners of openings and at the pier between door and window. In the out-of-plane direction, the west wall sustained crack damage in several locations, while the east wall had only one crack, extending diagonally from the bottom of the window toward the lower north corner. Note that in this thick-walled model, cracks began in the in-plane walls.

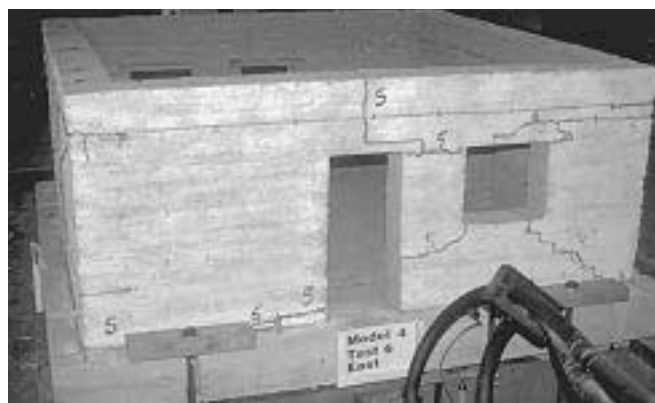
Model 4, test level V, showing (a) east wall (out of plane); (b) north wall (in plane); (c) west wall (out of plane); and (d) south wall (in plane). Some additional cracks were initiated in the in-plane walls and the east, out-of-plane, wall. No additional crack damage was observed in the west wall. At this point in the testing, dynamic displacements remained small and the retrofit system (horizontal straps) had little or no effect on the model's performance.

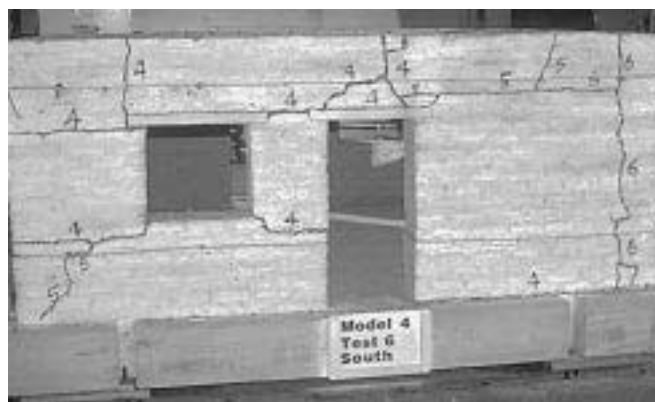
Model 4, test level VI, showing crack damage in (a) east wall (out of plane); (b) north wall (in plane); (c) west wall (out of plane); and (d) south wall (in plane). Although cracking remained nearly constant from that of test level V, the motion of the cracked wall sections became substantially larger during this test level as the cracks began to open up and the wall sections started to move relative to one another. There was little rocking of the cracked wall sections in the out-of-plane walls. The retrofit straps were engaged during this test sequence.

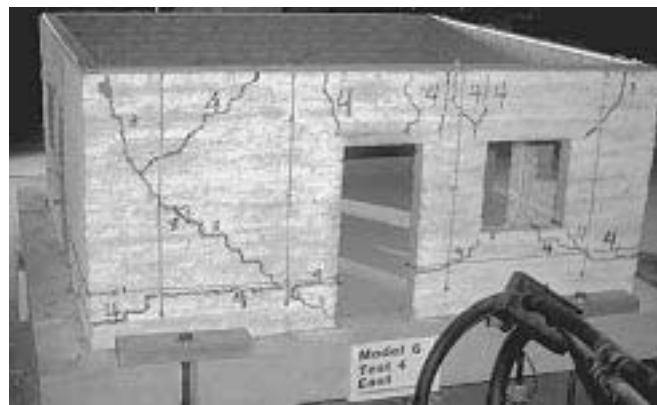
Model 6, test level III, showing (a) east wall (out of plane); (b) north wall (in plane); (c) west wall (out of plane); and (d) south wall (in plane). Initial cracking is visible, and a classic flexural pattern was observed in the east wall, though only small cracks were observed in the west wall. No cracks developed in the north wall, and only two or three slight cracks developed in the south wall.

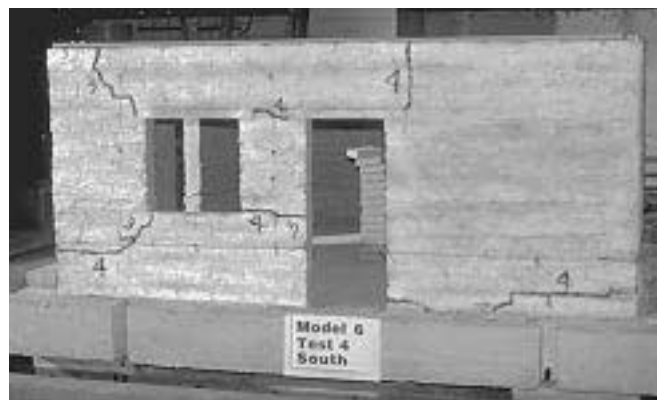
Model 6, test level IV, showing (a) east wall (out of plane); (b) north wall (in plane); (c) west wall (out of plane); and (d) south wall (in plane). A more complete crack pattern is apparent, particularly in out-of-plane walls. Flexural displacements at the tops of these walls are clearly visible. Spalling at the top of the west wall is indicative of large displacement motions; the diagonal cracks in the large solid wall sections of both east and west walls are typical of flexural cracking. Damage to the north and south walls is still relatively minor. The horizontal crack in the upper right corner of the north wall is typical of cracking in walls reinforced with a bond beam.

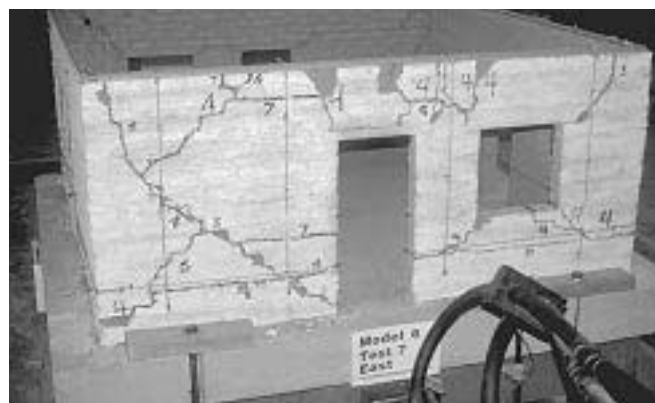
Model 6, test level VI, showing (a) east wall (out of plane); (b) north wall (in plane); (c) west wall (out of plane); and (d) south wall (in plane). During test levels V and VI, most of the dynamic motions were observed in the out-of-plane walls. Deflections at the tops of the walls were large and completely dependent on the stiffness of the bond beam. In the in-plane direction, the cracks were largely developed, but there was little motion or displacement across cracks.

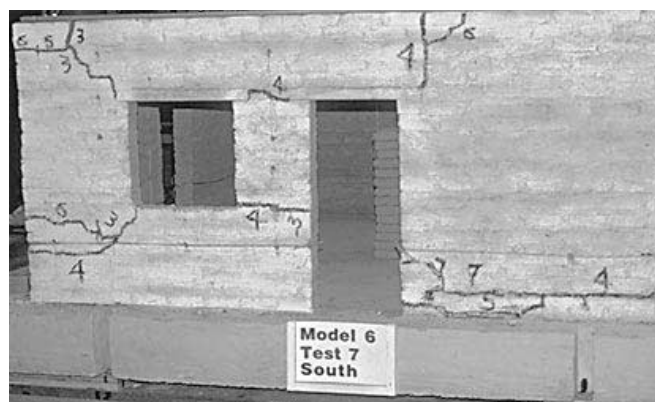
Model 6, test level VII, showing (a) east wall (out of plane); (b) north wall (in plane); (c) west wall (out of plane); and (d) south wall (in plane). Spalling at the top of the east and west walls is indicative of large out-of-plane displacements. Some additional minor cracks developed during this test. In-plane displacements of north and south walls became more substantial, but little new cracking developed. Some small permanent displacements occurred at the end of this test.

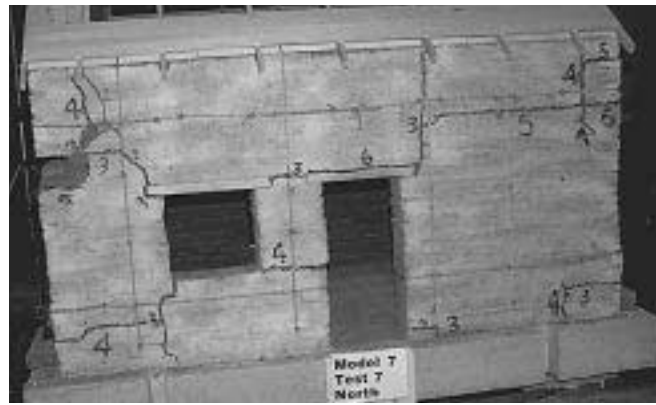
Model 7, test level V, showing (a) north wall (in plane); (b) west wall (out of plane); (c) south wall (in plane); and (d) east wall (out of plane). Most new damage was in the east and west walls. The upper section of the walls continued to rock, and vertical cracks developed near the center of both the east and west walls. An additional horizontal crack developed in the east wall above the attic-floor line. The north and south wall damage remained relatively constant, although a new horizontal crack developed in the north wall in the large panel at the attic-floor level.

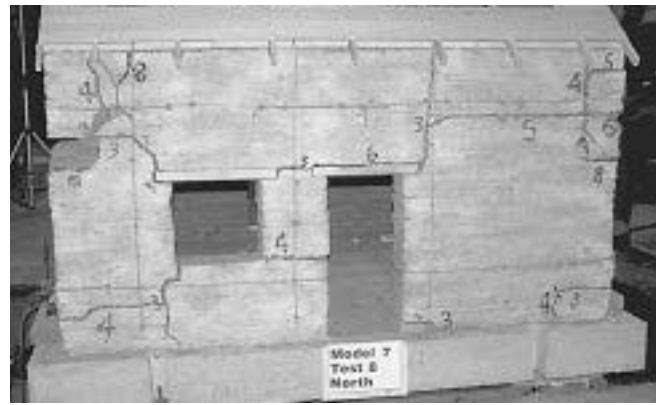
Model 7, test level VII, showing (a) north wall (in plane); (b) west wall (out of plane); (c) south wall (in plane); and (d) east wall (out of plane). Major crack patterns were nearly complete after test level V. During test levels VI and VII, some cracks were extended, but most remained unchanged. The principal exceptions were a diagonal crack in the west wall near the north end during test level VI and a similar crack in the east wall during test level VII. Only a few new cracks developed in the north and south walls during these tests. During test level VII, a section in the upper east corner of the north wall dislodged, and a permanent displacement occurred at the lower east corner of the window on the north wall.

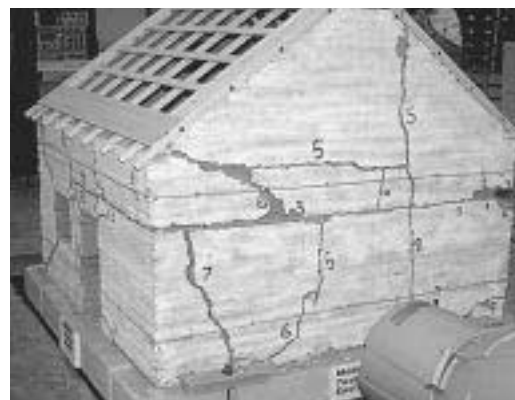
Model 7, test level VIII, showing (a) north wall (in plane); (b) west wall (out of plane); (c) south wall (in plane); and (d) east wall (out of plane). Additional cracks developed in the east and west walls, notably a horizontal crack in the lower portion of the west wall and a vertical crack in the right lower portion of the east wall, which was a continuation of an existing vertical crack in the upper gable portion of the wall. Additional cracks developed in the north and south walls. Of further significance were the permanent offsets of 0.64–1.27 cm (0.25–0.5 in.) at some locations.

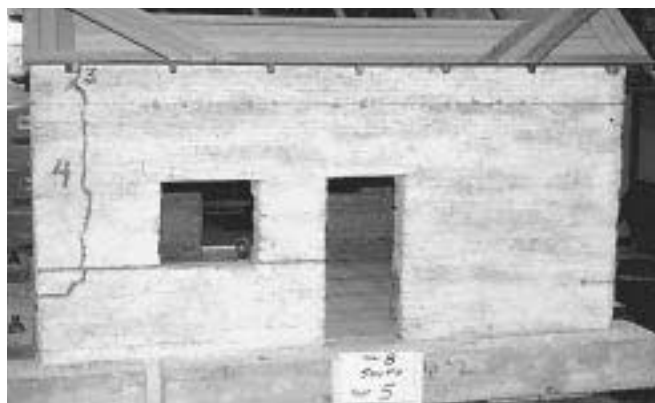
Model 8, test level V, showing (a) east wall (out of plane); (b) north wall (in plane); (c) west wall (out of plane); and (d) south wall (in plane). The in-plane walls sustained little additional damage. Minor cracks developed in the north wall, and no cracks appeared in the south wall. The out-of-plane walls developed considerably more cracks. The location of the cracks followed typical yield-line patterns. Each wall developed a diagonal crack from the upper corner on one side, extending to the center of the base of the wall. The east wall developed an additional, nearly vertical crack near the south end.

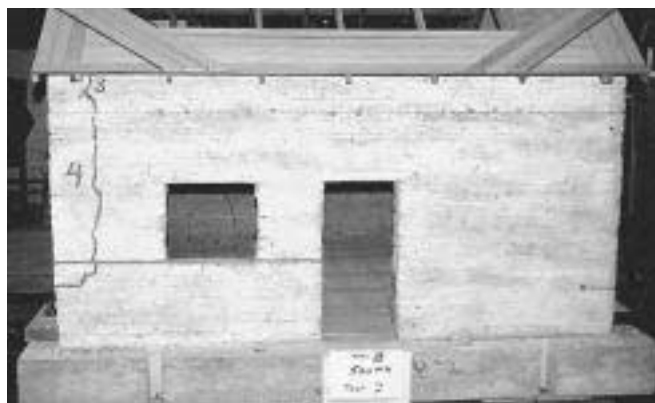
Model 8, test level VII, showing (a) east wall (out of plane); (b) north wall (in plane); (c) west wall (out of plane); and (d) south wall (in plane). At this point, the building walls had cracked into major sections that allowed them to move dynamically without sustaining substantial additional damage. Minor fragmentation of the wall continued in the north and west walls (straps), and little additional damage developed in the west wall (center core). The center cores in the south wall continued to provide adequate reinforcement that prevented cracks from occurring.

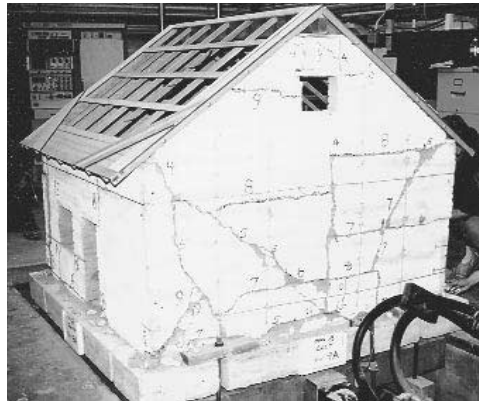
Model 8, test level IX(1), the first of two tests at this level, showing (a) east wall (out of plane); (b) north wall (in plane); (c) west wall (out of plane); and (d) south wall (in plane). Crack patterns changed little, but the substantial amount of additional spalling at crack edges and corners was indicative of the large motions to which the building was subjected during this test. The center cores in the west wall allowed the formation of major blocks with two center-core rods in each block. Damage to the south wall (with center cores) increased but was considerably less than that observed in the north wall (with straps).

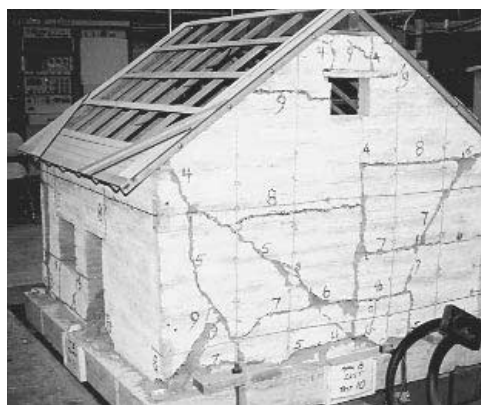
Model 8, test level IX(2), the second of two tests at this level, showing (a) east wall (out of plane); (b) north wall (in plane); (c) west wall (out of plane); and (d) south wall (in plane). Offsets at existing cracks increased to about 1.25 cm (0.5 in.). Damage to the basic panels in the south wall was still negligible. The walls were beginning to slide at the foundation level.

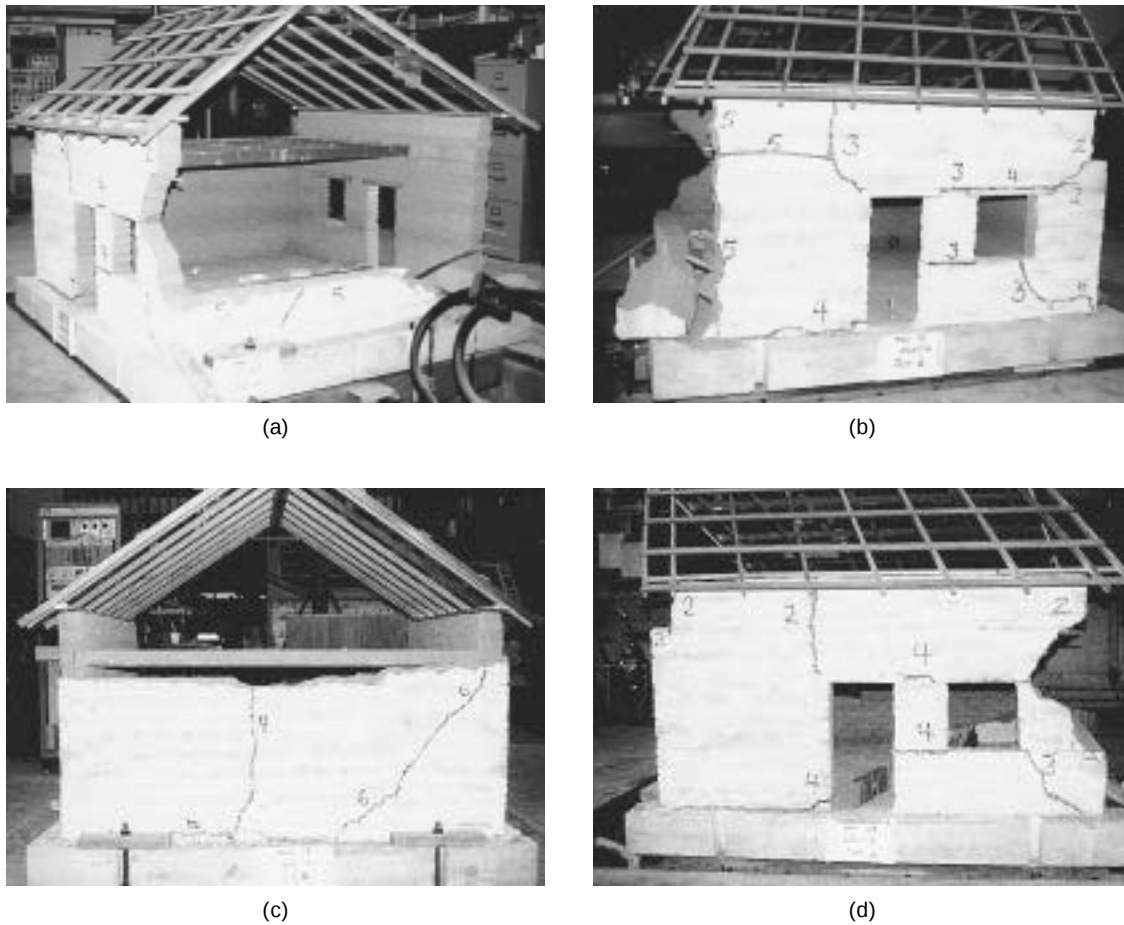
**Figure 5.28**

Both gable-end walls collapsed during test level VI (fig. 5.28). The collapse of the east wall was more complete because the upper section of the wall collapsed inward and, simultaneously, the lower section of the wall collapsed outward. The west wall collapse was incomplete. The difference in the behavior between the two walls can be attributed to the crack patterns that developed during earlier tests. There were two horizontal cracks in the east wall, and both the upper and lower sections

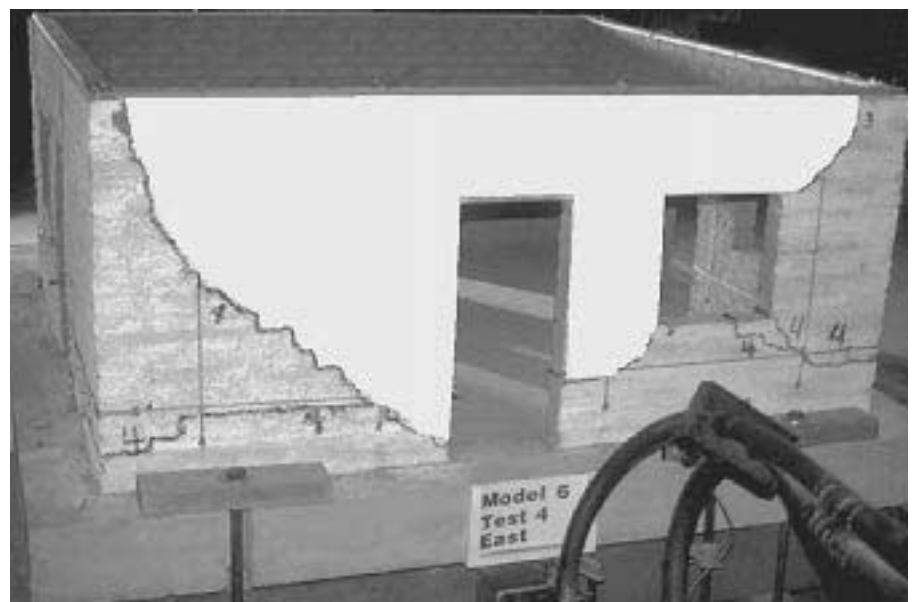
Cracked wall section of model 6, showing pattern typical of a section of wall subjected to out-of-plane rocking about its base.

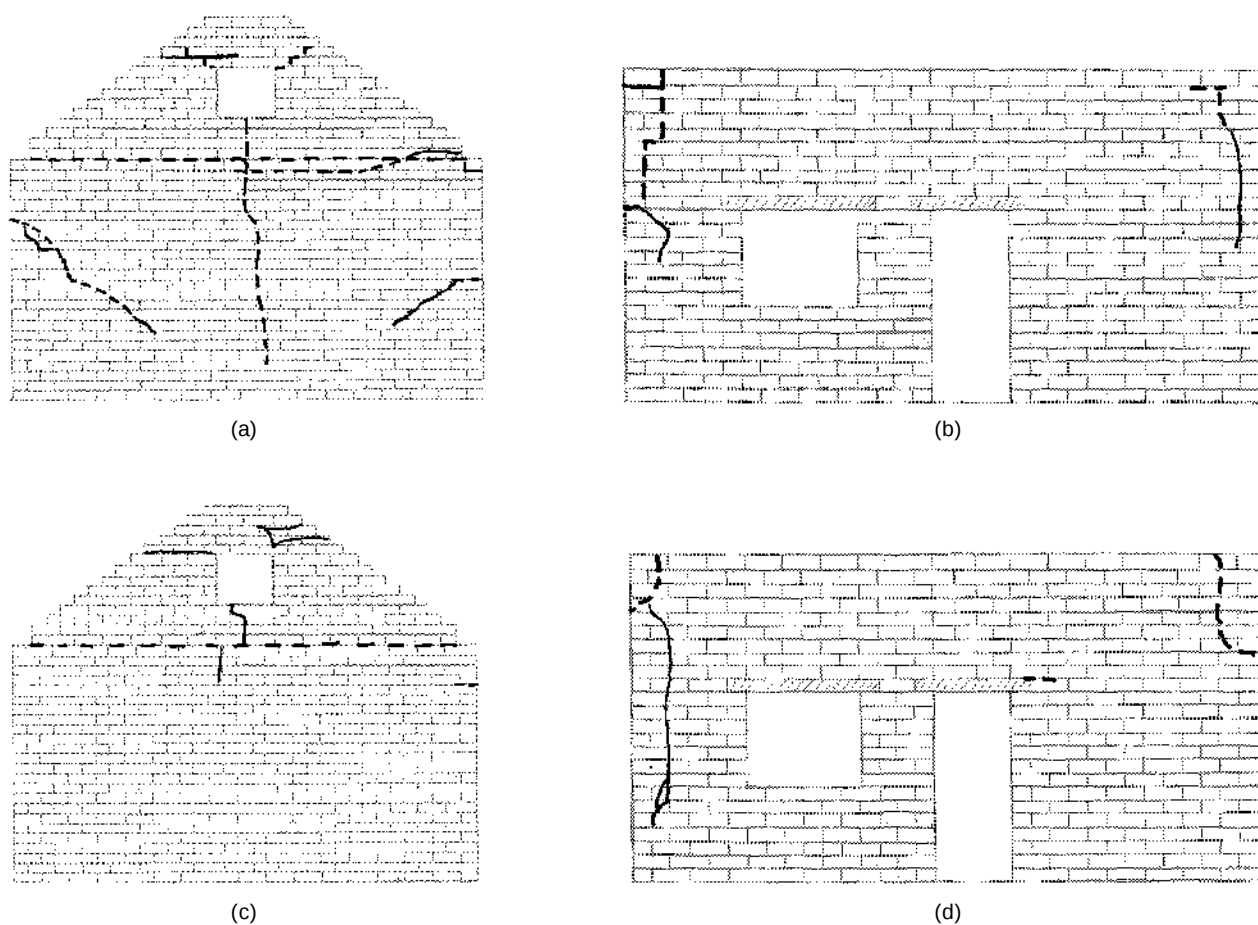
**Figure 8.2**

The crack patterns after test V are illustrated in figure 8.2. The cracks in the gable-end walls show the variety and types of cracks that can occur during out-of-plane motions of walls. In the east wall, the vertical crack below the window developed first, followed by the horizontal and diagonal cracks. In the west wall, the horizontal crack developed

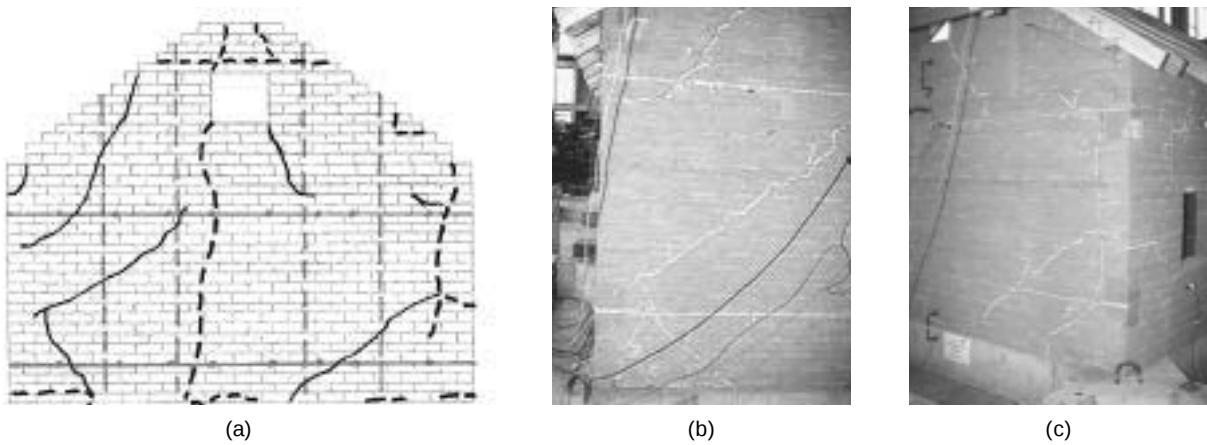
**Figure 8.34**  
Damage to model 11, west wall (retro-fitted with center-core rods) after test VII, shown in (a) diagram of crack pattern; (b) photograph of north side of wall; and (c) photograph of south side of wall.
