**Mogao Grottoes  
Cave 85 Project**

# Objectives of the Cave 85 Project

# Conservation History and Condition Survey of Cave 85

# Causes and Mechanisms of Deterioration and Damage in Cave 85

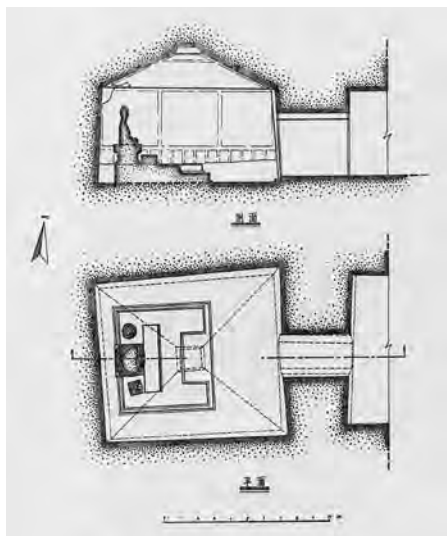
FIGURE 2 Cave 85 in plan and section. The cave is divided into three parts: antechamber, corridor, and main chamber.

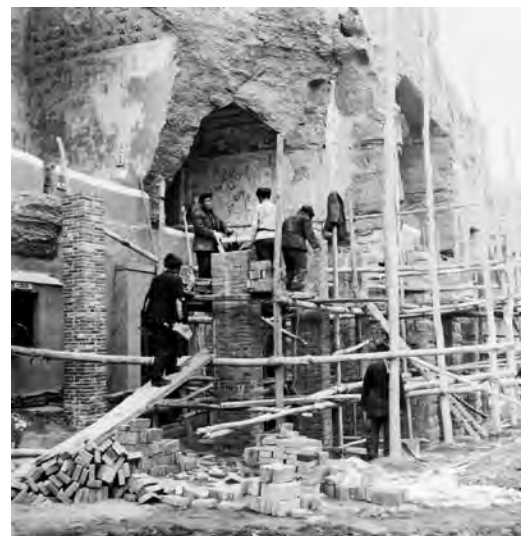
FIGURE 3 Cave 85 during construction of facade and walkways (1957–58). Pillars were built in front of the cave to support a wooden walkway and provide support to the fronts of caves 242 and 243.

In the 1950s large-scale plaster repairs were carried out on the lower part of the four walls of the main chamber, part of the west wall, the lower part of the south and north walls of the corridor, and the upper and lower parts of the west and north walls of the antechamber. In 1957 and 1958 reinforcement work of the cliff face was started in the zone of caves 78–93 on the ground level, which includes cave 85, and caves 237–48 on the second tier.<sup>3</sup> Pillars of stone and bricks were built up to support a new facade to protect the cliff face and to accommodate stairs and walkways (fig. 3). At this time, the floor of cave 85 was paved with concrete.

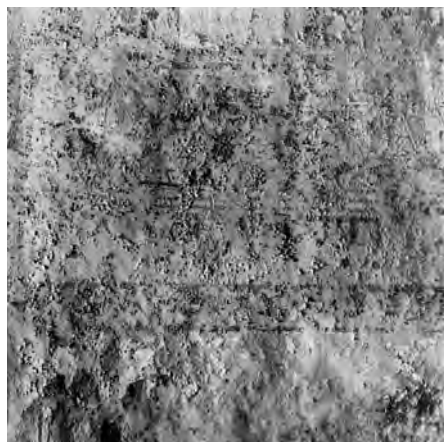
**FIGURE 4** Flaking on the east wall of cave 85 (1973).

A condition survey undertaken in cave 85 in 1973 showed that flaking of the paint layer was a serious problem on the southern and northern parts of the east wall of the main chamber (fig. 4), as well as toward the rear, west end of the cave, including the west wall and ceiling slope and western ends of the south and north walls and ceiling slopes. As a result, in 1974 a wooden entrance door to the cave was installed, and 186 square meters of flaking paint and separated plaster were treated. An aqueous mixture of PVA (1.5%) and PVAC (2%) was used as an adhesive in a ratio of 4:1 by volume (Duan Xiuye and Sun Hongcai 1990: 92–94). The adhesive was first injected behind the flakes and then gently pressed back and relaid with brushes and cotton balls. After this operation, PVA (2%) and PVAC (3%), in a ratio of 4:1, were sprayed on to consolidate the surface.

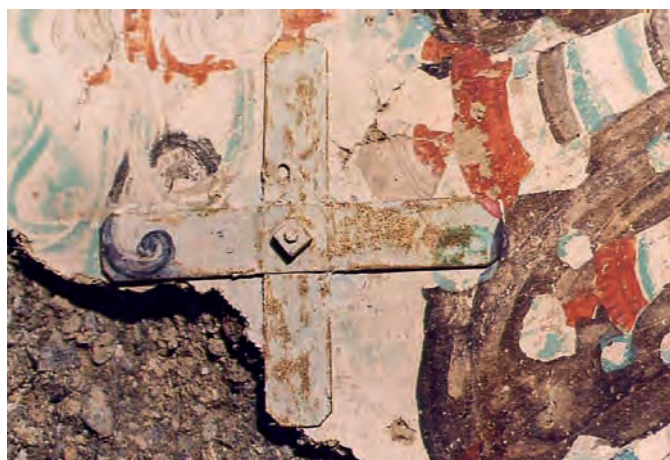
**FIGURE 5** Example of the steel anchors used to secure areas of detached painted plaster in cave 85. The anchor was painted to match the decoration of the original painting.

The detached paintings were pinned with two different kinds of anchors (or cross braces), one made of steel (fig. 5) and the other made of poly(methylmethacrylate) or acrylic glass. Steel anchors were used throughout the cave, one on the northern part of the east wall, two on the west wall (the upper parts of the north and south ends), and five in the corridor; two acrylic glass anchors were used on the eastern part of the north wall. The anchors were soon found to be an imperfect solution to the problem of detach-

ment as they sometimes caused cracking in the earthen plaster when inserted and they created stress in the painting around the anchor.

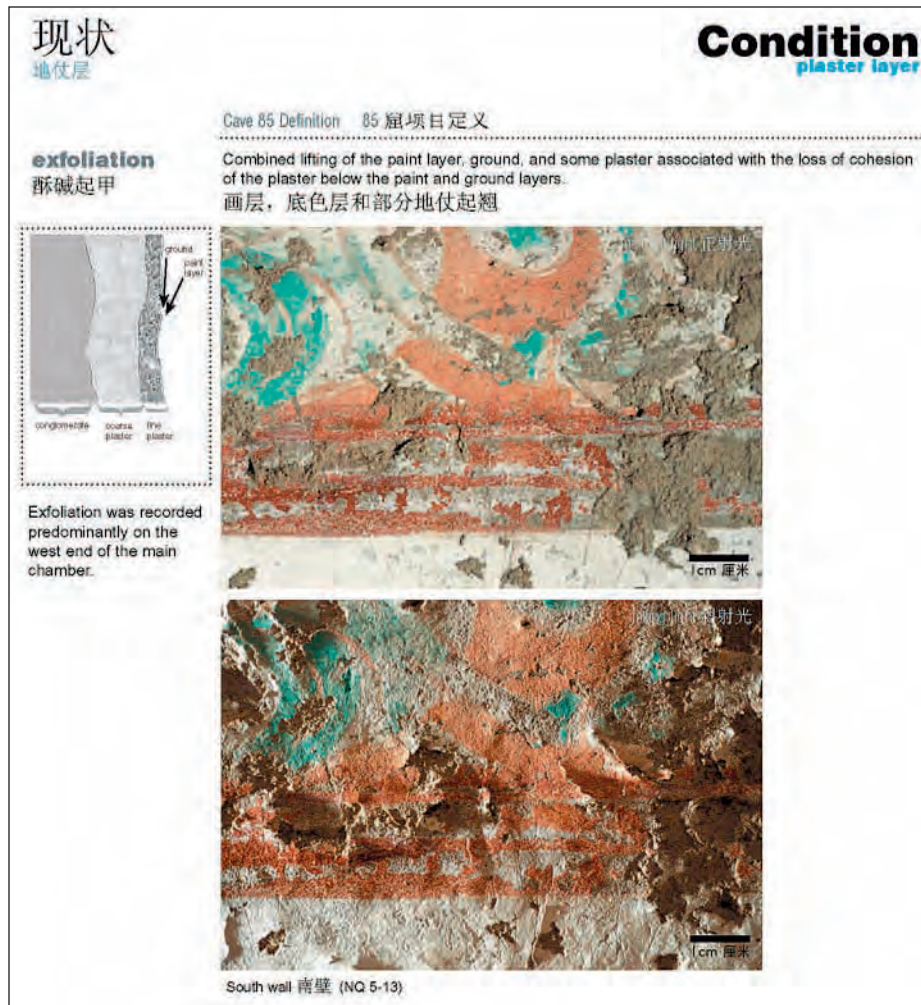
FIGURE 6 Example of the visual glossary for “exfoliation.”

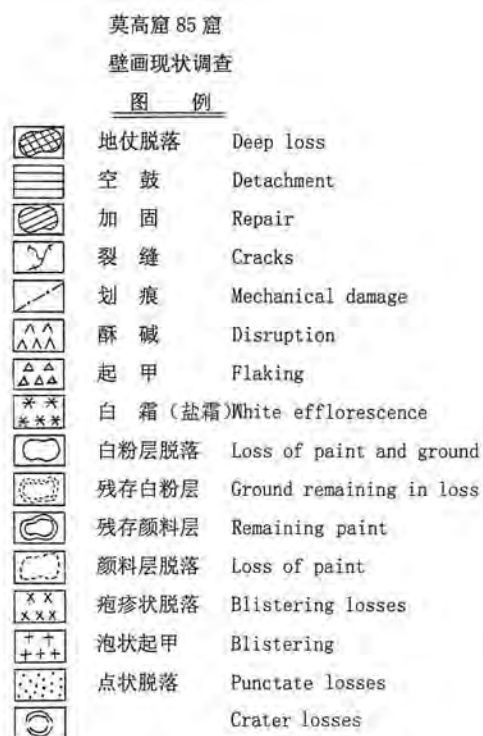
FIGURE 7 The graphic documentation key.

Using the predetermined deterioration categories and legend (fig. 7), deterioration was mapped on transparent paper overlaid on the black-and-white photographic prints at 1:5 scale (fig. 8). Altogether, 523 sections were recorded by hand and are archived at the Dunhuang Academy. Manual graphic documentation was subsequently computerized, using AutoCAD software, to summarize the information on measured line drawings by entire wall and slope (1:20 scale) in order to illustrate general patterns of deterioration within the cave and to provide greater flexibility in the analysis and presentation of data. In addition, a three-dimensional model of the cave was constructed and condition overlaid to show the spatial distribution of deterioration in cave 85 (fig. 9).

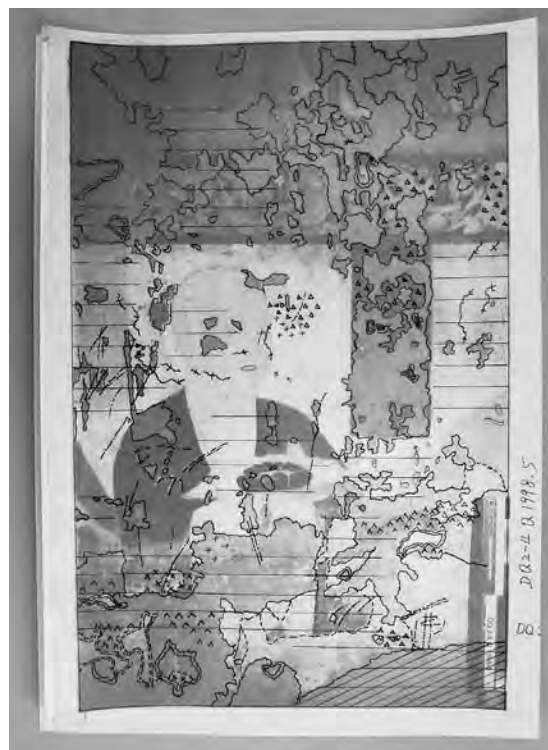
FIGURE 8 Example of the manual graphic documentation carried out using overlays on photographs.

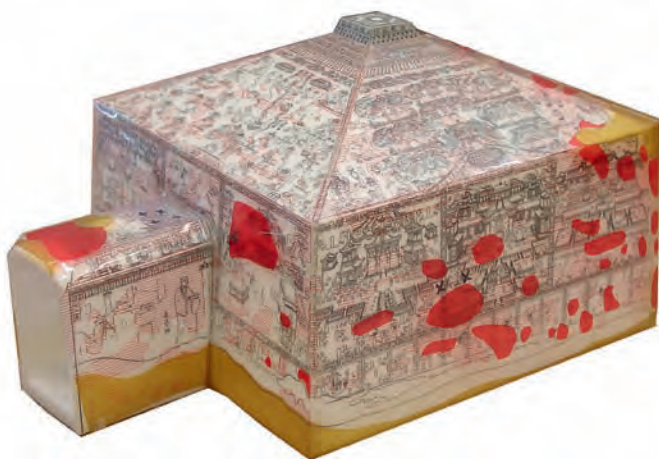
**FIGURE 9** Scale model (1:35) of cave 85 with condition overlaid to show the distribution of deterioration.

Both in-depth and surface conditions showed a similar distribution pattern throughout the cave on a southeast to northwest axis (on both walls and ceiling slopes), increasing in severity toward the northwest end of the cave and most severe at the upper northwest corner of the cave. In contrast, the east end had noticeably less plaster detachment (with the exception of a large area on the north side of the east wall)

In summary, it is clear that all forms of ongoing deterioration progressively worsen in both severity and extent toward the west end of the cave, with a concentration in the northwest corner. Visible surface salt activity also increased toward the west end of the cave.

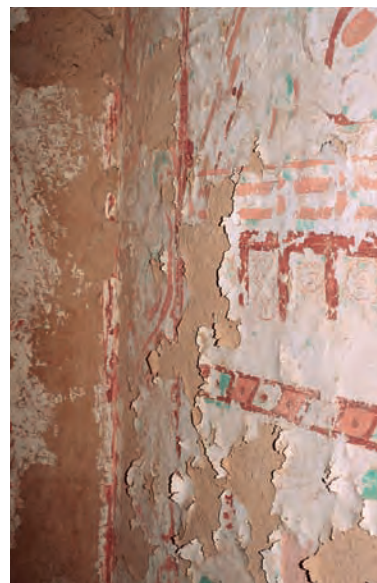
**FIGURE 10** Area of severe exfoliation of the wall paintings in the northwest corner of cave 85.

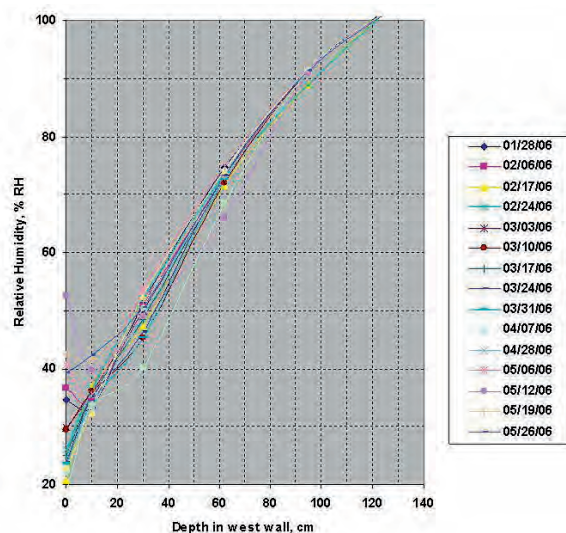
**FIGURE 1** Relative humidity in the conglomerate of the west wall of cave 98 as a function of depth and season. Fluctuations due to the cave environment extend to a depth of 10 centimeters. Individual sensors in the monitoring hole were well isolated from each other.

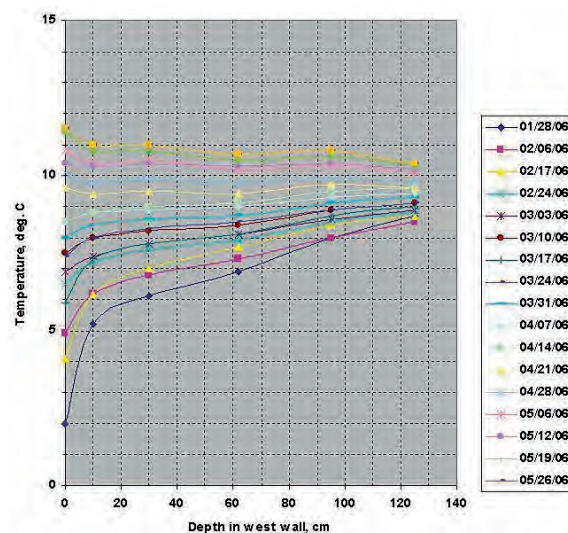
**FIGURE 2** Temperature in the same monitoring hole shown in figure 1. Seasonal temperature variations extend more than 100 centimeters into the rock.

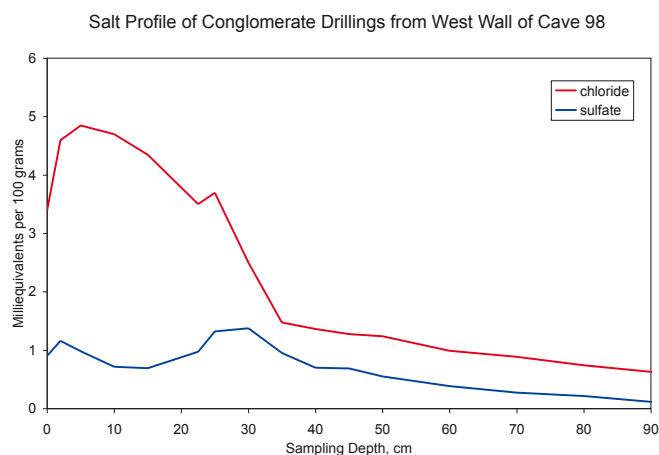
**FIGURE 3** Chloride and sulfate ion distribution with depth in the same monitoring hole shown in figures 1 and 2. (Data provided by Dunhuang Academy)

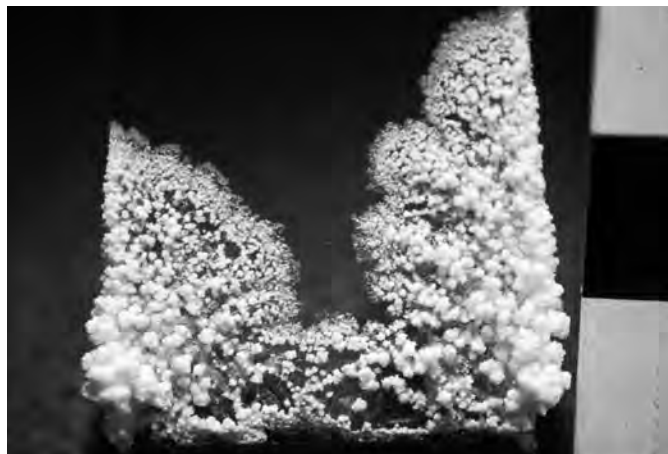
**FIGURE 4** Creep of sodium chloride up a microscope slide as the solution evaporated.

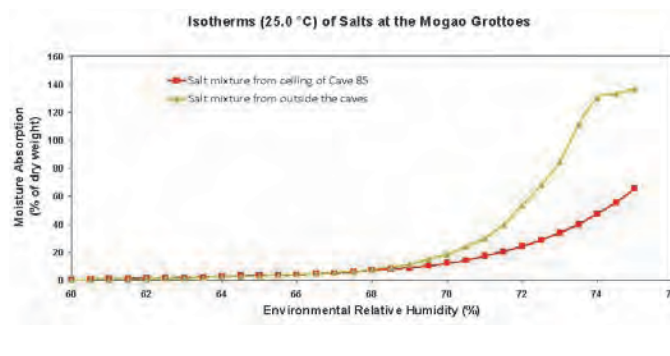
**FIGURE 5** Weight increase as a function of relative humidity of salt mixtures sampled from the interface between the plaster and conglomerate in cave 85 and taken from external conglomerate.

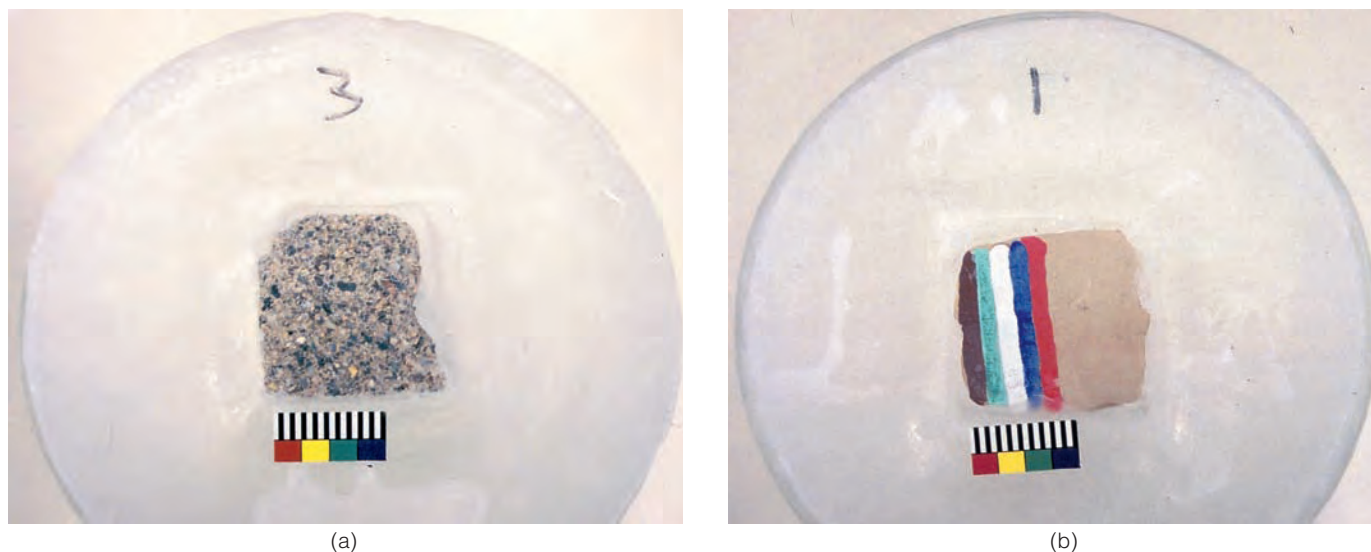
**FIGURE 6** Sodium chloride migration experiments. (a) Conglomerate; (b) conglomerate with a layer of clay plaster, half of upper surface painted with pigments found at Mogao.

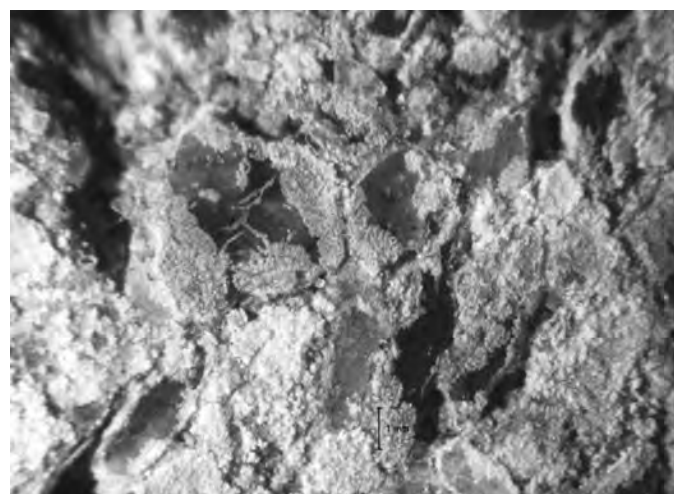
**FIGURE 7** Sodium chloride crystallization on upper surface of conglomerate. Note salt creep around edges of larger grains.

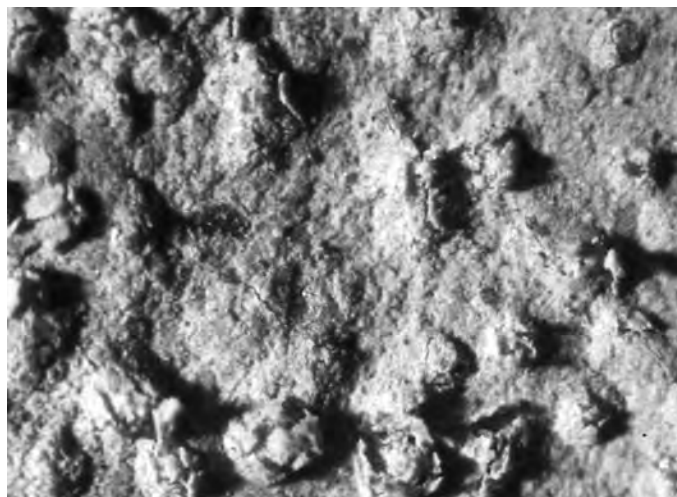
**FIGURE 8** Salt eruption on the unpainted clay plaster.

A further relevant observation was that in samples of conglomerate that were overlaid with clay plaster and painted with pigment and binding medium, replicating those in the caves, sodium chloride eruption occurred on the clay surface (fig. 8) but was not observed on the paint surface. Instead, on examination of lifted paint flakes, euhedral crystals of salt were observed (fig. 9). Only in one instance, after five cycles, did the beginning of damage to the paint layer occur. Moreover, accumulation of salt at the conglomerate-clay interface was observed. In the caves this is a probable contributor to plaster detachment because of disaggregation and fretting of the rock from cycles of deliquescence-recrystallization. In other words, conglomerate may recede behind the plaster by salt-induced fretting; it is not buildup of salts that detaches plaster.

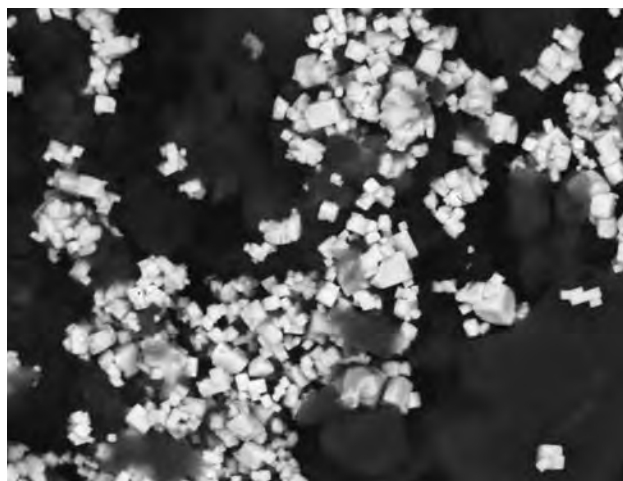
**FIGURE 9** Well-formed cubic crystals of sodium chloride below the paint layer (also at the clay-conglomerate interface).

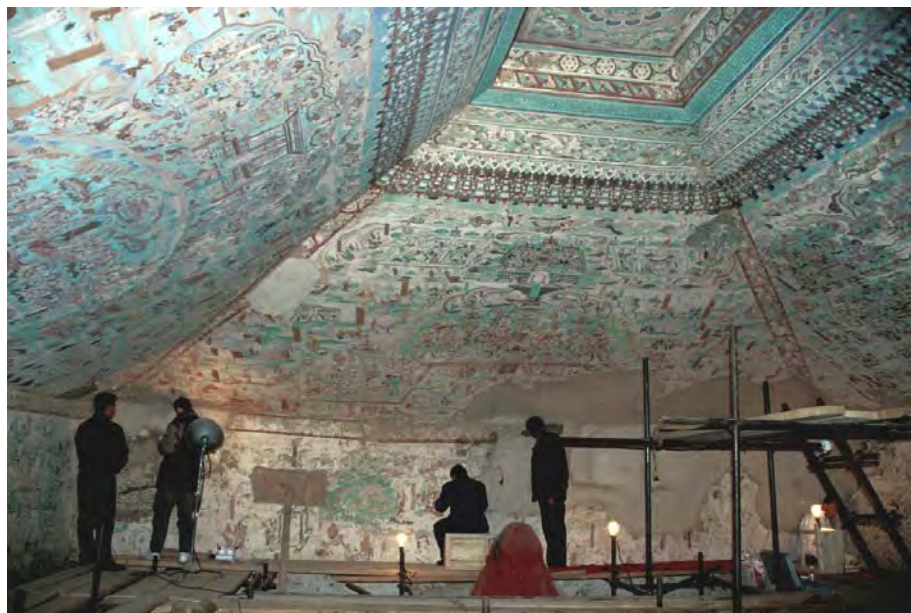
**FIGURE 1** Cave 85 (upper level, west side ceiling) during early stages of the project.  
Credit: J. Paul Getty Trust

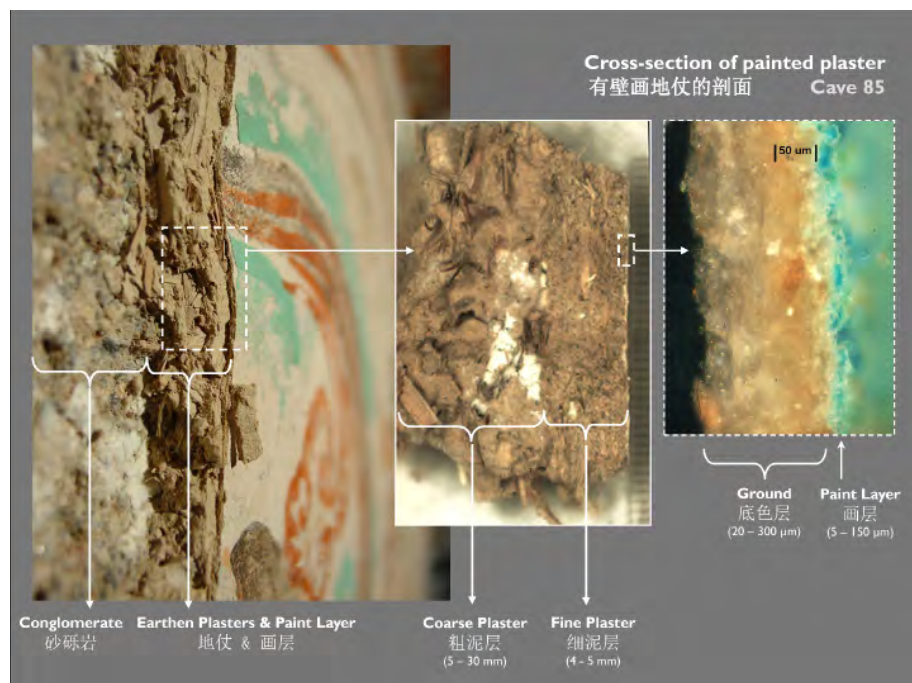
**FIGURE 2** Stratigraphy of the painted plaster in cave 85.  
Credit: J. Paul Getty Trust

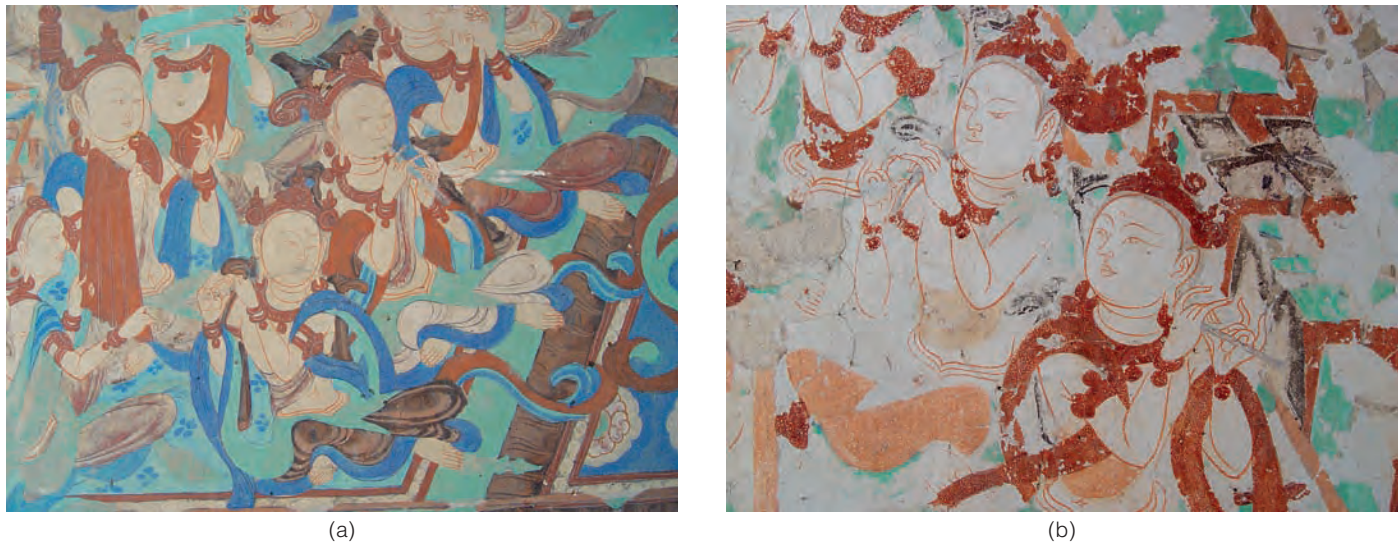
**FIGURE 3** Details of similar scenes taken from the east and west ends of the south wall illustrating the difference in condition: (a) the paintings at the east, toward the front of the cave, are in near-pristine condition; (b) at the west, toward the back of the cave, they are in poor condition (loss of paint layer and color change).

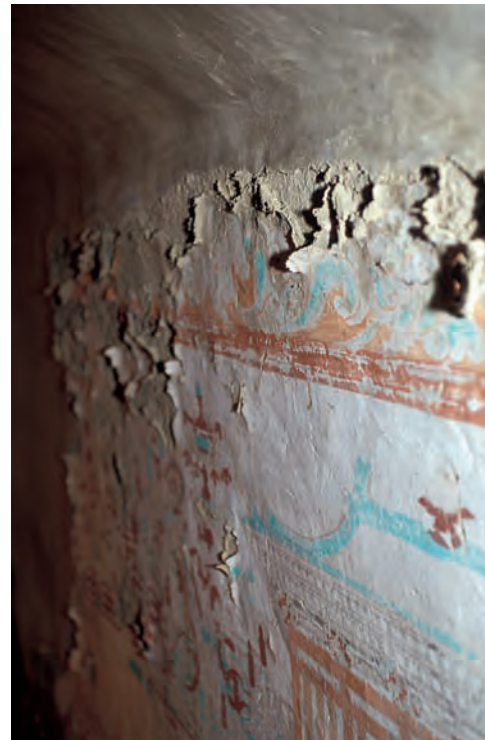
**FIGURE 4** Exfoliation, the lifting of paint, ground, and upper plaster layers, apparently exacerbated by treatments for flaking (in the 1970s) using polyvinyl acetate and polyvinyl alcohol fixatives. The continued loss of painting indicates that this problem is ongoing, most notably at the northwest end of the cave.

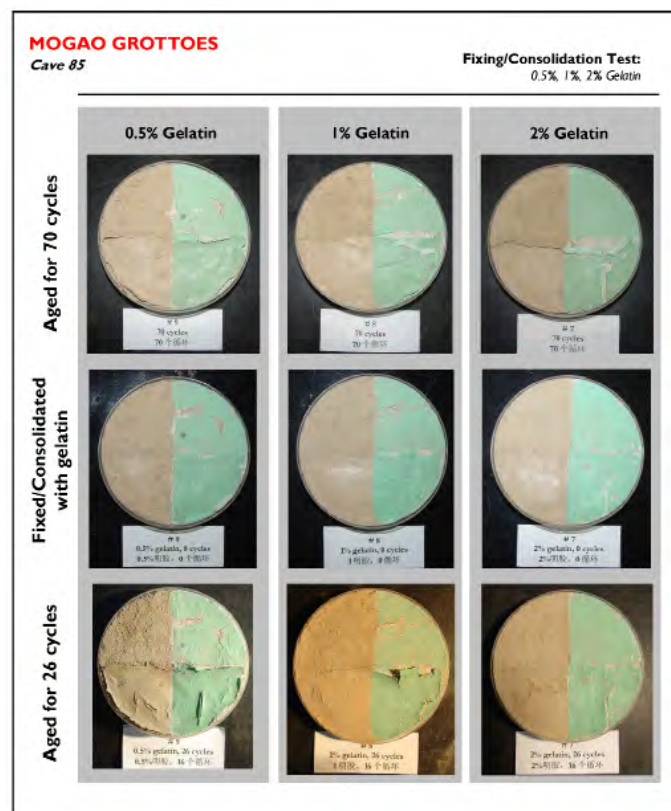
**FIGURE 6** Painted plaster disks (loaded with 2% NaCl by wet weight and previously artificially aged for 70 relative humidity cycles [48 hr/100% and 24 hr/ambient RH]) were fixed and consolidated using different amounts of gelatin in water (0.5%, 1%, and 2%). These disks were again cycled to evaluate the performance.

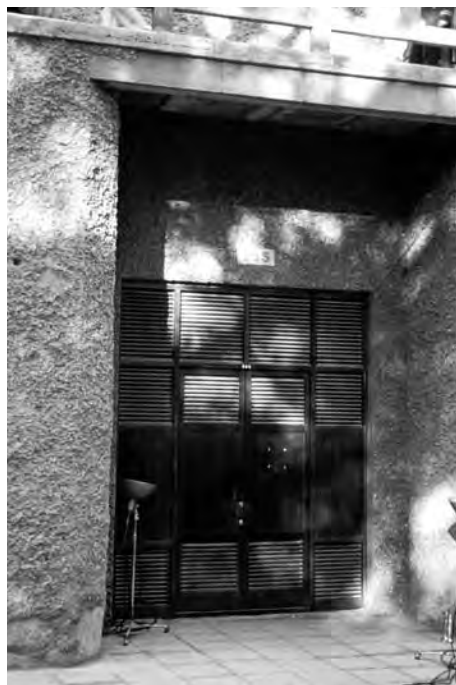
**FIGURE 7** Exterior of cave 85 with door closed. A management decision was made to control relative humidity by keeping the cave closed during periods of rain when ambient relative humidity can rise to 75 to 80 percent.

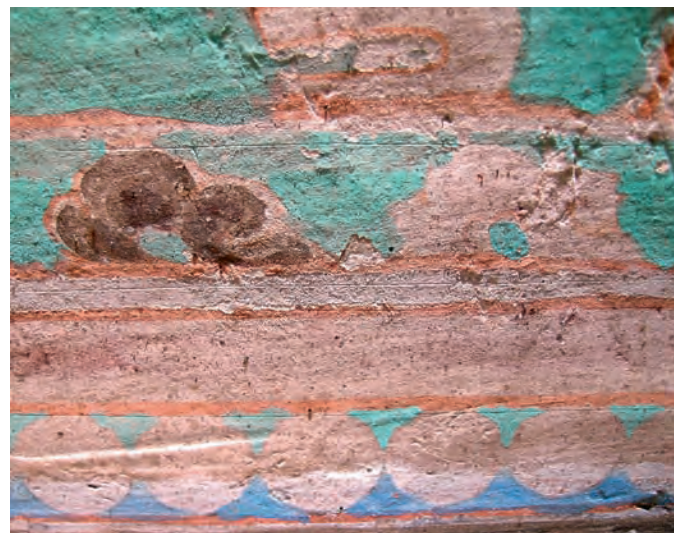
**FIGURE 1** Fine straight-edge incisions in the ground layer provide guides for the painted design on the ceiling caisson. Photo: Rickerby/Shekede 2004

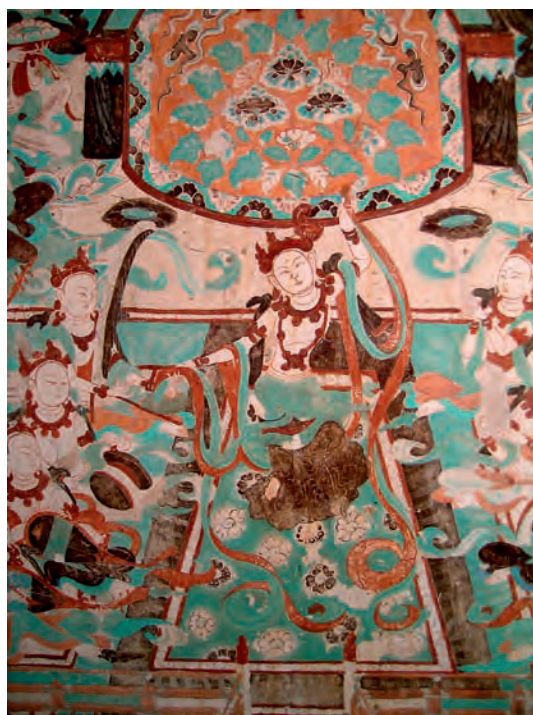
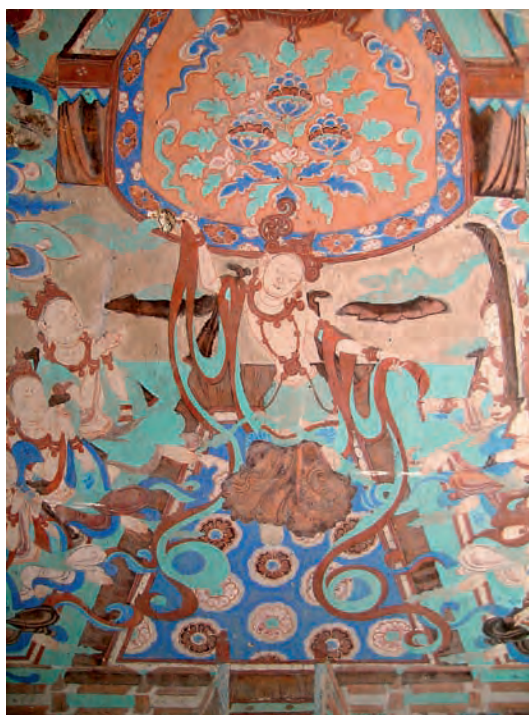
**FIGURES 2 AND 3** Pigment alteration and degradation of organic components is far more severe to the west and north of the cave, clearly demonstrated by comparing a scene on the north wall (left) with a similar scene on the less affected south wall (right). Photos: Rickerby/Shekede 2004

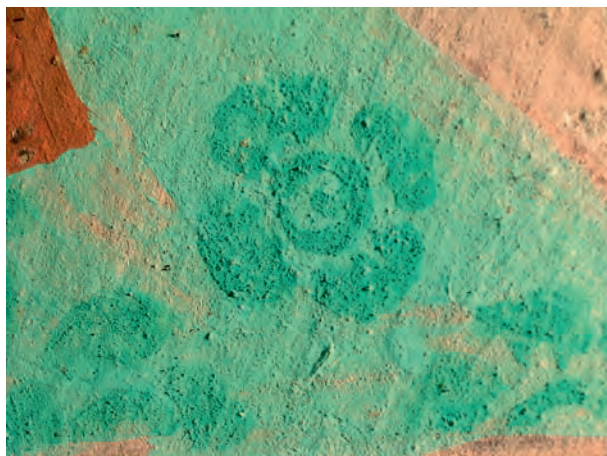
**FIGURE 4** A coarse grade of atacamite green superimposed on a finer grade in the depiction of brocade. Photo: Rickerby/Shekede 2004

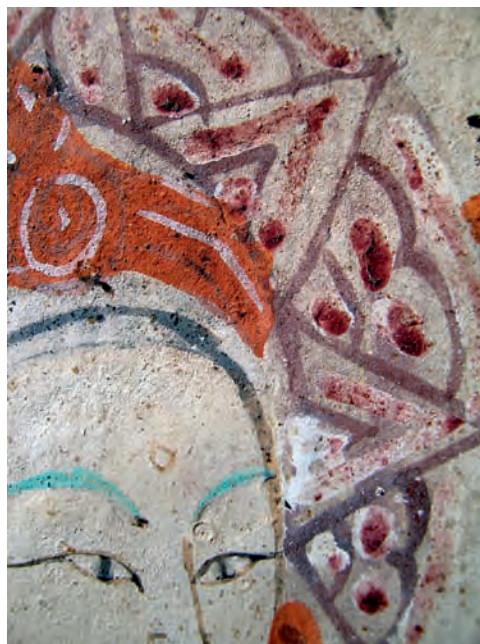
**FIGURE 5** The rich purple-red organic glaze on a decorated halo survives at the east end of the south wall, but few traces have survived toward the west end of the cave due to light exposure and other environmental factors. Photo: Rickerby/Shekede 2004

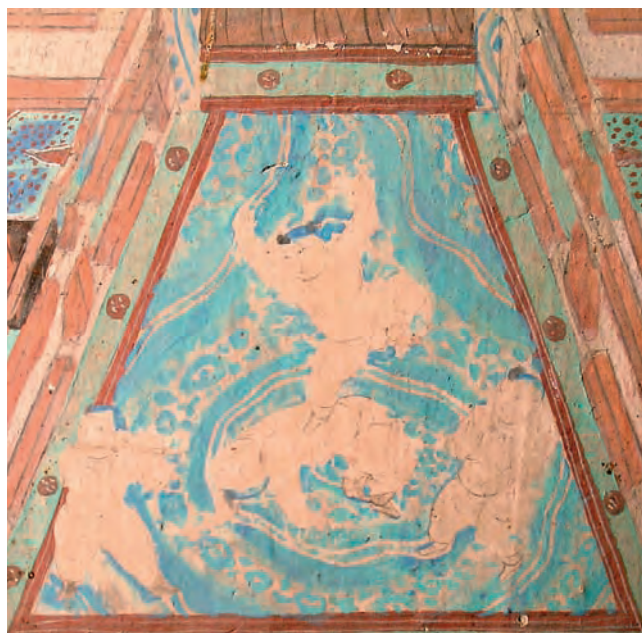
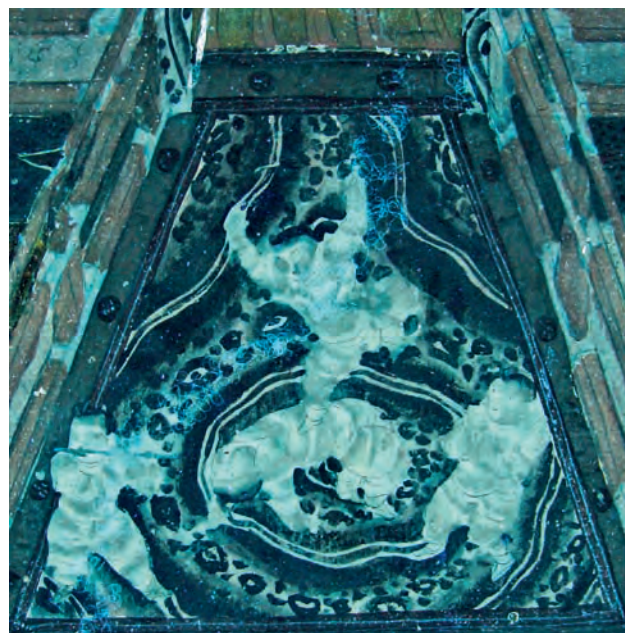
**FIGURES 6 AND 7** The rosy flesh tones of these chubby boy acrobats, no longer visible in normal light (left), seem to have been achieved using organic glazes, but these can now be seen only in UV-induced fluorescence (right). Photos: GCI 2004

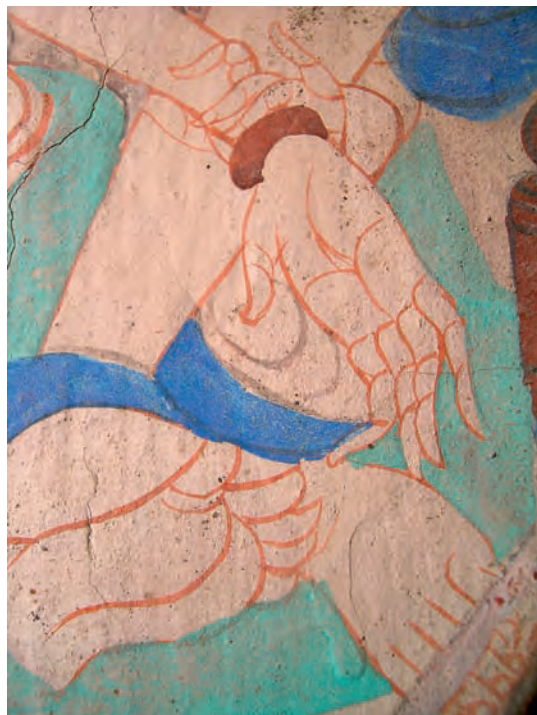
**FIGURE 8** Sinuous and highly controlled line drawing from an especially fine figure group on the south wall. Photo: Rickerby/Shekede 2004

During the Tang dynasty, the final delineation of objects became an increasingly important stage of the painting’s execution and would have been carried out by the most senior members of the painting workshop (Barnhart 1997: 83–85). Extremely refined and economical drawing can be observed in cave 85. Both black and red were used for this purpose and would have been applied using the same bamboo- and animal-hair brushes as those used by calligraphers, whose mastery of line was equally prized (Zhuang Jiayai and Nie Chongzheng 2000: 16–17) (fig. 8).

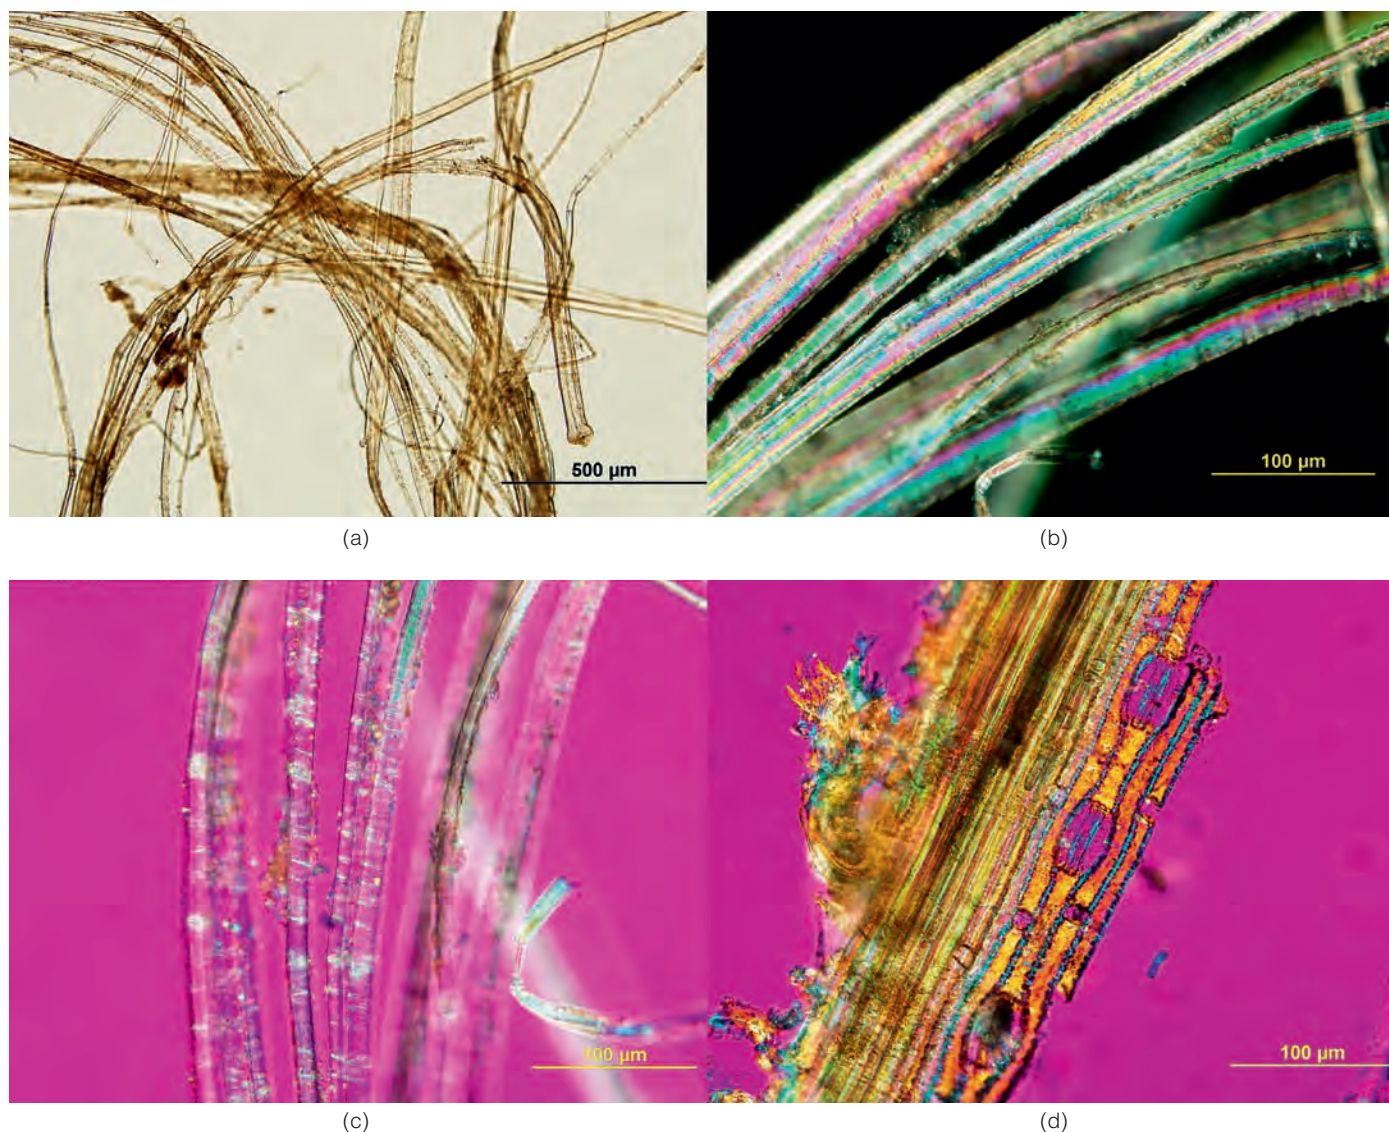
**FIGURE 1** Photomicrographs of plant fibers from the upper and lower plaster layers.

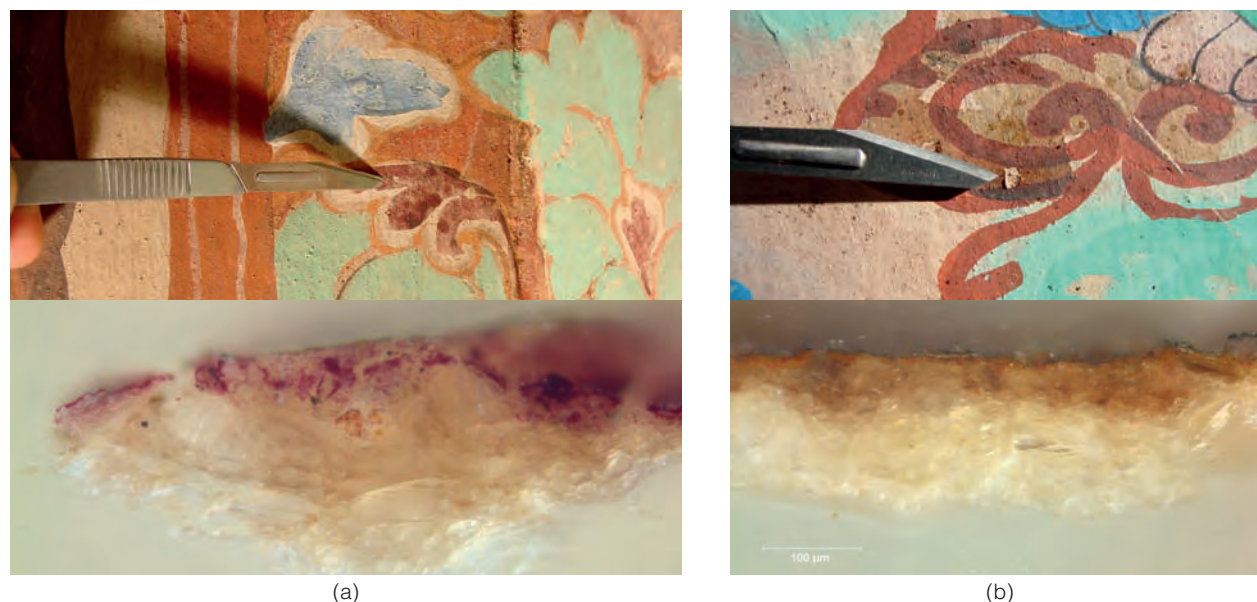
**FIGURE 2** (a) Reddish purple color from a decorative border on the east wall with inset darkfield photomicrograph of paint cross section (sample F03S01); (b) translucent brown from cloud on south wall with inset darkfield photomicrograph of paint cross section (sample F03S21).

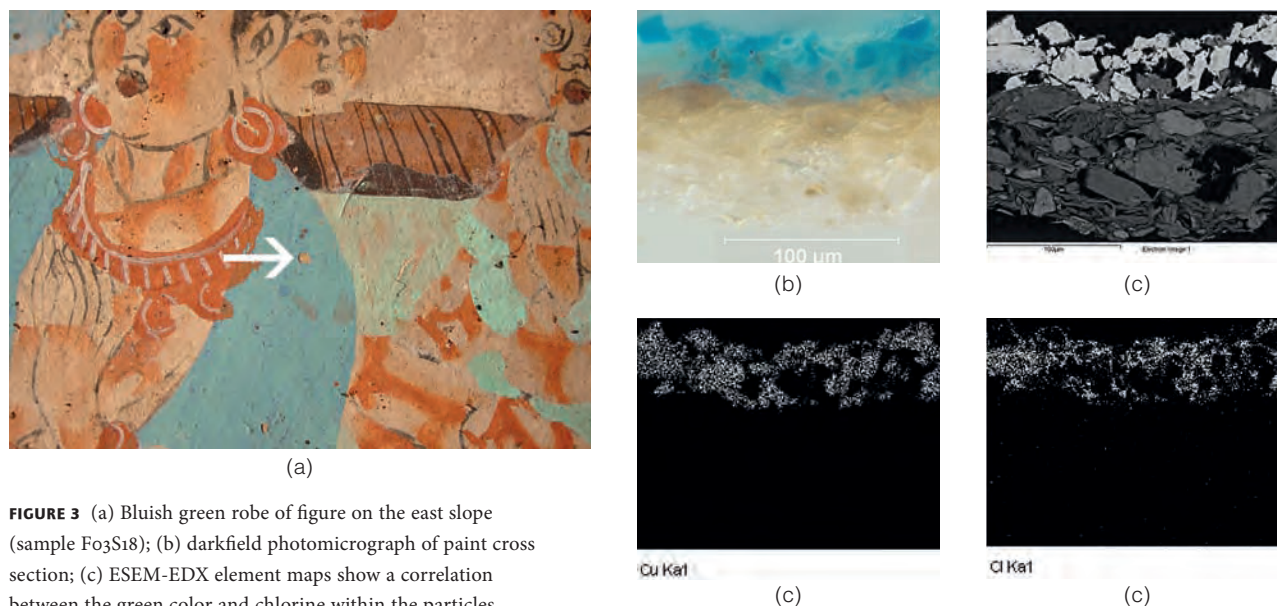
**FIGURE 3** (a) Bluish green robe of figure on the east slope (sample Fo3Si18); (b) darkfield photomicrograph of paint cross section; (c) ESEM-EDX element maps show a correlation between the green color and chlorine within the particles, which indicates a progressive inward transformation of blue azurite into green atacamite.

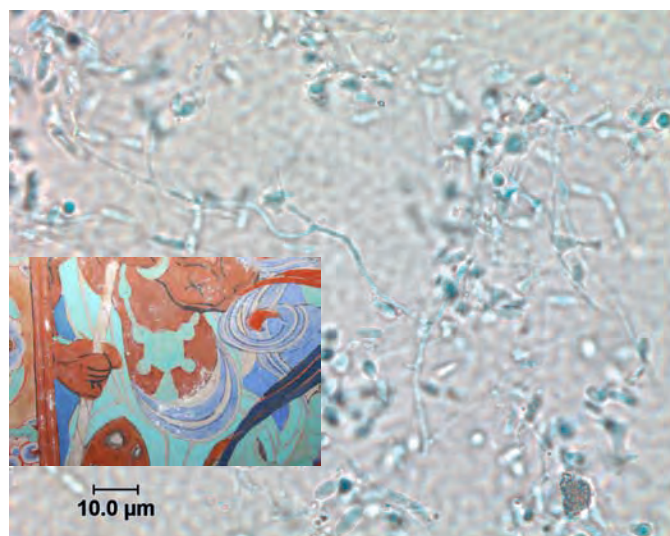
**FIGURE 5** Photomicrograph of white microbial deposit (after staining with methylene blue) that is present on the wall paintings in cave 98.

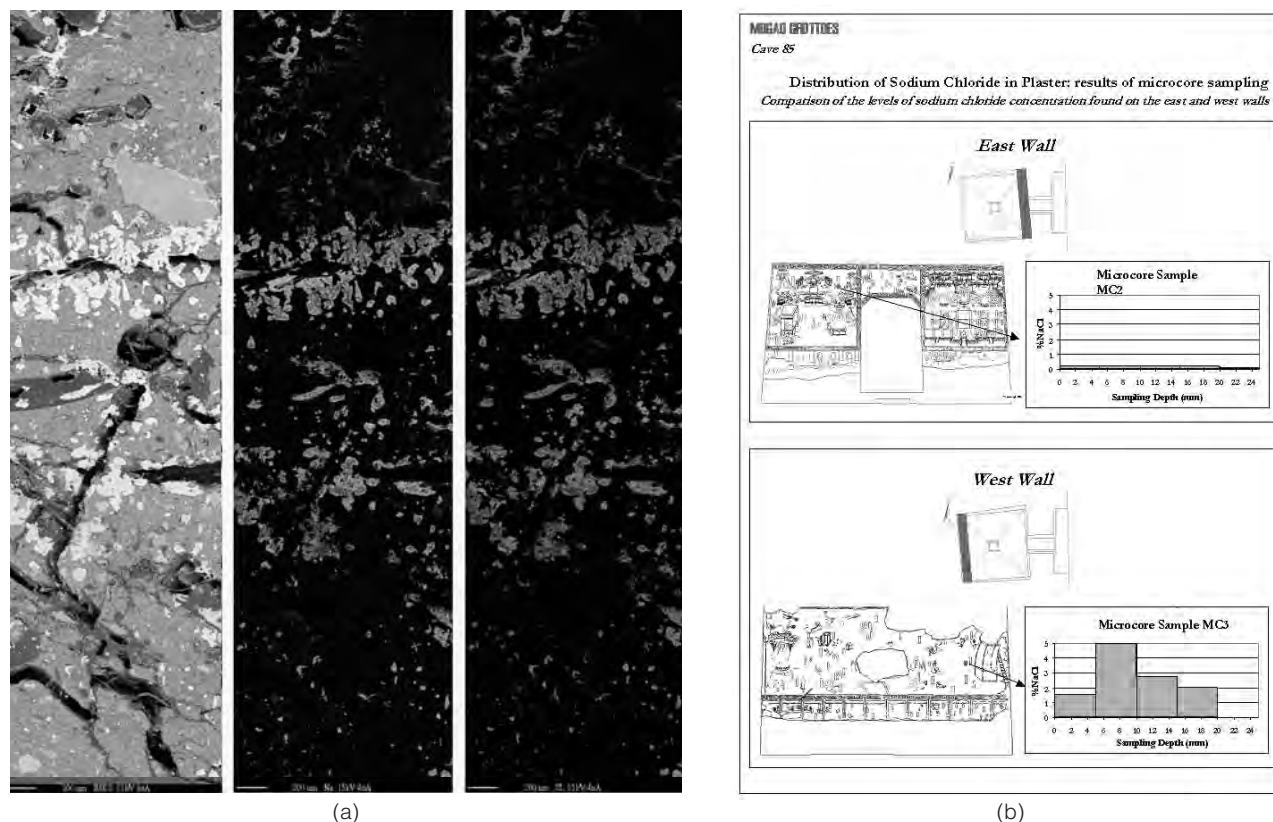
**FIGURE 6** (a) ESEM-EDX element maps for a cross section of plaster from the west end of the north wall (sample 85BQ99E3); (b) salt profiles for plaster microcore samples from the east and west walls.

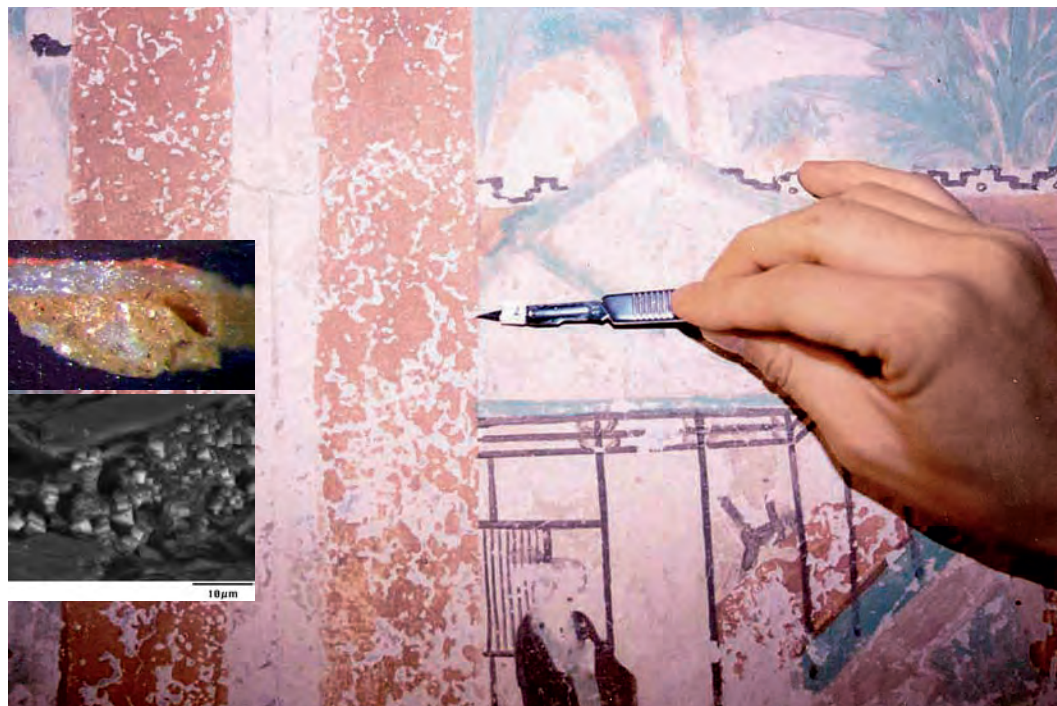
**FIGURE 7** Punctate eruption of sodium chloride crystals between the red paint and ground layers in sample 85NQ98PE2. (a) Darkfield photomicrograph of paint cross section; (b) ESEM enlargement showing cubic crystals of sodium chloride.

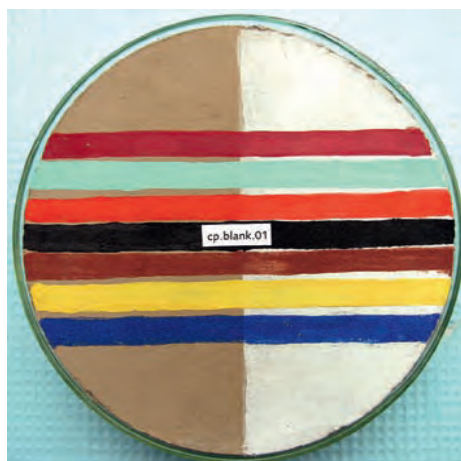
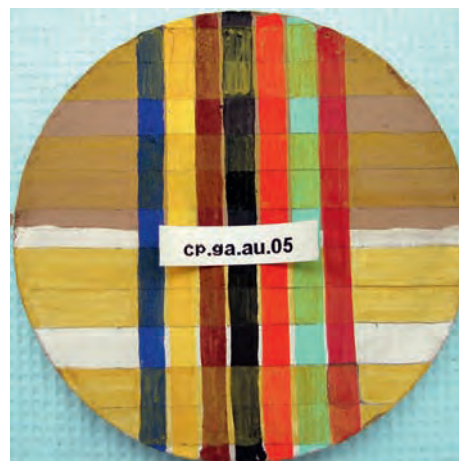
**FIGURE 3** (a) Blank painted plaster coupon as received from the Dunhuang Academy. (b) Coupon with *Gardenia augusta* pigment paints in gum and animal glue applied.

One hundred forty painted plaster coupons, 15 centimeters in diameter, replicating the stratigraphy of the Mogao wall paintings were prepared by the Dunhuang Academy using clay and other materials available at Mogao. Each coupon has a traditional ground layer applied to half of its surface, overlaid with seven stripes of common inorganic paints used in the grottoes (fig. 3a). Organic paints prepared with the reference pigments were applied on the painted plaster cou-

pons (fig. 3b). The plaster, ground, inorganic paints, and lake pigments provide crucial combinations for evaluating an analytical scheme. From each biological source, four mock-ups are produced: two for investigating the best possible analytical procedure(s), one for accelerated aging at the GCI, and one that will be kept in the GCI reference collection for future research.

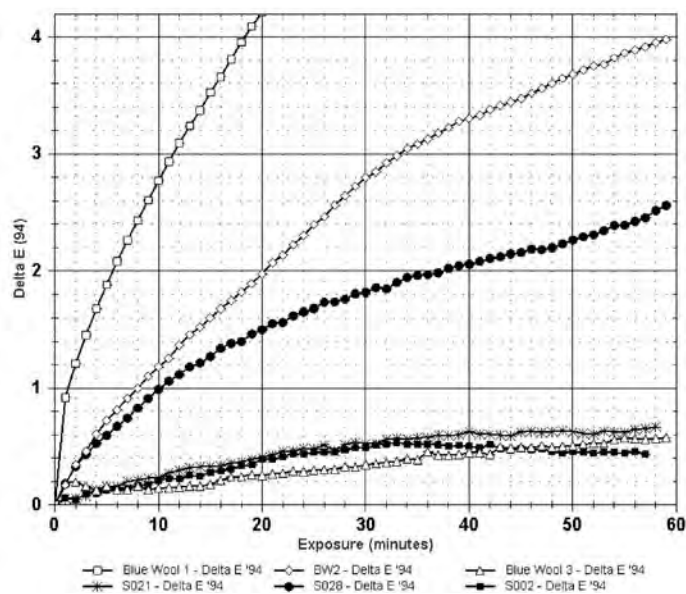
**FIGURE 2** Cave 85, 60-minute comparison of ISO Blue Wools 1–3 and So02 (possible change  $\geq$  BW3), So21 (possible change  $\geq$  BW3), So28 (definite change = BW2–3).

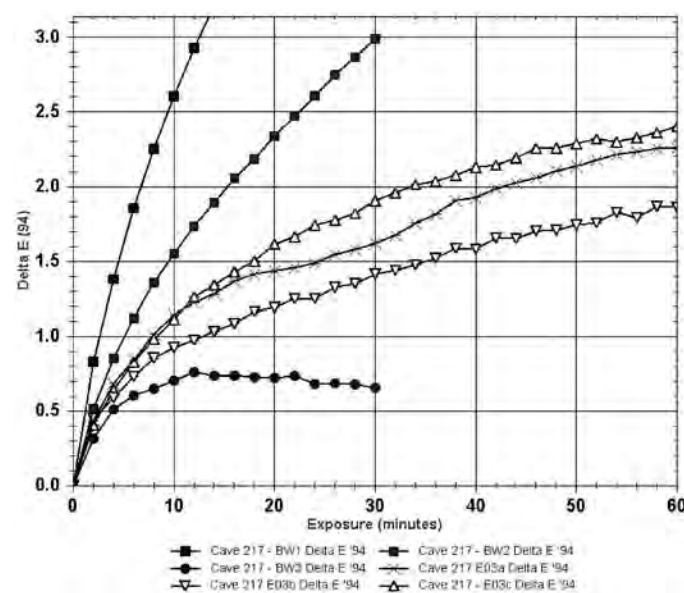
**FIGURE 3** Data from cave 217 for three replicate measurements of sample E03.

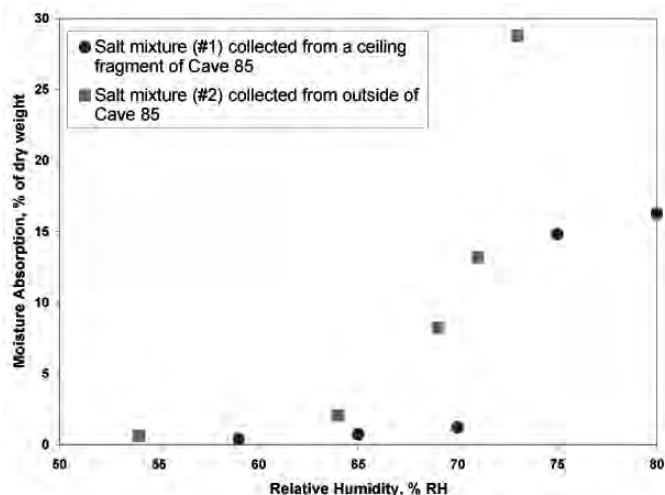
**FIGURE 1** Moisture absorption of salt mixtures collected from the Mogao Grottoes.
