**Mogao Grottoes  
Cave 85 Project**

# Objectives of the Cave 85 Project

# Conservation History and Condition Survey of Cave 85

# Causes and Mechanisms of Deterioration and Damage in Cave 85

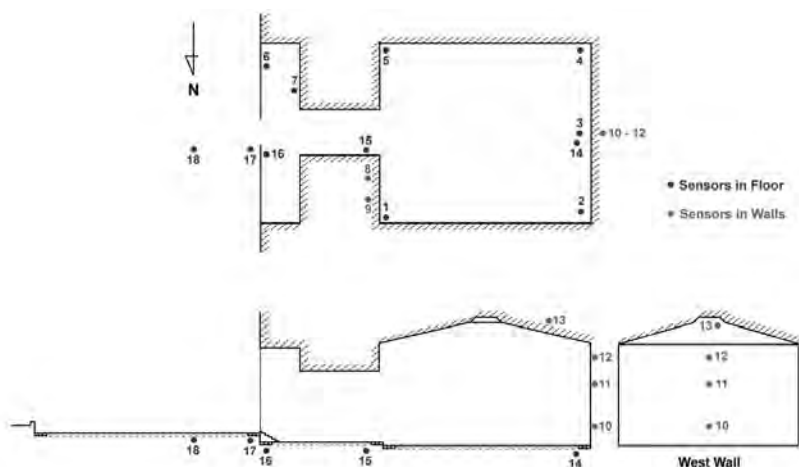
**FIGURE 2** Locations of structural relative humidity and temperature sensors placed in the bedrock conglomerate of cave 85.

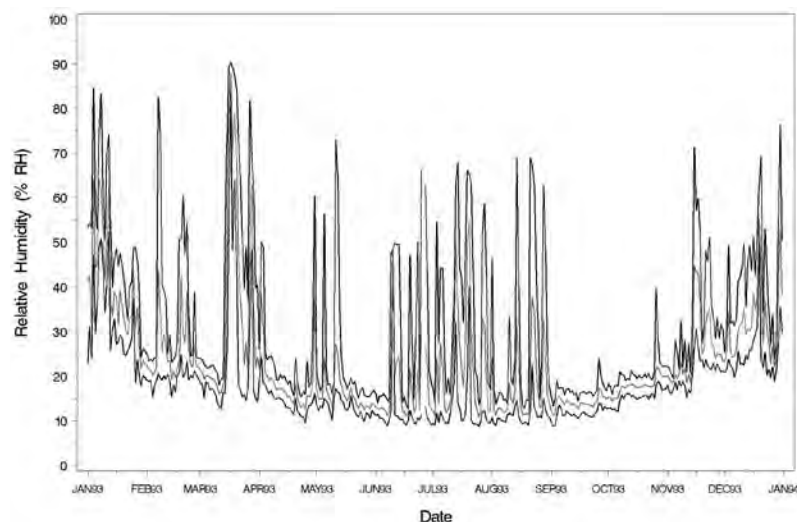
**FIGURE 3** Typical annual variation of relative humidity at the Mogao Grottoes. This example is from 1993.

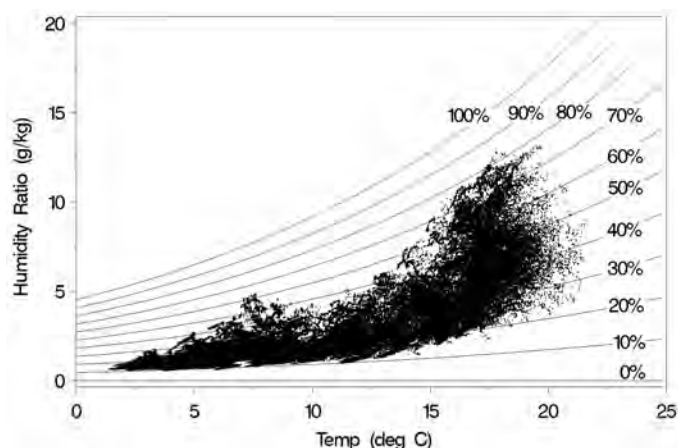
**FIGURE 4** Temperature and relative humidity in cave 85 between 1993 and April 1998 (the cave was open to self-guided tours during operational hours), plotted on a psychrometric chart. Each dot represents a 15-minute (temperature and relative humidity) measurement. Conditions of higher than 75 percent RH were recorded annually during the period.

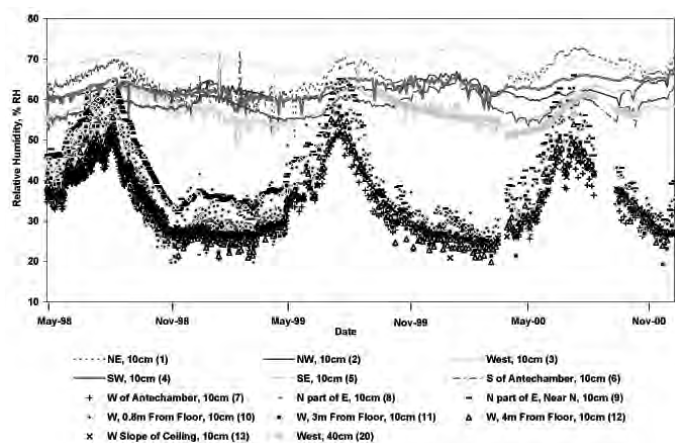
**FIGURE 5** Annual variations of relative humidity in the bedrock of cave 85 between May 1998 and November 2000.

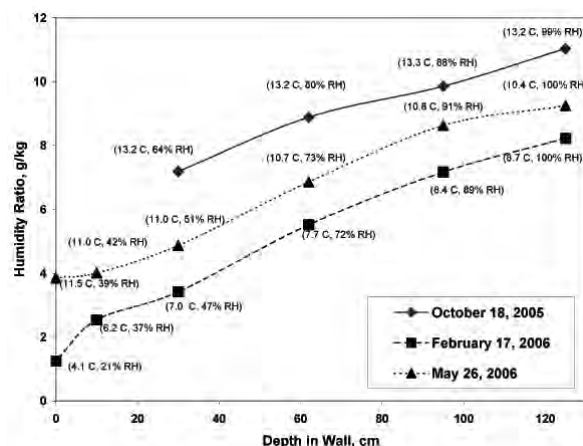
**FIGURE 6** Humidity ratio of the bedrock in the west wall of cave 98 at various depths and seasons. Temperature and relative humidity are also indicated at each measured location.

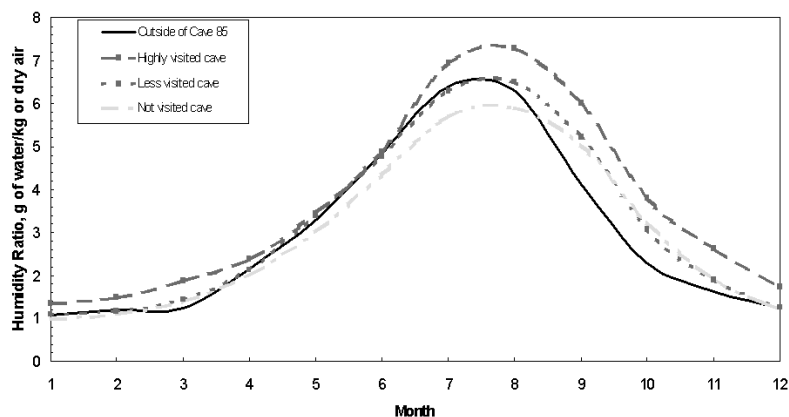
**FIGURE 7** Monthly averages of humidity ratio at the site and inside highly visited, less visited, and not visited caves of the Mogao Grottoes.

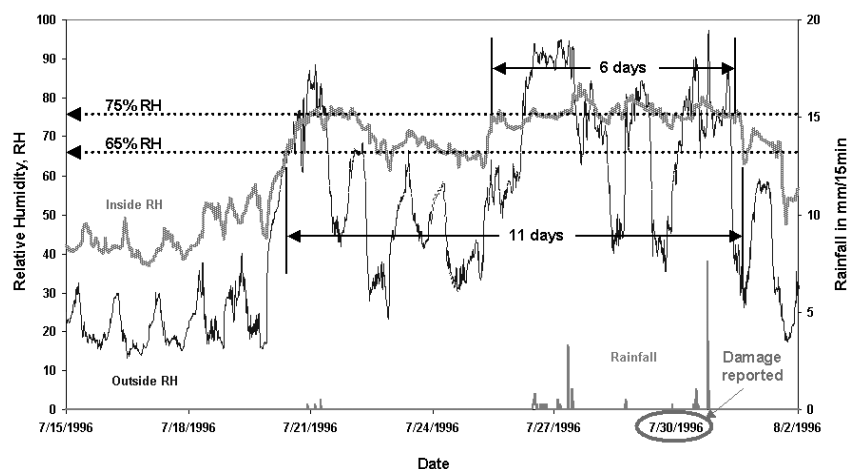
**FIGURE 8** Combined plot of the rainfall, relative humidity of outside air, and relative humidity in cave 85 between July 15 and August 2, 1996. Bars extending from the baseline indicate the measured amount of rainfall for fifteen-minute periods. The Dunhuang Academy reported damage to the wall paintings in the cave on July 30.

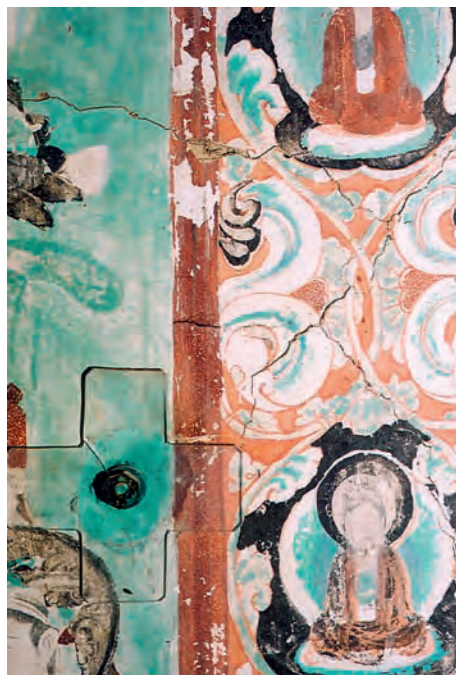
**FIGURE 1** Previous attempts to address the problem of plaster separation in cave 85 have included pinning with rods and anchors. These have tended to concentrate stresses on already weakened plaster layers, leading to further damage and loss. Photo: Stephen Rickerby

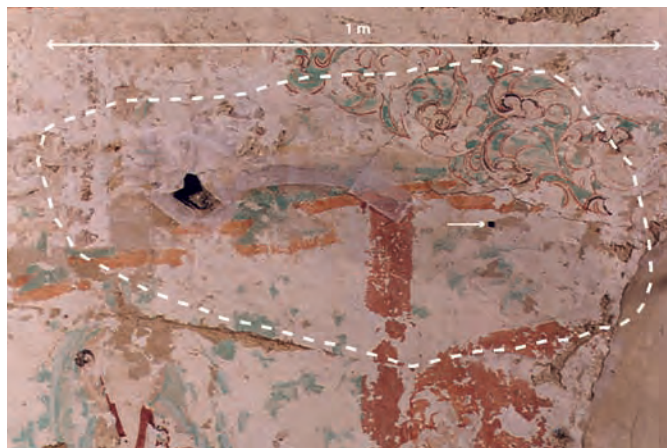
**FIGURE 3** Grout Area 5 on the west wall of cave 85, showing the extent of a typical area of plaster separation. In the development of the soluble-salt reduction procedures, comparative microcore samples were taken *before* grouting and *after* grouting and salt-reduction treatment. The white arrow indicates the location of a *before grouting* microcore, taken in an area of unpainted plaster. The *after grouting* microcore would be taken adjacent to this, to minimize analytical error.

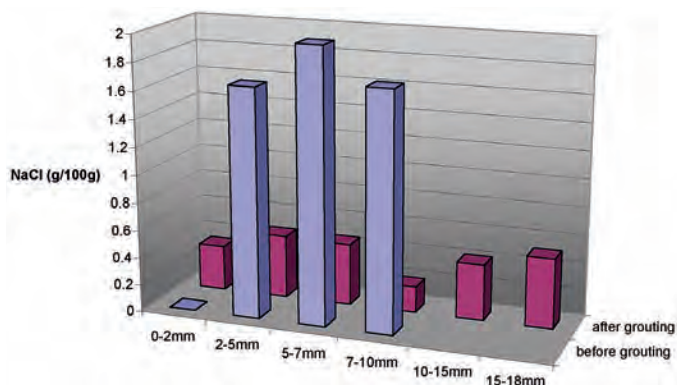
**FIGURE 4** Soluble-ion (Cl<sup>-</sup>) results of microcores taken *before* and *after* grouting and soluble-salts reduction treatment for Grout Area 5 (also see fig. 3). The *before grouting* microcores attained an overall depth of 10 millimeters (mm) before reaching the void in the detached plaster; the result for the 0–2 mm increment is anomalous, probably due to loss of material during sampling. For the *after grouting* microcores, the 10–15 mm and 15–18 mm increments were taken through the injected grout, reaching back to the conglomerate rock. The results indicate a significant reduction in chloride levels after treatment.

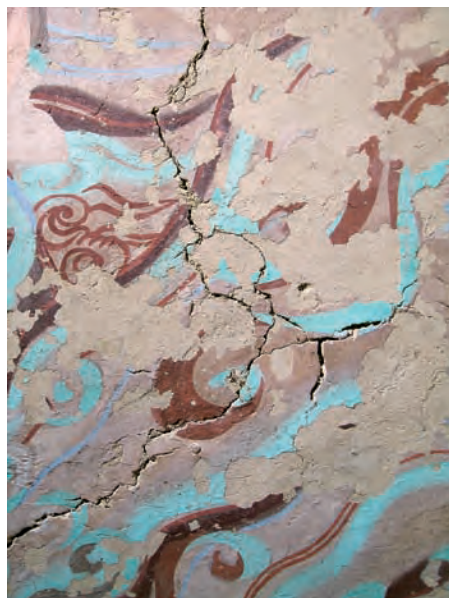
**FIGURE 2** Cracks in the painted earthen plaster in cave 85. Photo: S. Rickerby

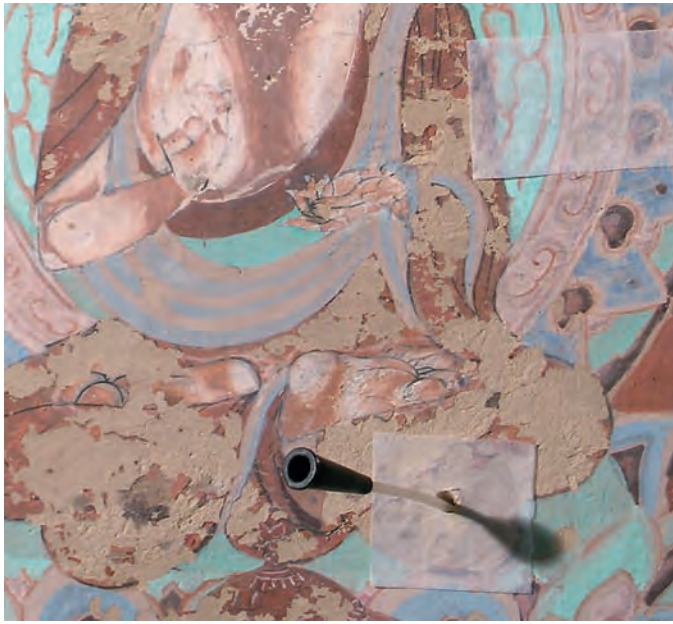
**FIGURE 3** A grout catheter placed in an insertion point that has been stabilized with a temporary facing. Photo: S. Rickerby

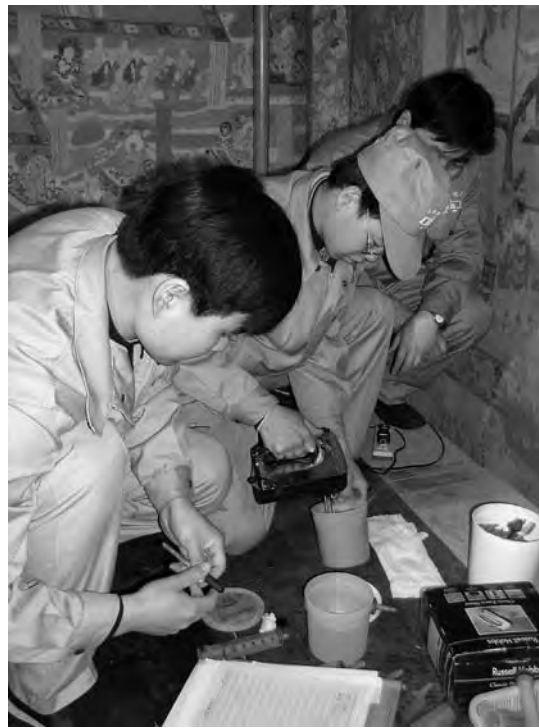
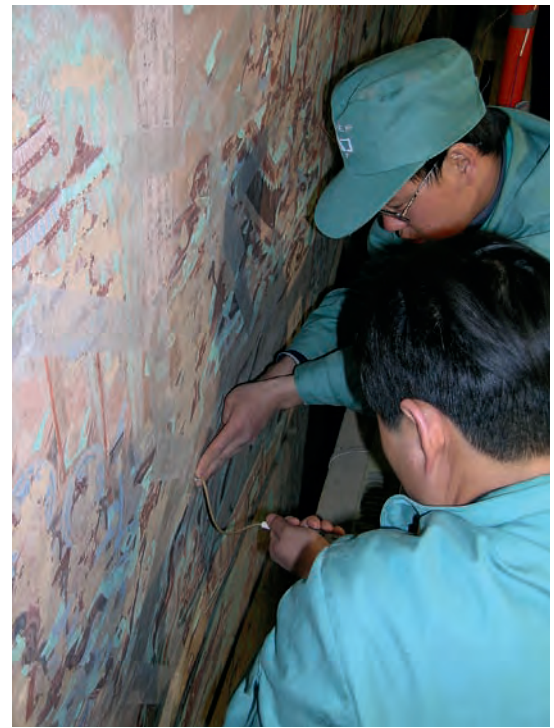
**FIGURE 4** Grouting was a team exercise. Dunhuang Academy conservators (a) prepare grout and syringes and (b) deliver grout while supporting the treated area. Photos: S. Rickerby

Because of the risks, caution and restraint were essential. Usually four conservators were involved in the grouting of a single area: two preparing the grout and syringes, one delivering the grout, and the other manually checking and supporting the plaster (fig. 4). Since grouting is a team exercise, effective communication was key. Oversight was maintained by compiling treatment logs detailing the amount of injected grout and the quantities of added water required to fluidize the basic grout mixture in response to differing grouting situations.

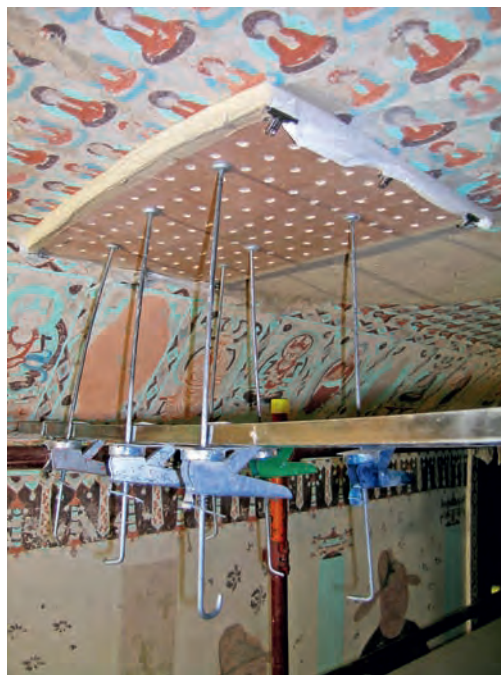
**FIGURE 5** A customized press placed against treated plaster for support and to absorb moisture released from the grout. Photo: S. Rickerby

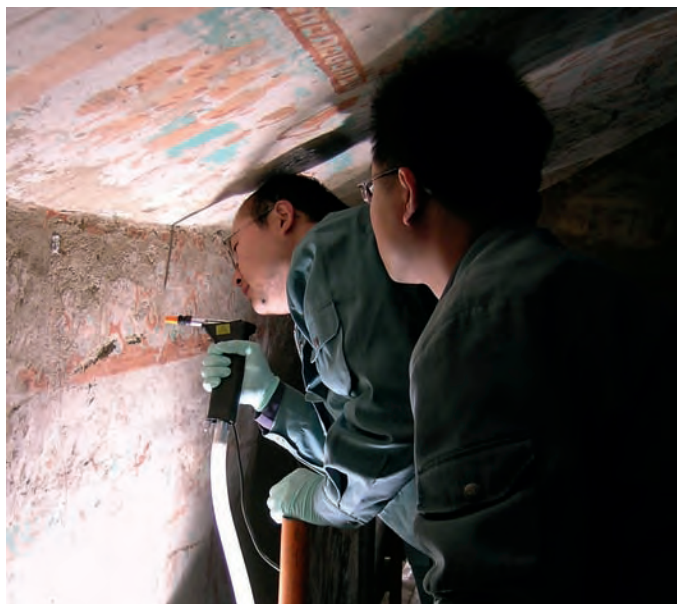
**FIGURE 6** An ultrasonic humidifier being used to dissolve surface salts on the treated area of a wall painting. Photo: S. Rickerby

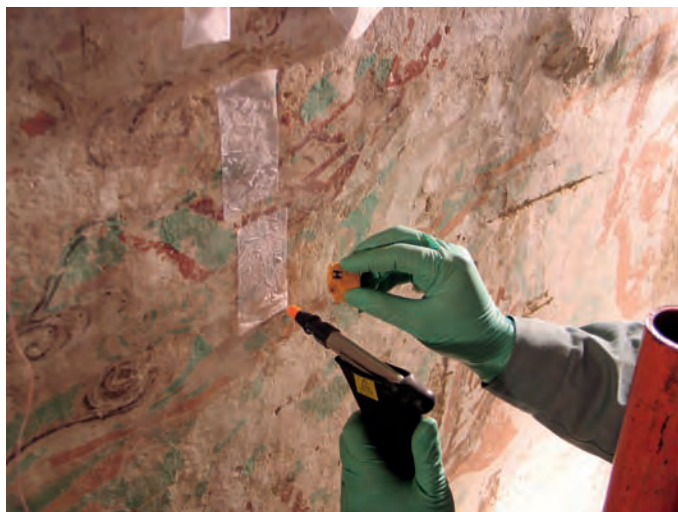
**FIGURE 2** Salts being removed with the Preservation Pencil.

plaster layers (Li Zuixiong 2005; Rickerby et al., “Testing and Development,” this volume). After poulticing, the salt content in the wall paintings was further reduced through the use of a Preservation Pencil (fig. 1), an ultrasonic humidifier manufactured by Preservation Equipment Ltd., England. By misting the wall paintings with water vapor directed from the nozzle of the device and blotting the paintings immediately with cotton paper, a portion of the salts could be removed safely from the painted surfaces (fig. 2).

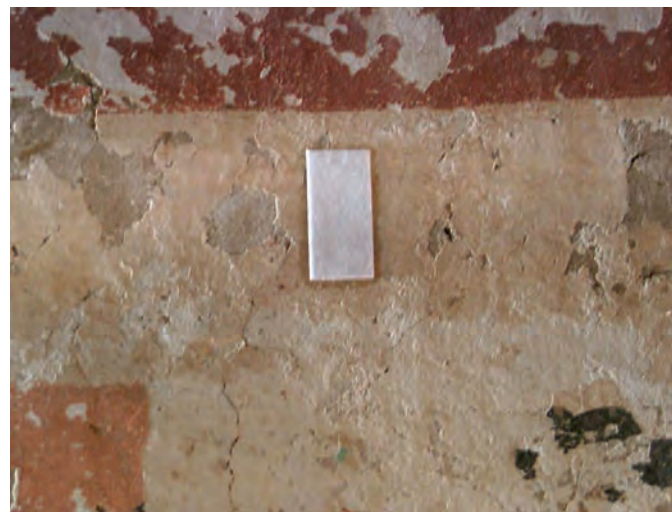
**FIGURE 3** Prewetted paper strip applied to a wall painting in cave 85.

spot test method, a **prewetted and standardized size of absorbent chromatography paper** was applied to the surface of the wall painting for a specified amount of time, then removed and immersed in deionized water. The concentration of chloride ion in the water was then measured by a chloride-specific ion electrode.

A single layer of chromatography paper (Grade 81-24) was cut into strips 1 centimeter by 2 centimeters (approximately 40 mg in weight and 1 mm in thickness). The paper strip was placed into distilled water using a fine-point tweezers and removed after five seconds. Excess water was removed by touching the paper strip to the container wall. The average weight of water in the saturated paper was 160 milligrams  $\pm$  2 percent relative standard deviation (based on twenty-seven replicate measurements). The wetted strip was applied to the surface of a prefabricated clay coupon that contained 6 percent by weight of salt (Chen Gangquan et al. 2005), carefully avoiding pockets of air. It was determined that the paper should be removed after forty seconds, by which time a maximum of 60 milligrams of water will have entered the plaster coupon and penetrated to a depth of 2 millimeters. The paper strips were then put into plastic tubes that contained exactly 2 milliliters of deionized water, and after six hours the chloride ion concentration was measured using a chloride-specific ion electrode (Thermo Orion Model 290 meter and

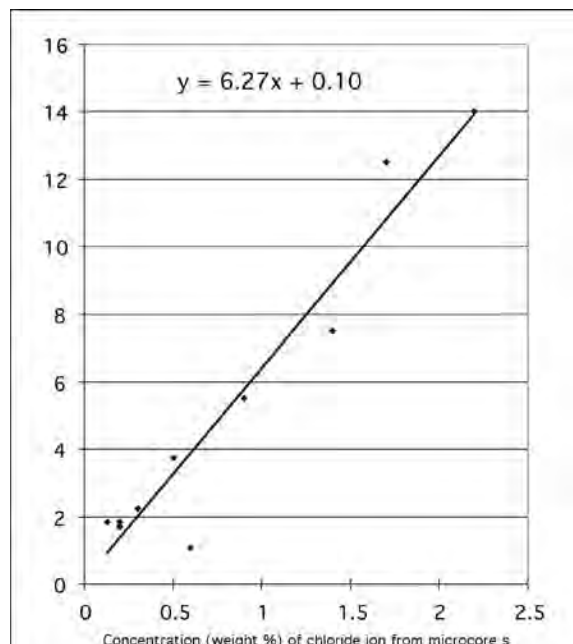
**FIGURE 4** Relationship between chloride ion concentration in spot tests and plaster microcores.

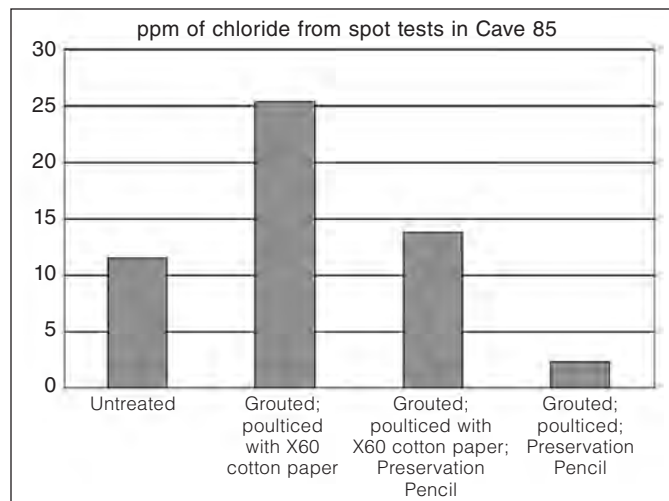
**FIGURE 5** Summary of results from tables 1–5.

The spot test method was used to assess the results of poulticing on the west wall in cave 85. Tables 1–4 list chloride ion concentrations for various types of plaster: untreated (ungrouted) plaster (table 1), grouted plaster poulticed with X60 cotton paper (table 2), grouted plaster poulticed with X60 cotton paper and treated with the Preservation Pencil (table 3), and ungrouted plaster treated with the Preservation Pencil (table 4). Table 5 summarizes the results from the previous tables, and figure 5 illustrates the mean data from table 5. The test results indicate that after grouting the moisture from the grout redistributes hygroscopic salts within the plaster layer and enriches them at the surface.

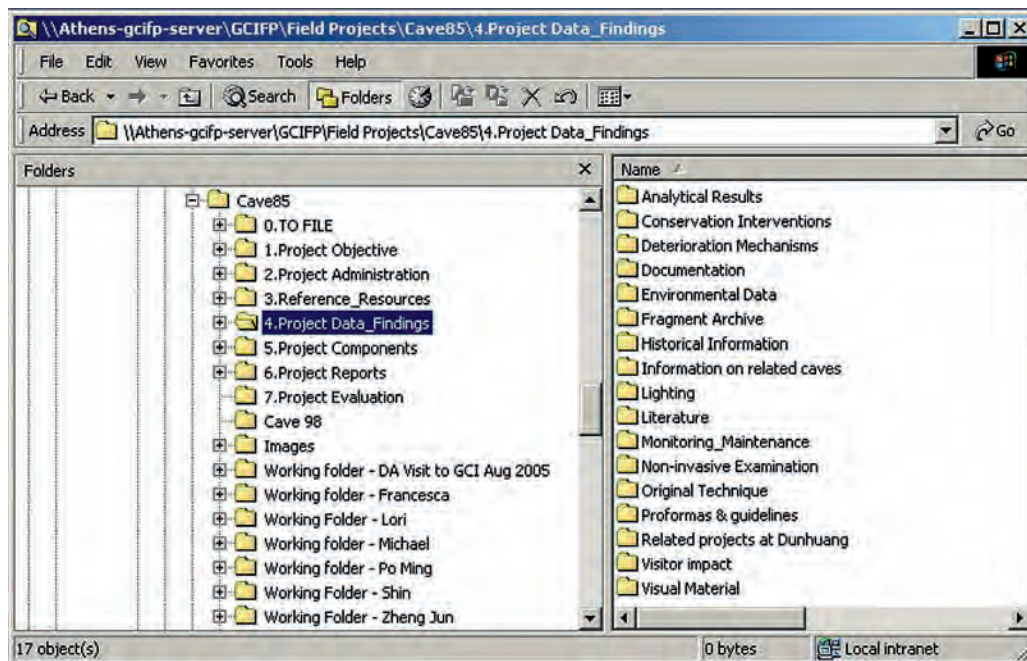
FIGURE 1 File organizational structure for the cave 85 project.

The cave 85 project data in electronic form consist of over 50 gigabytes of text, data, photographic, and graphic files. The files are in a number of different formats, including Microsoft® Word, Excel, and PowerPoint documents, Autodesk® AutoCAD drawings, Adobe® InDesign, Photoshop and Illustrator files, and thousands of digital images in RAW, TIFF, and JPEG format. The amount of information has steadily increased throughout the project, with a dramatic rise starting in 2003 with the transition from film to digital photography.

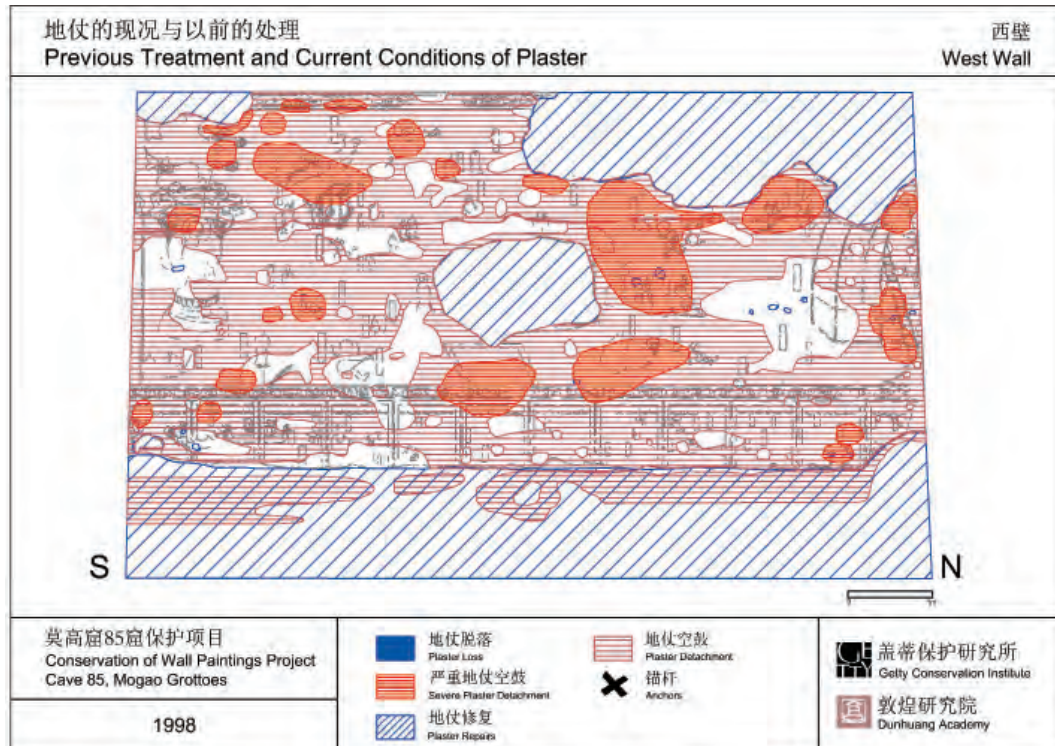
**FIGURE 4** The condition of the wall paintings was recorded on transparencies laid over photographs and then transferred into digital format as CAD drawings. This image shows the west wall of the cave with areas of loss and plaster detachment graphically indicated.

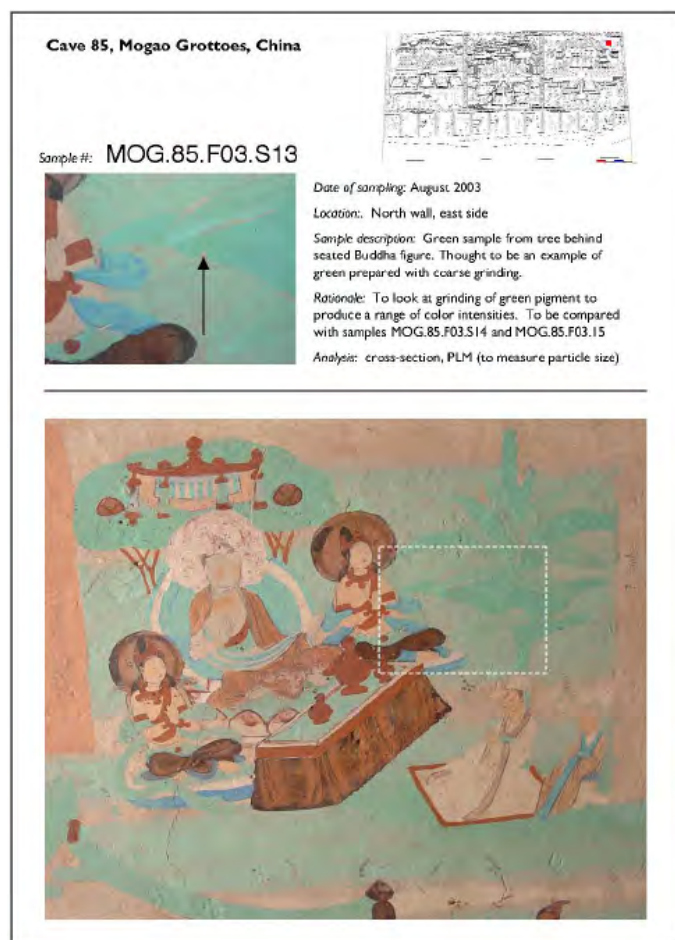
**FIGURE 5** An example of the reports created for each individual sample.

Sampling was undertaken to characterize the original materials of the painting and to understand painting techniques. Each sample was documented, and analytical tests were employed depending on the particular questions to be answered. A separate report was then created for each sample (fig. 5). This included a description of the sample, its location, sampling rationale, and results of the analysis. The raw data resulting from each analysis were also archived separately to allow for future reference and study.

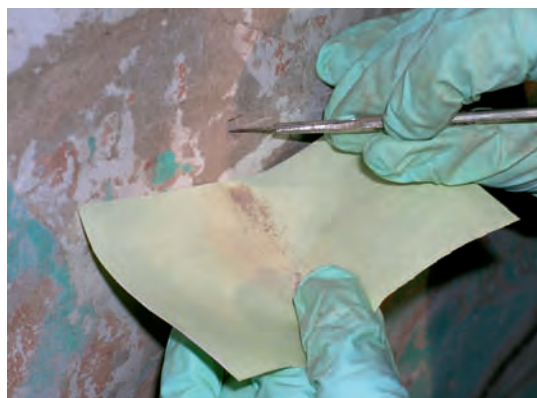
**FIGURE 6** Plaster microcores being sampled as part of a comprehensive salt survey. Each core was taken at four or five incremental depths into the upper 10 millimeters of the wall where paint has been lost. The samples were analyzed to identify ions of soluble salts present and their topographic and stratigraphic distribution throughout the cave.
