# Seismic Stabilization of Historic Adobe Structures

**Final Report of the Getty Seismic Adobe Project**

**E. Leroy Tolles**

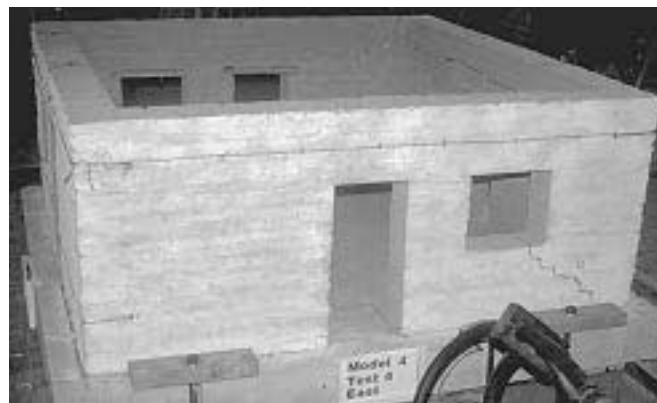
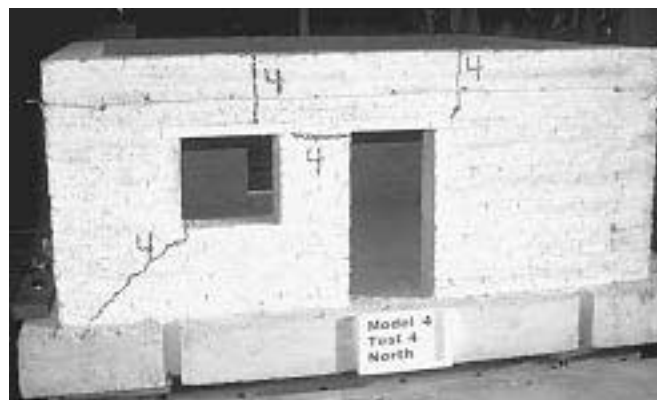
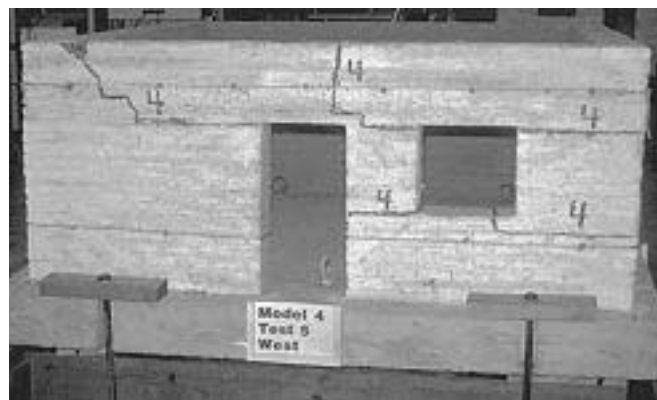
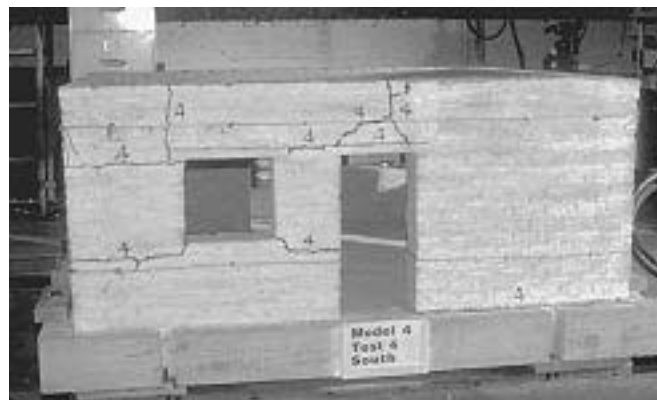
**Figure 3.2**

Damage began during test level IV when cracks developed primarily in the in-plane walls (fig. 3.2). The thick walls ( $S_L = 5$ ) resisted the out-of-plane motions, but the in-plane forces exceeded the strength of the adobe.

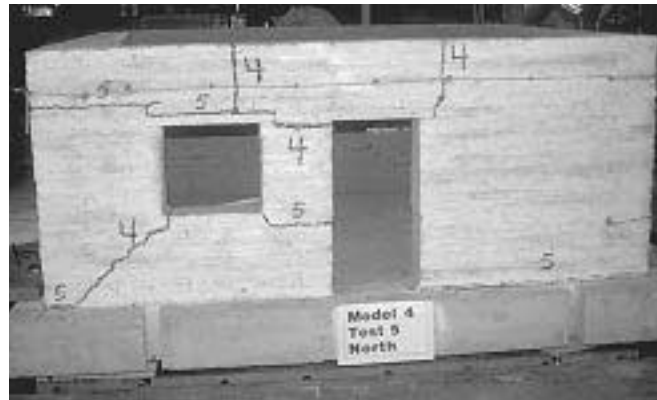
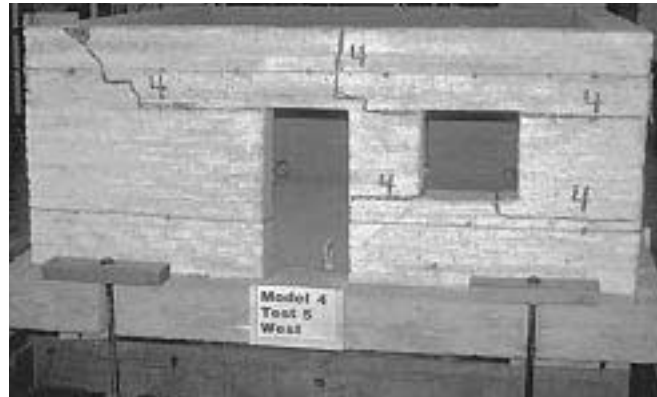
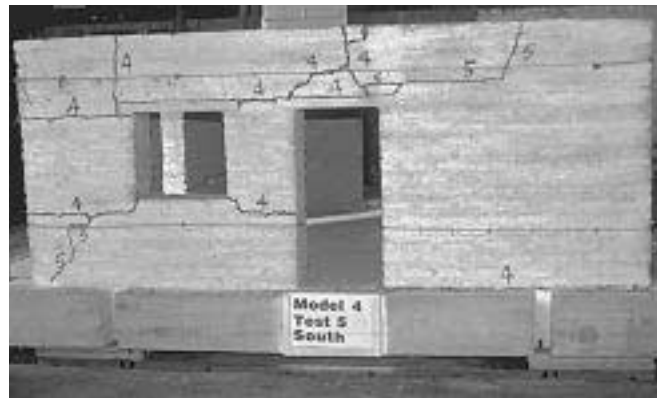
**Figure 3.3**

The development of the primary system of cracks was completed during test levels V and VI (figs. 3.3 and 3.4). At this point in the test sequence, the retrofit system became active.

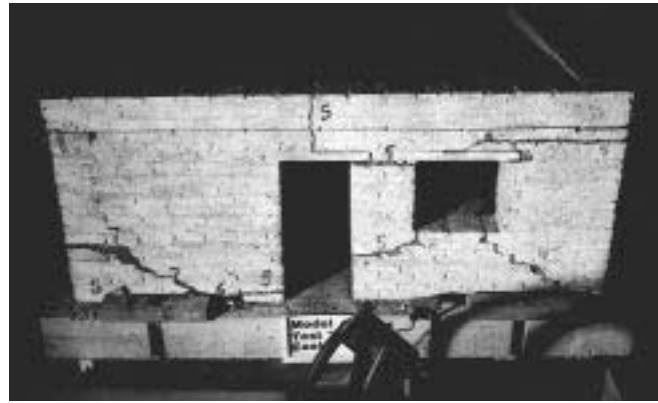
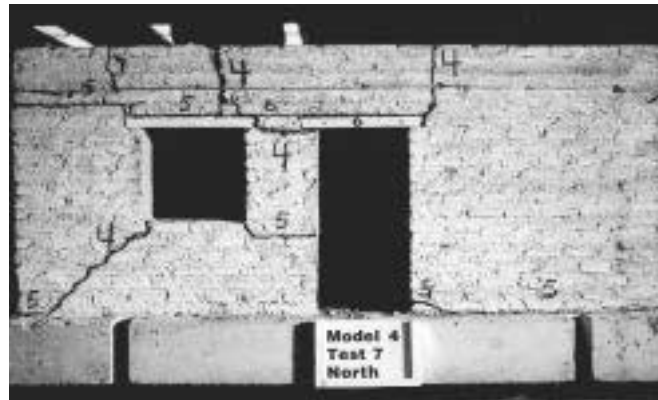
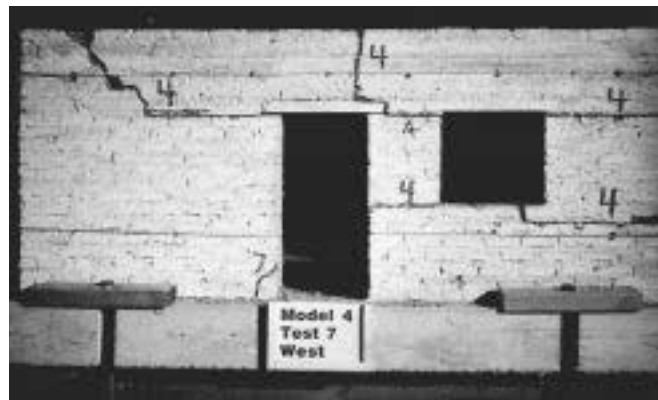
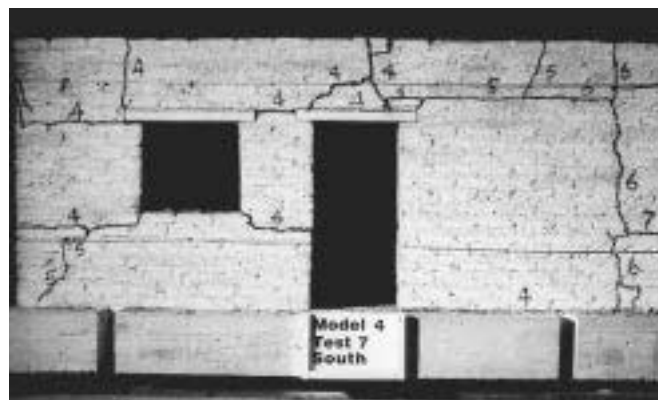
### Figure 3.5

Although no thick-walled ( $S_L = 5$ ) control model was tested, it would appear that an unretrofitted model ( $S_L = 5$ ) would have collapsed during test level VII (fig. 3.5) or VIII. During these tests, the retrofit system was very active, and the cracked wall sections began to undergo permanent displacements.

Model 4, test level VII, showing crack pattern in (a) east wall (out of plane); (b) north wall (in plane); (c) west wall (out of plane); and (d) south wall (in plane). Crack pattern was nearly complete. In the east wall, cracks developed along the base of the main panel as the wall rocked back and forth at the base. A similar crack extended completely across the base of the west wall. The retrofit straps were definitely effective during this test. They acted to restrain the out-of-plane motions of the walls and the relative in-plane displacements of the cracked wall sections. (Note: The photographs for test level VIII, which show only a few additional cracks and crack extensions, are not included here.)

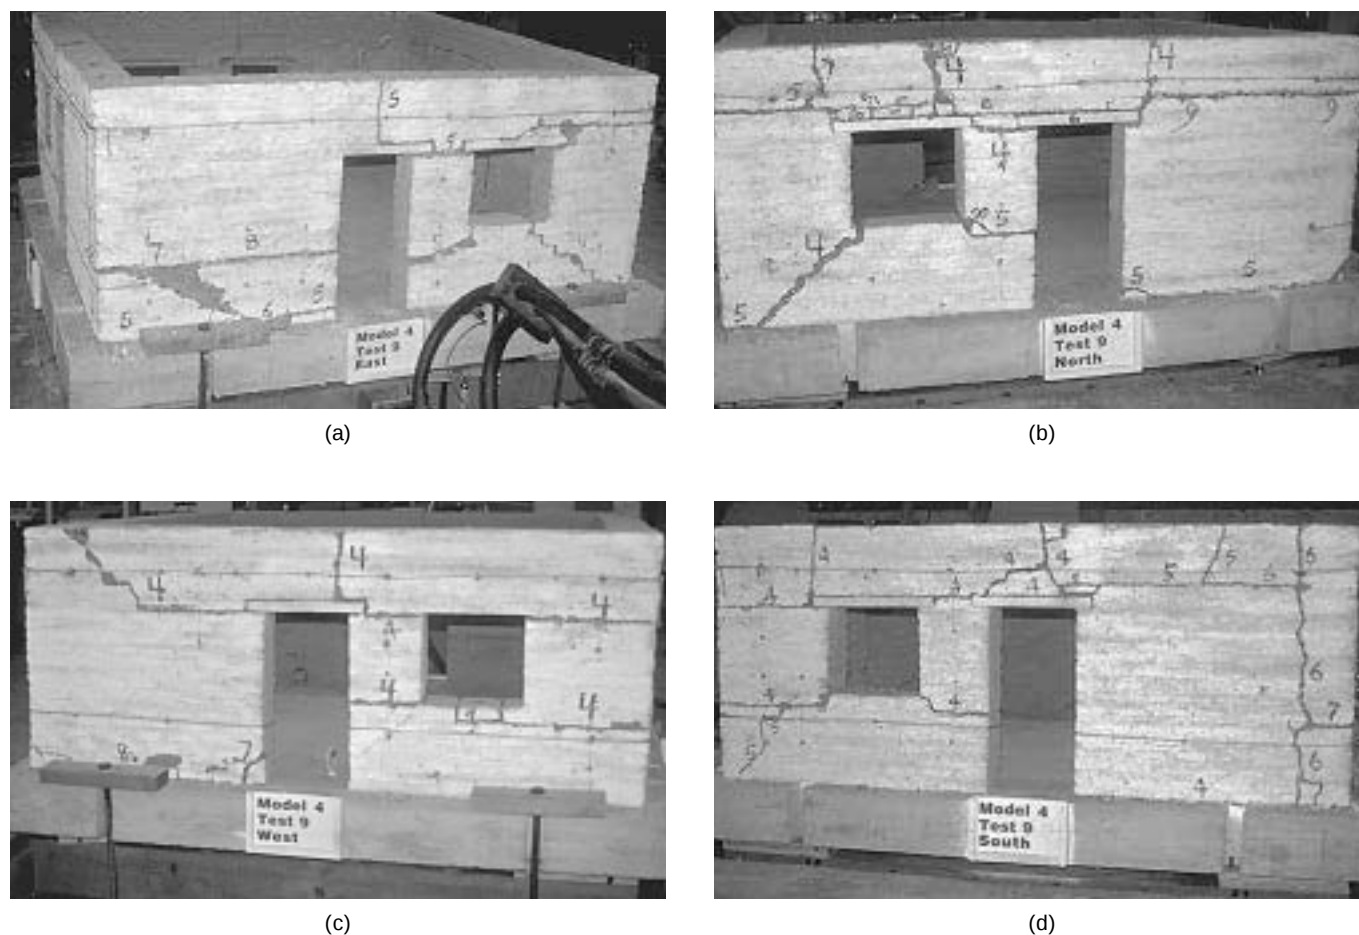
**Figure 3.6**

Model 4, test level IX, showing crack damage to (a) east wall (out of plane); (b) north wall (in plane); (c) west wall (out of plane); and (d) south wall (in plane). (Test level cracks are not marked on east and west walls; see Fig. 3.7a and c.) Before this test level, local crack ties were added to the pier blocks between the doors and windows because of the large displacements sustained during test level VIII. During test levels VIII and IX, rocking of the wall sections was greatly restrained by the upper horizontal strap. This restraint generated additional horizontal cracks in the large panel to the left of the door in the east wall at about one-third height.

offsets sustained during test level VIII. These blocks were pushed back into position before the ties were applied. The model behaved well during test level IX (fig. 3.6), although there were permanent offsets between many cracked wall sections.

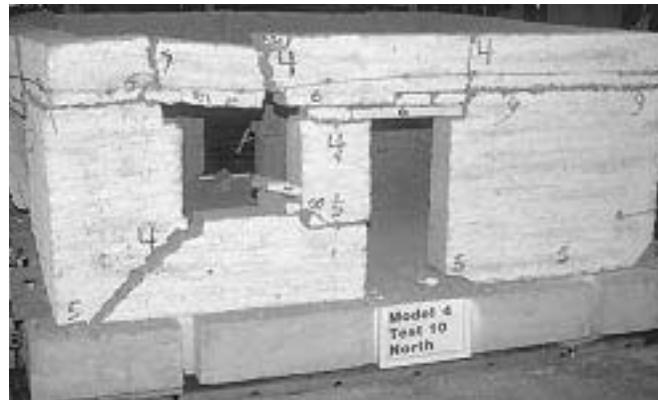
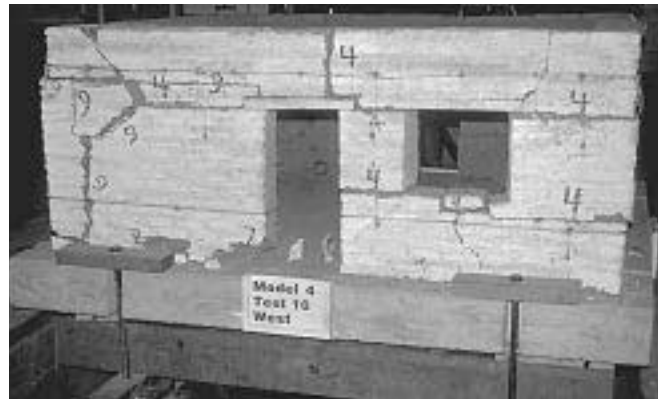
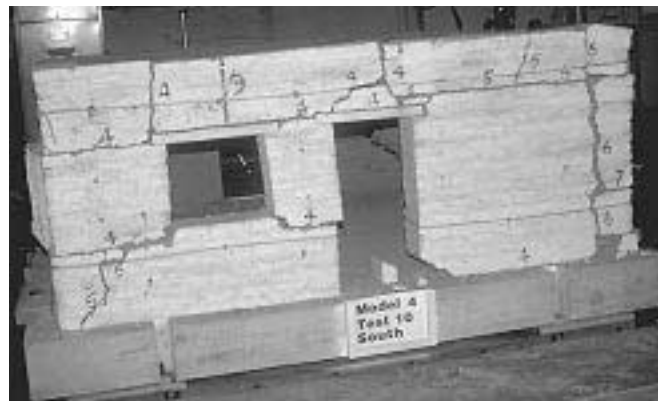
**Figure 3.7**

The model nearly collapsed during test level X (fig. 3.7). The east wall was leaning outward at the end of the test. The wood lintel over the door of the east wall was dislodged, and the adobe block above it was nearly dislodged.

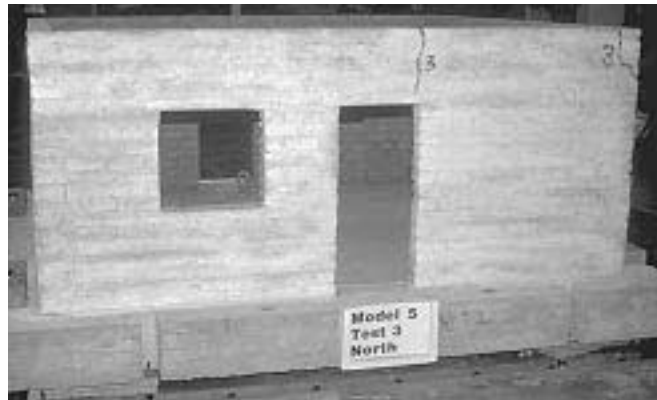
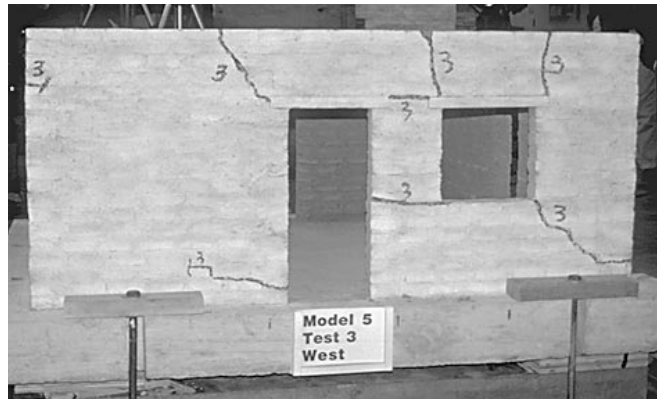
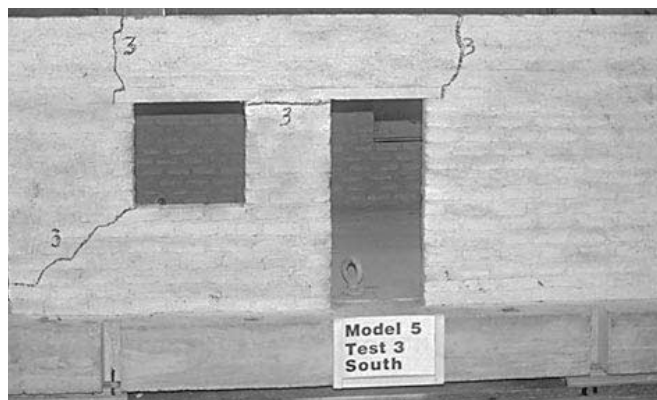
**Figure 3.8**

Model 5, test level III, showing (a) east wall (out of plane); (b) north wall (in plane); (c) west wall (out of plane); and (d) south wall (in plane). Minor cracking is seen with little visible out-of-plane wall displacement. Similar types and numbers of cracks developed in both in-plane and out-of-plane walls.

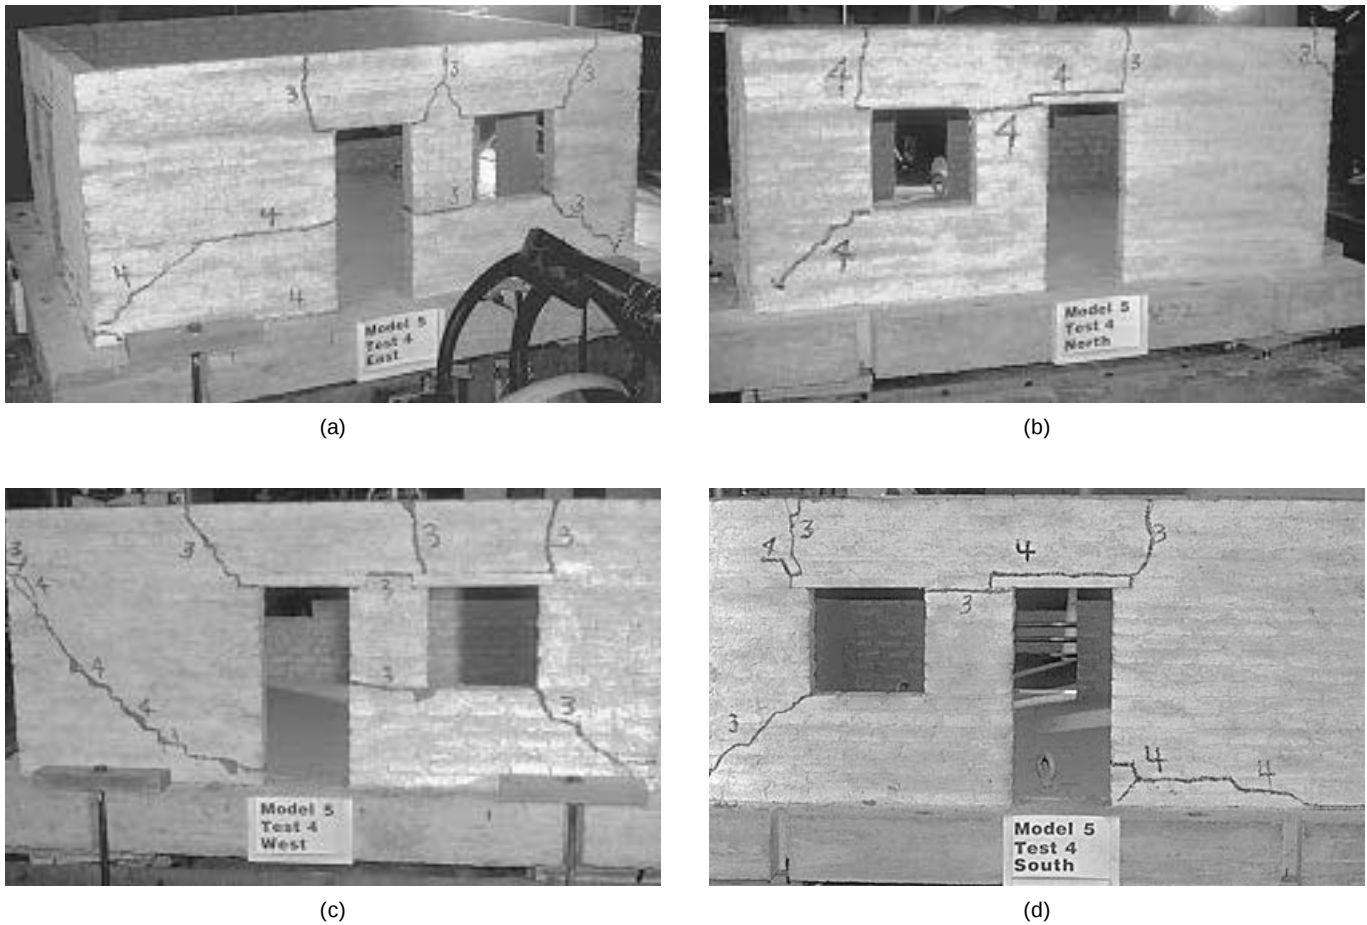
**Figure 3.9**

Model 5, test level V (fourth in the test sequence), showing cracking in (a) east wall (out of plane); (b) north wall (in plane); (c) west wall (out of plane); and (d) south wall (in plane). Fully developed crack pattern is visible with flexural cracks in the out-of-plane walls and shear cracks in the in-plane walls. The walls rocked noticeably during the test but did not collapse.

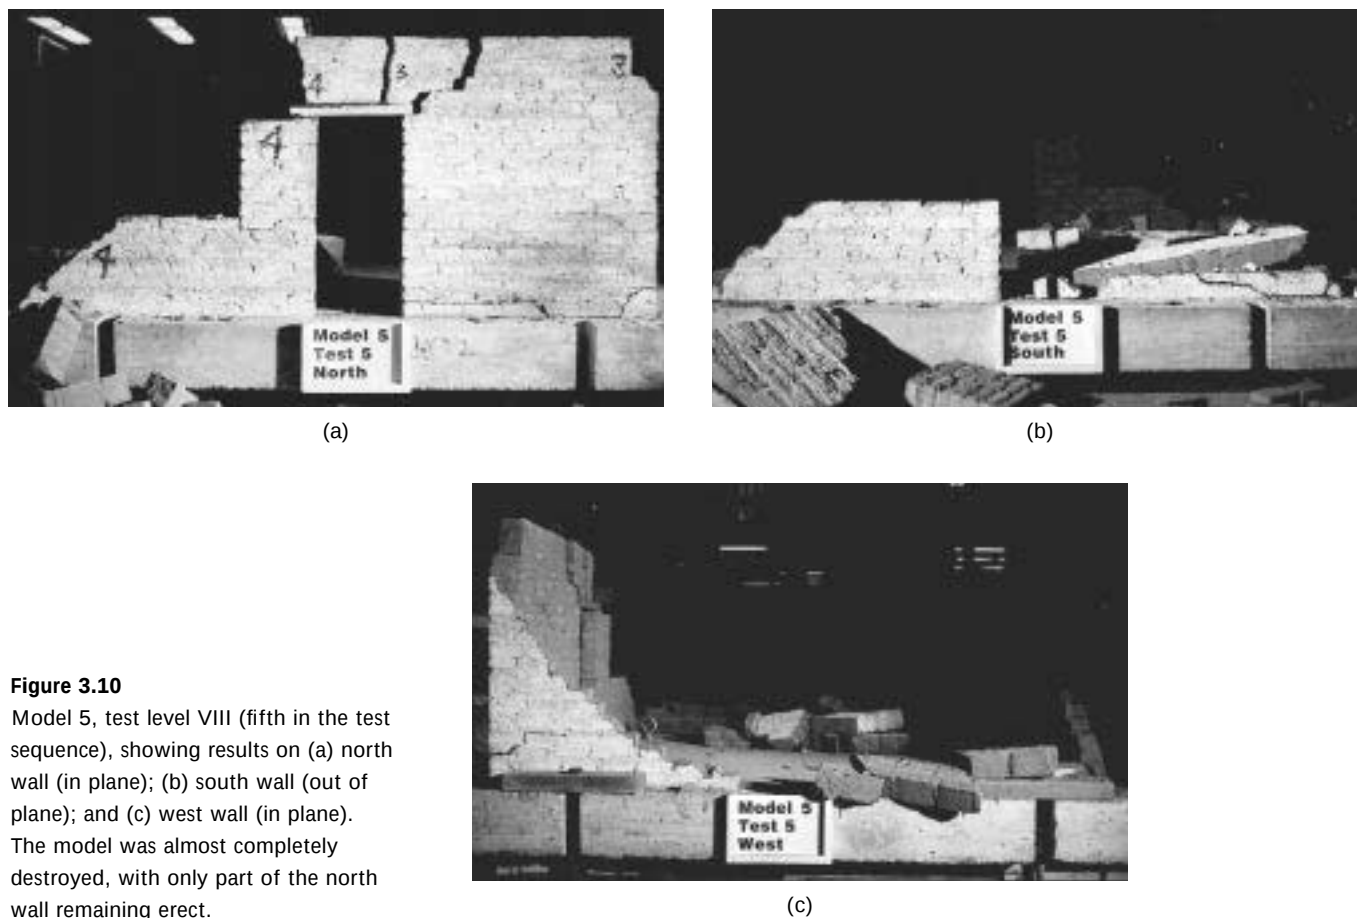
**Figure 3.10**

Model 5, test level VIII (fifth in the test sequence), showing results on (a) north wall (in plane); (b) south wall (out of plane); and (c) west wall (in plane). The model was almost completely destroyed, with only part of the north wall remaining erect.

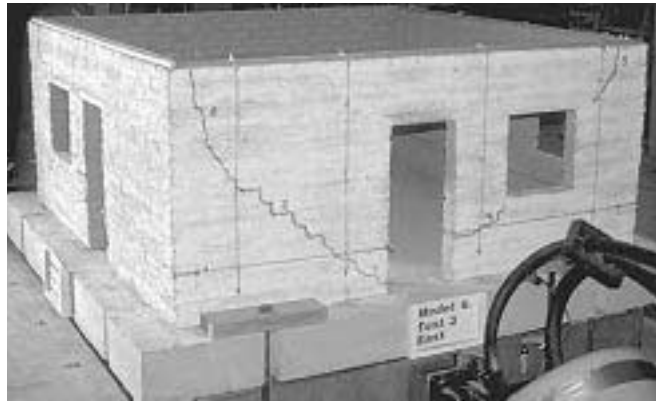
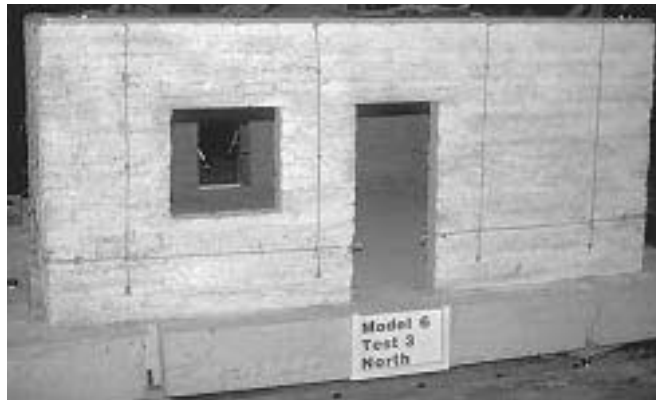
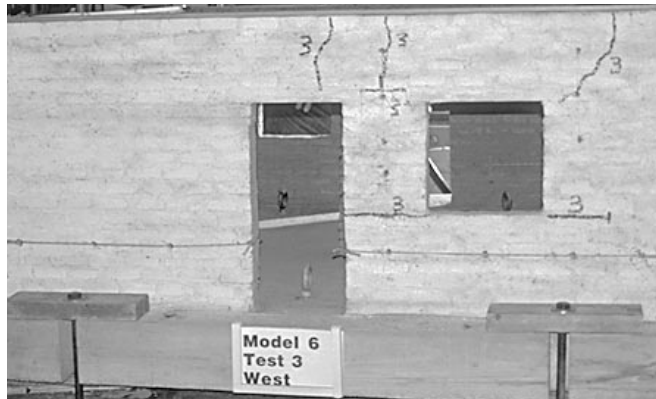
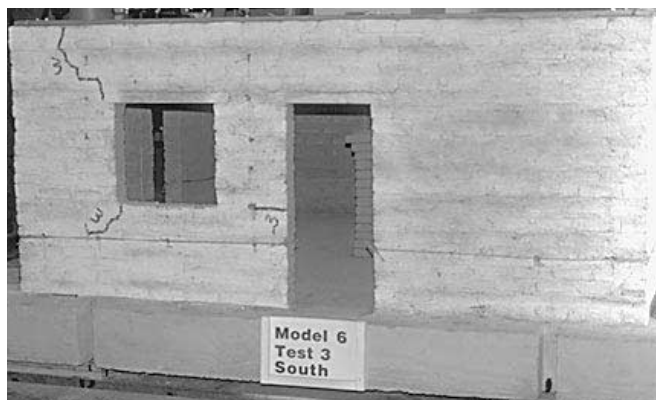
### Figure 3.11

As expected, the performance of the retrofitted model 6 was much better than that of model 5. During test levels III–V, the crack patterns were similar to those of the unretrofitted model (table 3.3; figs. 3.11–3.13). Large flexural, yield-line cracks developed in the east and west walls, which demonstrated that the bond beam had little effect on the elastic behavior of the model. Few additional cracks developed between test levels IV and VI.

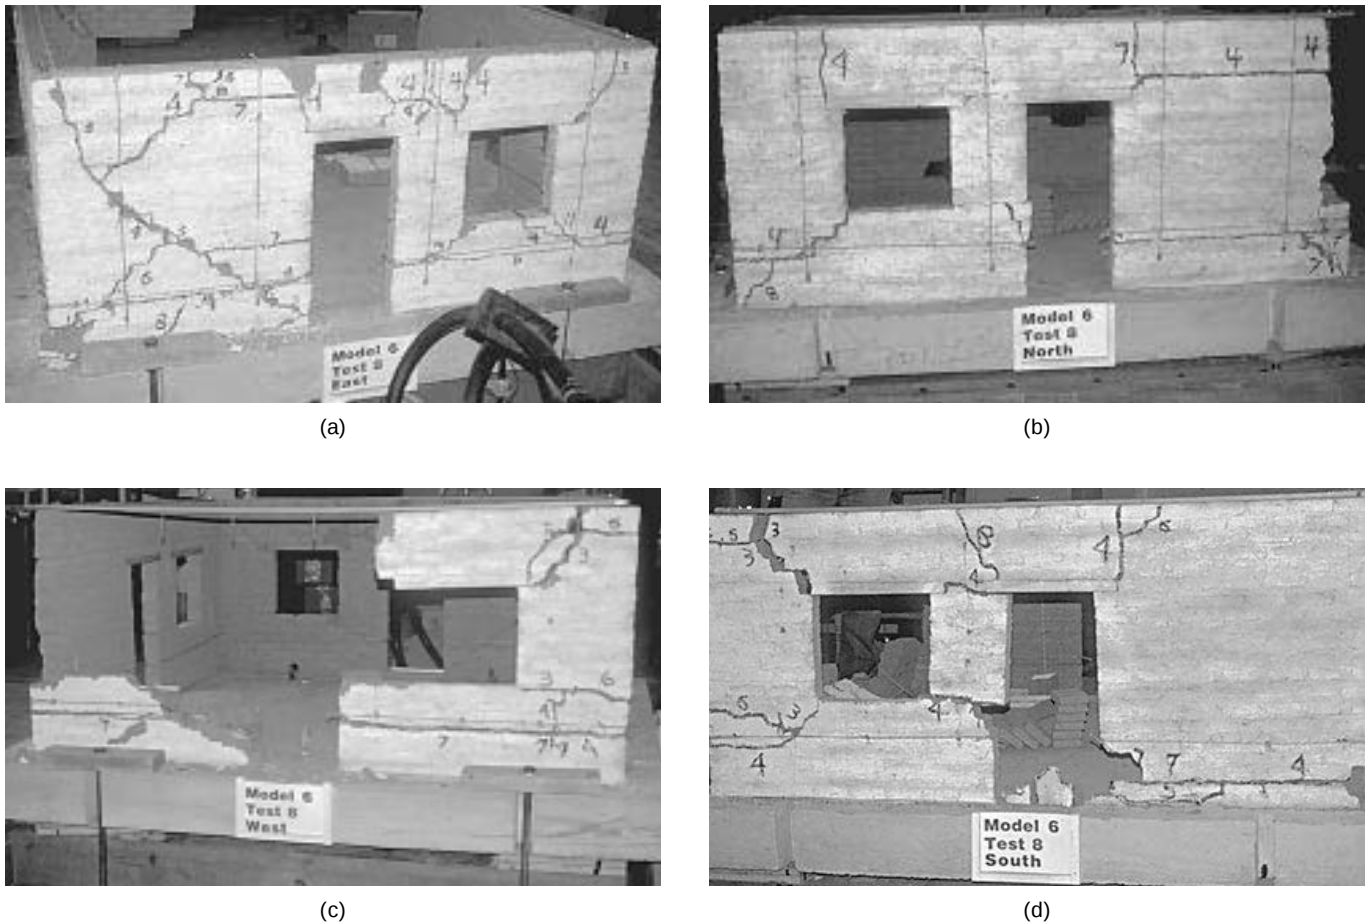
**Figure 3.15**

Model 6, test level VIII, showing (a) east wall (out of plane); (b) north wall (in plane); (c) west wall (out of plane); and (d) south wall (in plane). Dynamic motions of the model were substantial. During test levels VI and VII, stability of the out-of-plane walls was dependent on the bond beam. During test level VII, out-of-plane stability became dependent on both the bond beam and the vertical straps. Collapse of the west wall by overturning started below the horizontal crack that formed during test level IV at the north end of the west wall. The north and south walls were also subjected to substantial movement, resulting in significant permanent displacements. Relative displacements of cracked wall sections were less severe in the north wall, which had vertical straps, than in the south wall, which had only local through-ties.

In test level VIII, the lightly retrofitted west wall collapsed (fig. 3.15). Local crack ties had been applied at several locations but were not effective in preventing out-of-plane collapse.

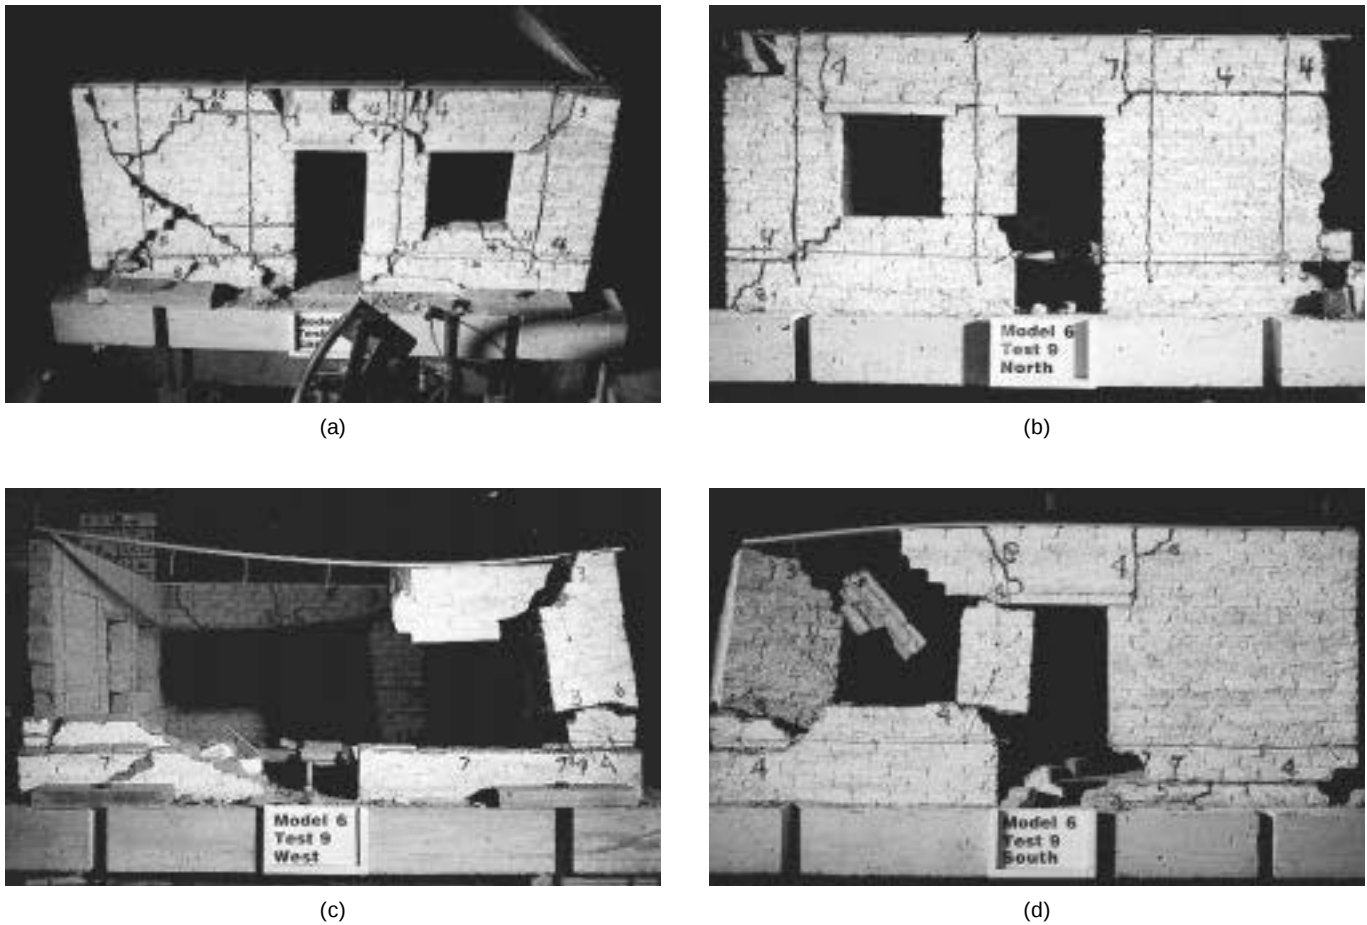
**Figure 3.16**

A portion of the in-plane south wall collapsed (fig. 3.16) during test level IX. Nevertheless, the two sections of the north wall that were retrofitted with vertical straps continued to perform well.

Model 6, test level IX, showing (a) east wall (out of plane); (b) north wall (in plane); (c) west wall (out of plane), collapsed at test level VIII; and (d) south wall (in plane). The test sequence continued, despite the collapse of the west wall, which undoubtedly compromised the structural performance of the south wall. Nevertheless, the continuous successful performance of the north and east walls demonstrated the robustness of the retrofit system used on these two walls. The east wall again showed large displacements, but the dynamics of the wall was also largely affected by displacements of the in-plane walls. Overall displacements in the north wall were smaller than those in the south wall. Local ties have some overall stabilizing influence but seem to be relatively poor as displacement controls.

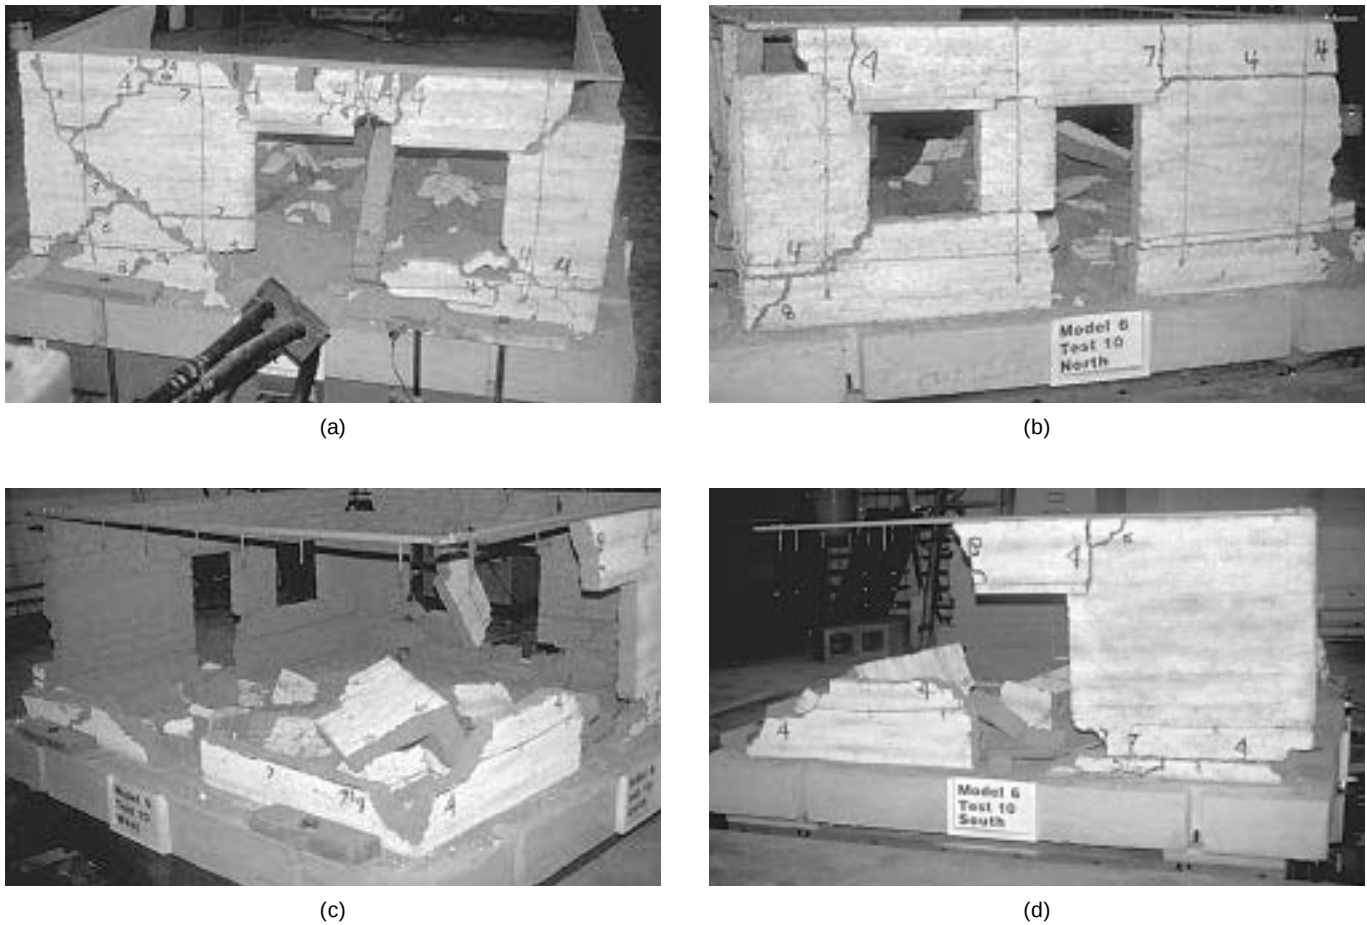
**Figure 3.17**

Most portions of the north and east walls performed well through test level X (fig. 3.17). The walls did not collapse nor was the building in the unstable condition noted for model 4 after test level X. The pier between the door and window was dislodged during the test and was suspended by the vertical straps. There were insufficient displacement controls on this pier to prevent it from being dislodged.

Model 6, test level X, showing (a) east wall (out of plane); (b) north wall (in plane); (c) west wall (out of plane); and (d) south wall (in plane). Model approached complete collapse. The north wall behaved well, the bond beam and vertical straps being quite effective. On the east wall, the vertical strap on the central pier did not provide enough stability to prevent collapse. The remainder of the east wall degraded severely, showing that this type of retrofit system for walls with  $S_L = 11$  is not as robust as on walls with  $S_L = 7.5$  (model 2), which withstood several repetitions at test level X.

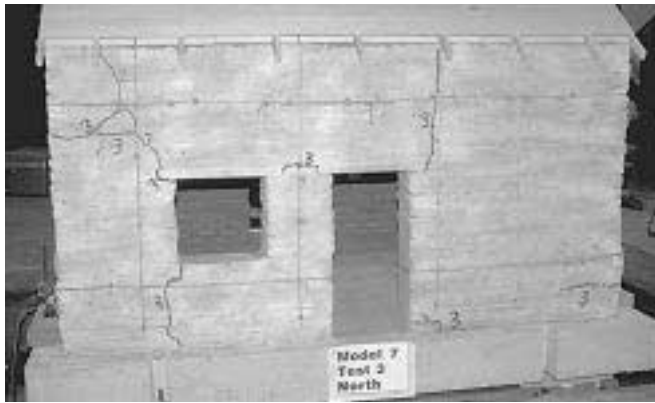
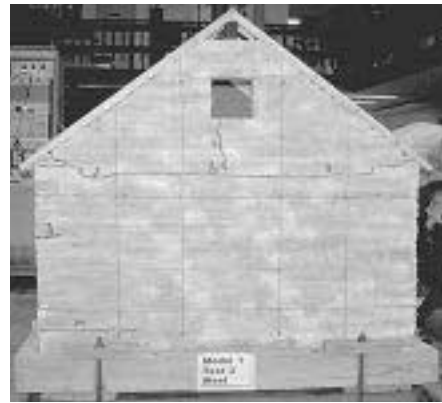
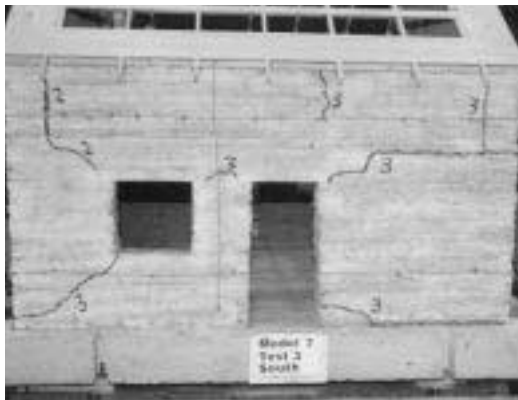
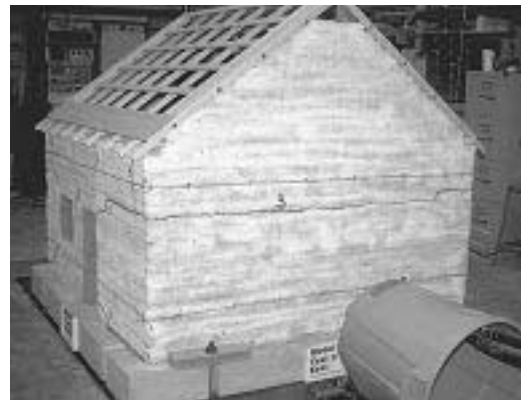
Model 7, test level III, showing (a) north wall (in plane); (b) west wall (out of plane); (c) south wall (in plane); and (d) east wall (out of plane). Initial cracking is visible. Shear cracks developed in the north and south walls at the corners of openings and at the base of the large wall panel to the right of the doorway. In the east and west walls, a single horizontal crack developed in each wall. In the east wall, the crack was just below the attic-floor line. In the west wall, the crack was just above the attic-floor line.

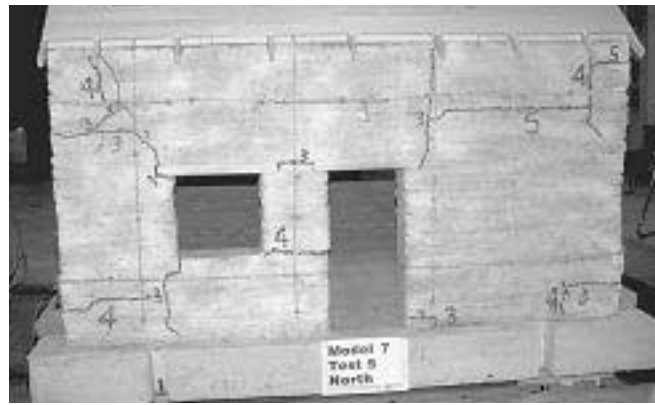
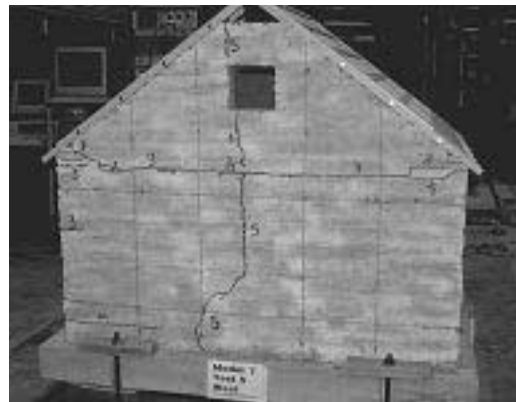
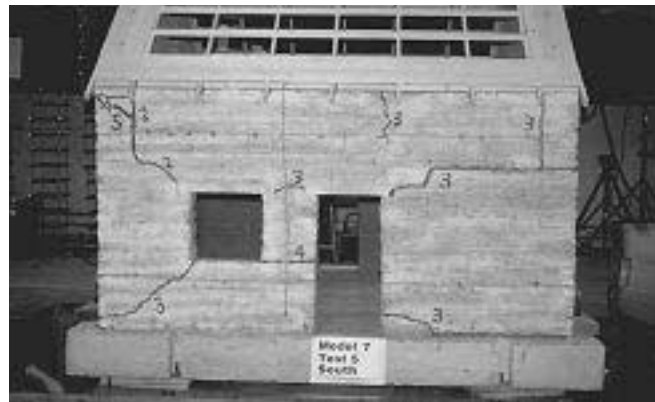
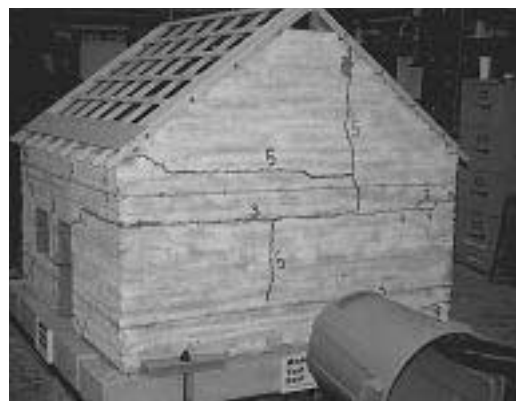
Model 7, test level V, showing (a) north wall (in plane); (b) west wall (out of plane); (c) south wall (in plane); and (d) east wall (out of plane). Most new damage was in the east and west walls. The upper section of the walls continued to rock, and vertical cracks developed near the center of both the east and west walls. An additional horizontal crack developed in the east wall above the attic-floor line. The north and south wall damage remained relatively constant, although a new horizontal crack developed in the north wall in the large panel at the attic-floor level.

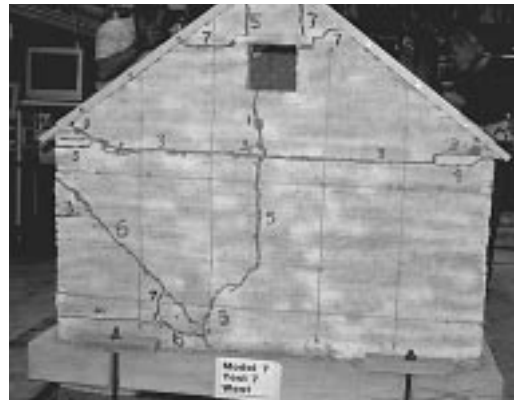
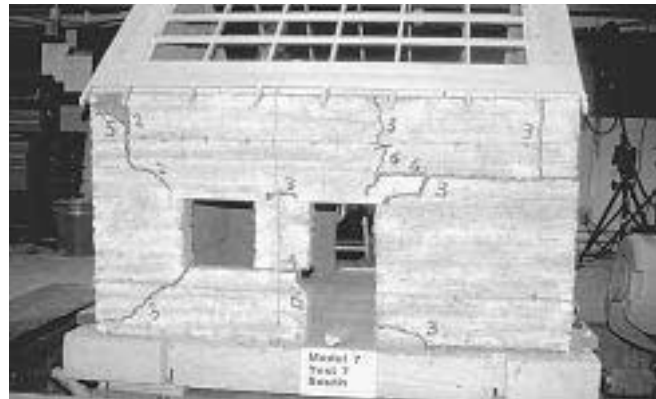
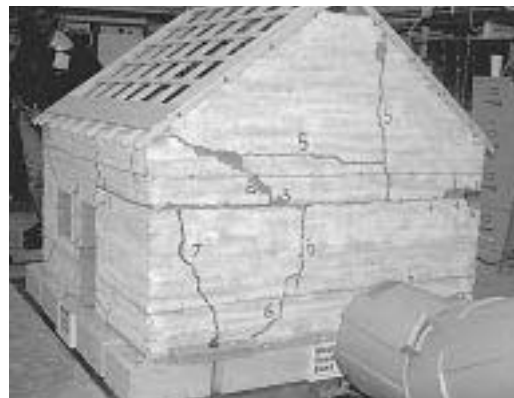
Model 7, test level VII, showing (a) north wall (in plane); (b) west wall (out of plane); (c) south wall (in plane); and (d) east wall (out of plane). Major crack patterns were nearly complete after test level V. During test levels VI and VII, some cracks were extended, but most remained unchanged. The principal exceptions were a diagonal crack in the west wall near the north end during test level VI and a similar crack in the east wall during test level VII. Only a few new cracks developed in the north and south walls during these tests. During test level VII, a section in the upper east corner of the north wall dislodged, and a permanent displacement occurred at the lower east corner of the window on the north wall.

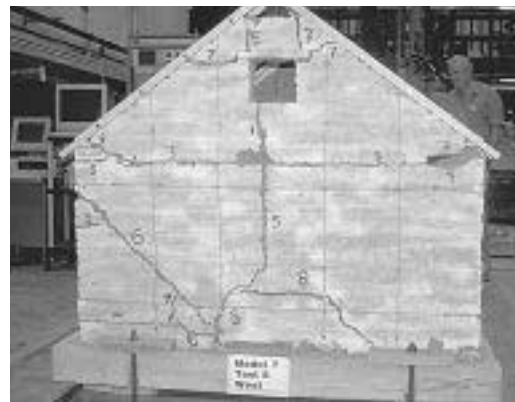
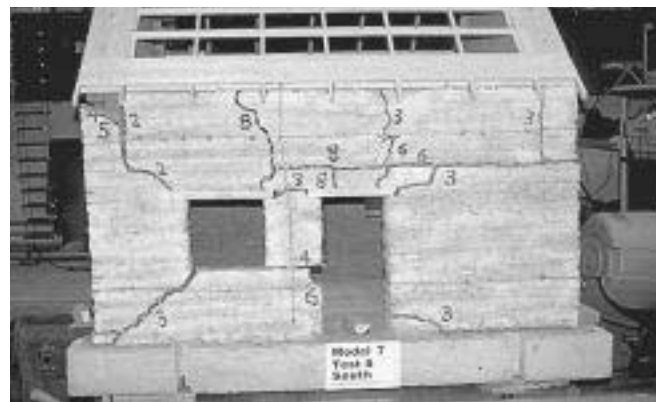
Model 7, test level VIII, showing (a) north wall (in plane); (b) west wall (out of plane); (c) south wall (in plane); and (d) east wall (out of plane). Additional cracks developed in the east and west walls, notably a horizontal crack in the lower portion of the west wall and a vertical crack in the right lower portion of the east wall, which was a continuation of an existing vertical crack in the upper gable portion of the wall. Additional cracks developed in the north and south walls. Of further significance were the permanent offsets of 0.64–1.27 cm (0.25–0.5 in.) at some locations.

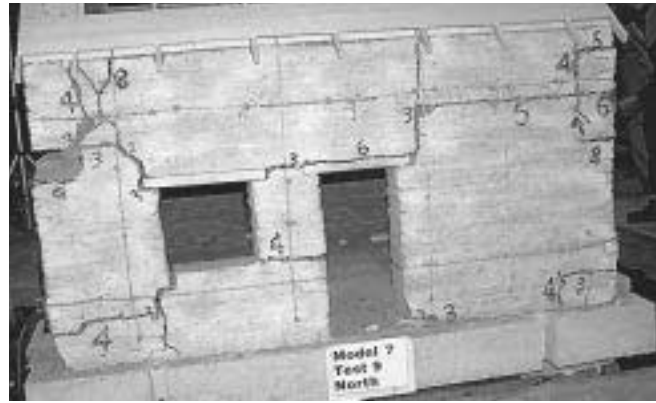
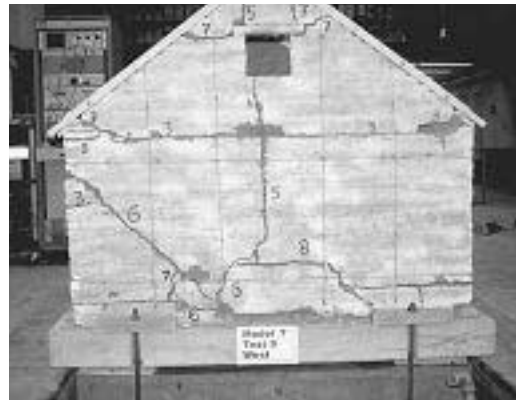
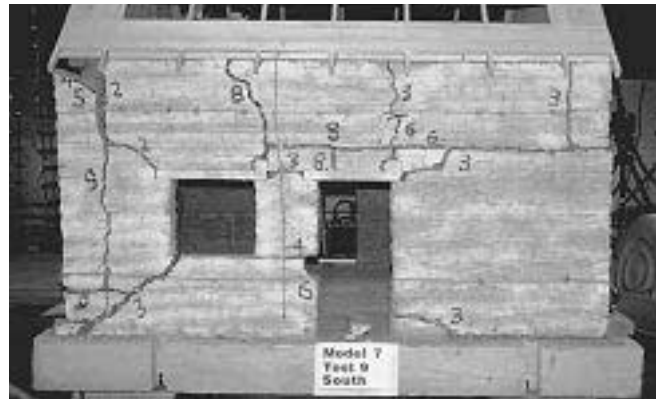
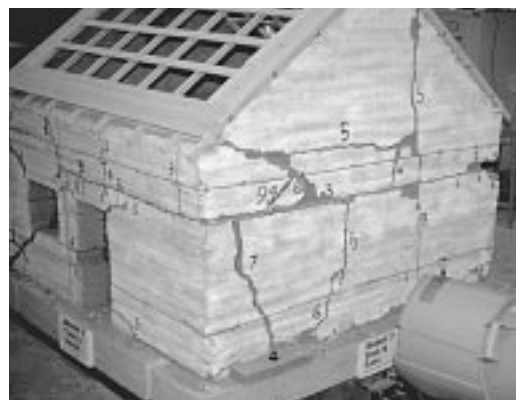
Model 7, test level IX, showing (a) north wall (in plane); (b) west wall (out of plane); (c) south wall (in plane); and (d) east wall (out of plane). Only a few new cracks developed in the model during the test, and wall motions were confined mainly to sliding and rocking of the cracked wall sections. In the east and west walls, some permanent offsets occurred at the horizontal cracks. The permanent offsets observed in the north and south walls continued to increase.

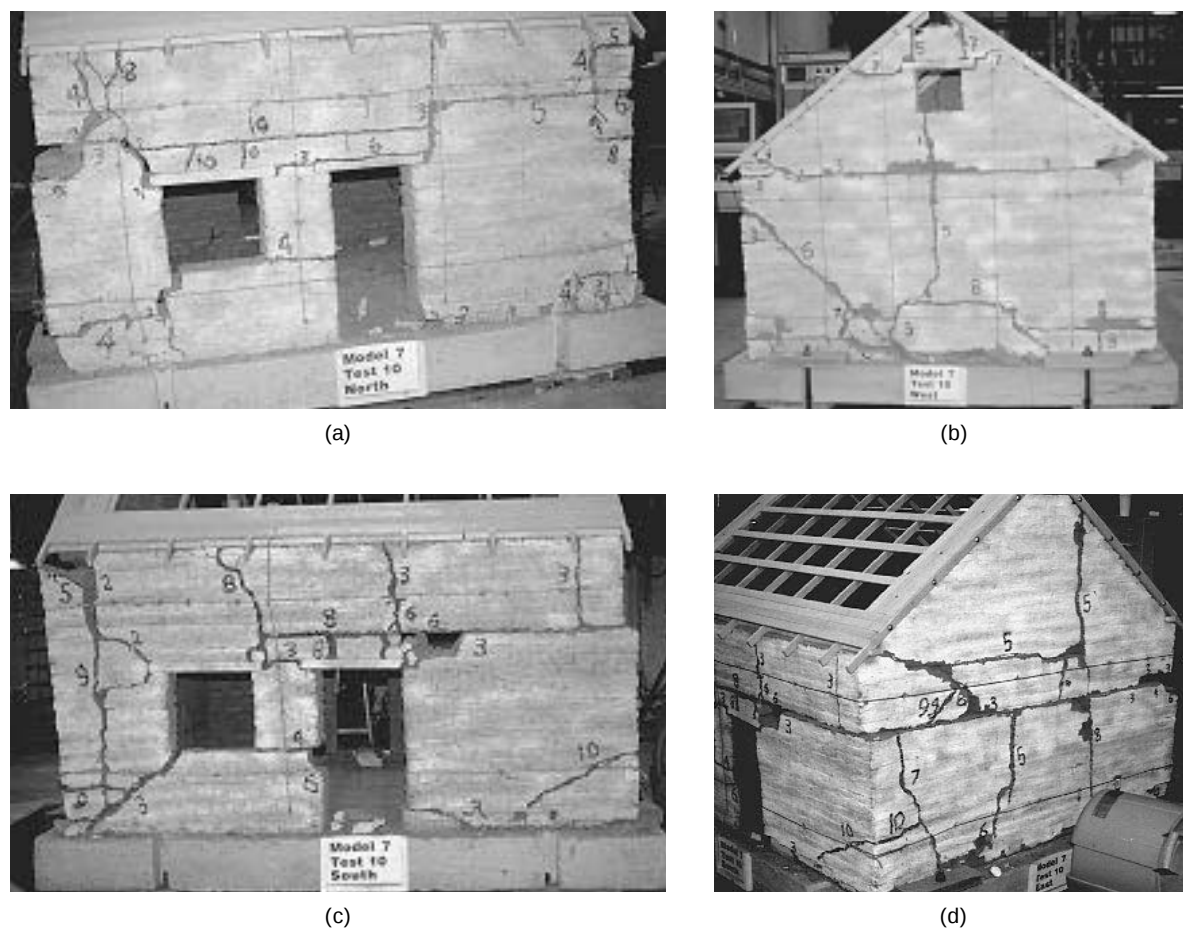
Model 7, test level X(1), the first of two tests at this level, showing (a) north wall (in plane); (b) west wall (out of plane); (c) south wall (in plane); and (d) east wall (out of plane). The dynamic stability of the structural system is clearly in question here. Horizontal offset at the attic-floor level in the east wall is most visible on the east side of the south wall elevation. The condition of the north and south walls continued to degrade. The section of the wall to the left of each window had offsets of approximately 1.88 cm (0.75 in.). The offsets at the upper west side of the south wall were largest. Both north and south walls had offsets of approximately 3.8 cm (1.5 in.) along the diagonal crack at the lower left corners of the windows.

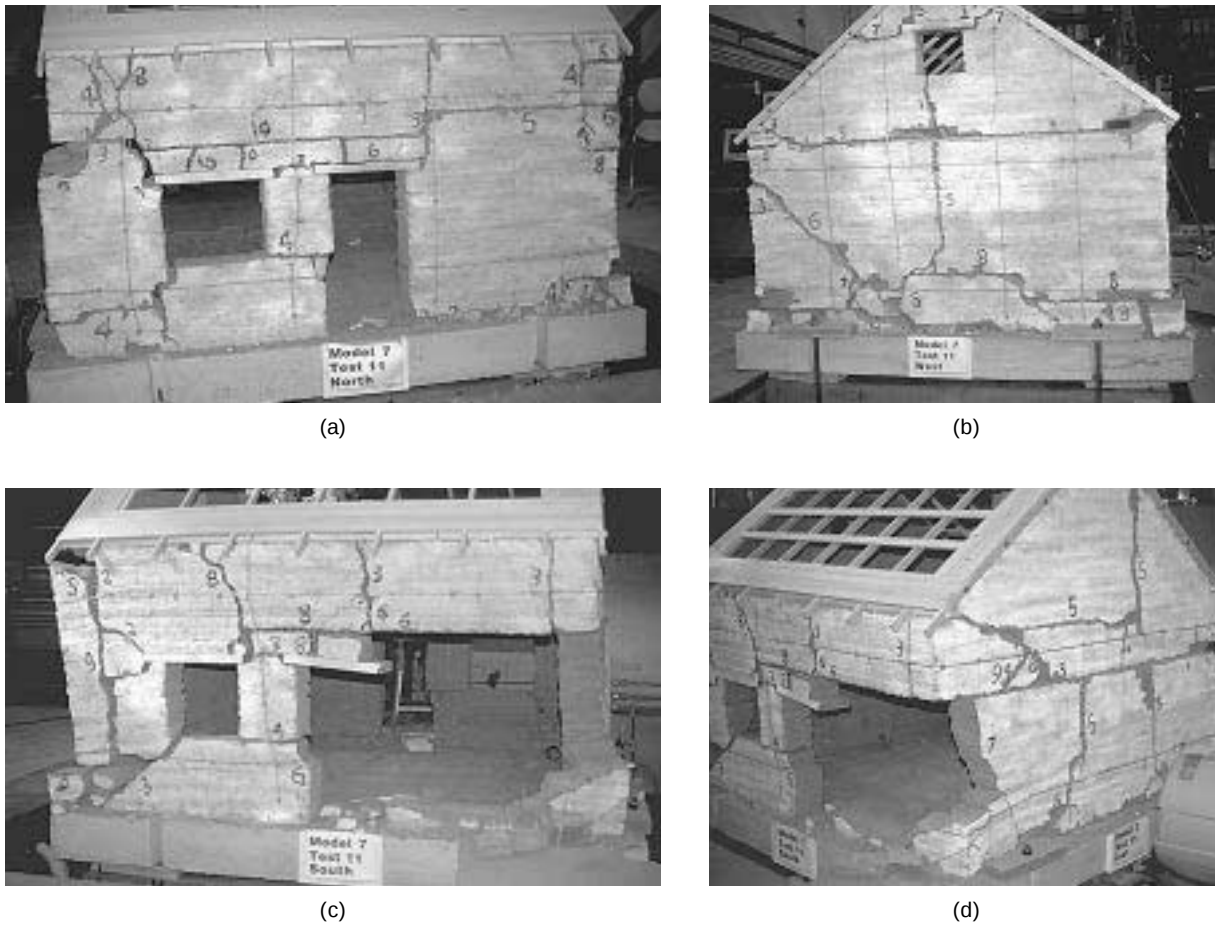
Model 7, test level X(2), the second of two tests at this level, showing (a) north wall (in plane); (b) west wall (out of plane); (c) south wall (in plane); and (d) east wall (out of plane). Lack of restraint in the southeast corner allowed the unstable wall section to collapse at the end of this test. The retrofit measure on the north and west walls, where vertical straps were used, provided sufficient restraint on the cracked wall sections to ensure overall structural stability.

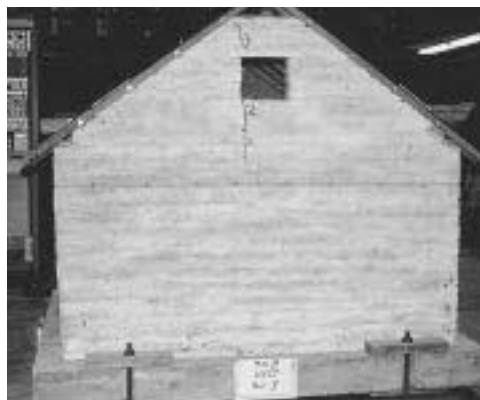
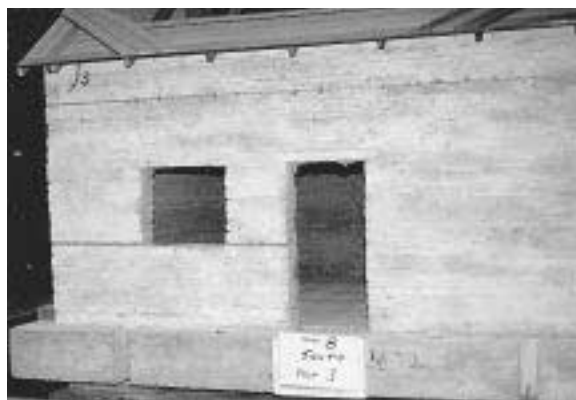
**Figure 5.16**

Model 8, test level III, showing (a) east wall (out of plane); (b) north wall (in plane); (c) west wall (out of plane); and (d) south wall (in plane). A few minor cracks were found during test levels II and III. More cracks were observed in the north (in-plane) wall than in the out-of-plane walls. In the north wall, cracks developed at the upper corners of the door and window. The only crack in the south (in-plane) wall was in the upper corner near the west wall. In the out-of-plane direction, the west and east walls suffered little damage. The west wall had a small vertical crack above and below the window. No damage was observed in the east wall.
