# Seismic Stabilization of Historic Adobe Structures

**Final Report of the Getty Seismic Adobe Project**

**E. Leroy Tolles**

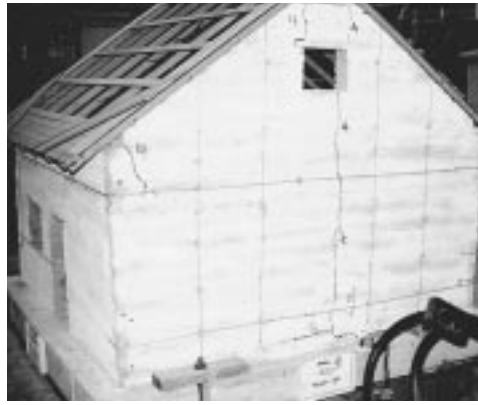
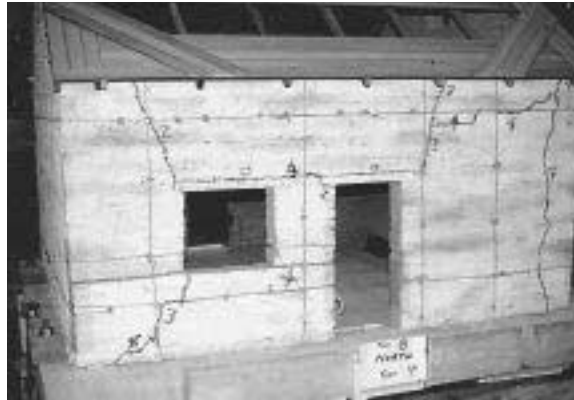
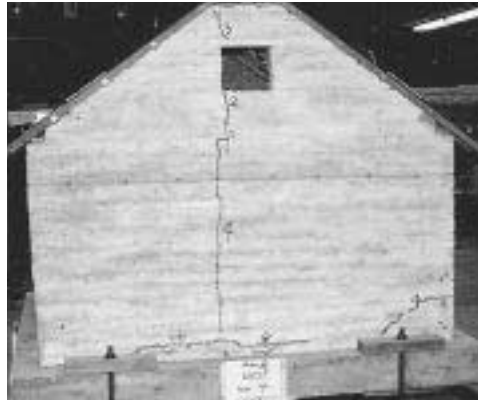
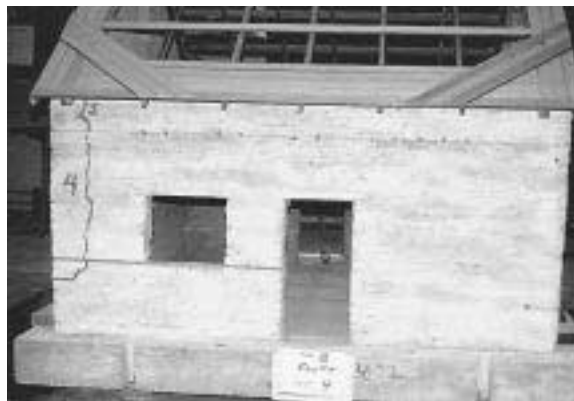
**Figure 5.17**

Model 8, test level IV, showing (a) east wall (out of plane); (b) north wall (in plane); (c) west wall (out of plane); and (d) south wall (in plane). In the out-of-plane direction, both the east and west walls developed vertical cracks near the center of the wall, and both had some horizontal crack damage near the base. The out-of-plane walls acted as plates with vertical yield lines at mid-span. In the in-plane direction, the north wall (straps) developed a more complete crack pattern that included a horizontal crack in the west side near the top of the wall and a vertical crack at the west end. The south wall (center cores) had a vertical crack at the west end caused by lateral movements of the west gable-end wall.

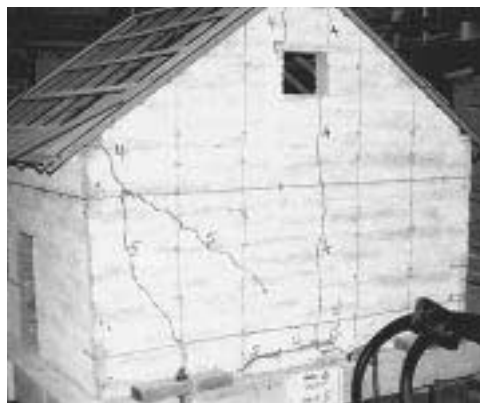
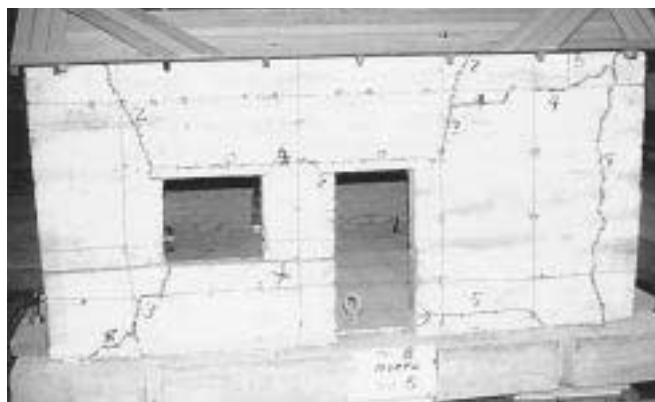
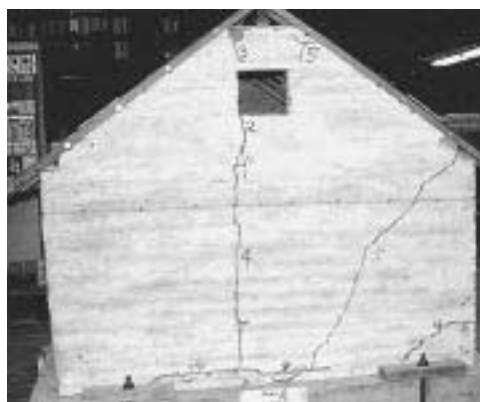
**Figure 5.18**

Model 8, test level V, showing (a) east wall (out of plane); (b) north wall (in plane); (c) west wall (out of plane); and (d) south wall (in plane). The in-plane walls sustained little additional damage. Minor cracks developed in the north wall, and no cracks appeared in the south wall. The out-of-plane walls developed considerably more cracks. The location of the cracks followed typical yield-line patterns. Each wall developed a diagonal crack from the upper corner on one side, extending to the center of the base of the wall. The east wall developed an additional, nearly vertical crack near the south end.

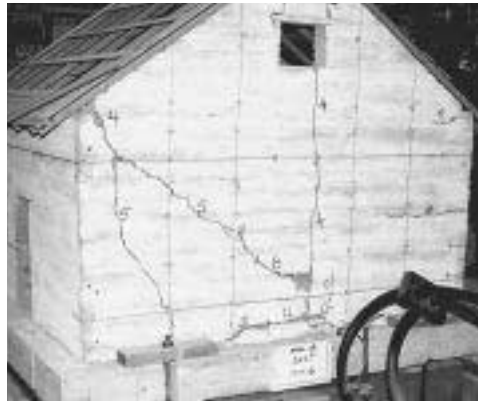
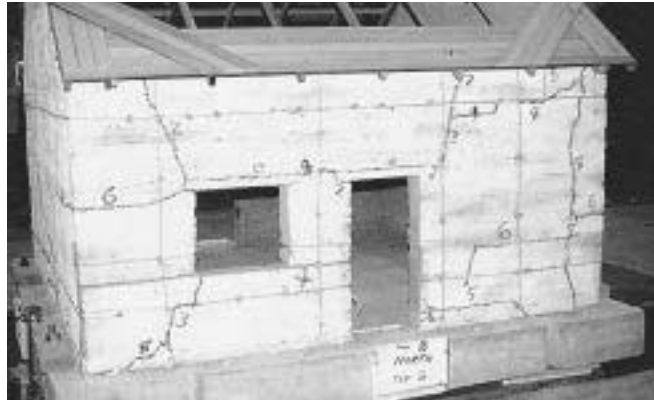
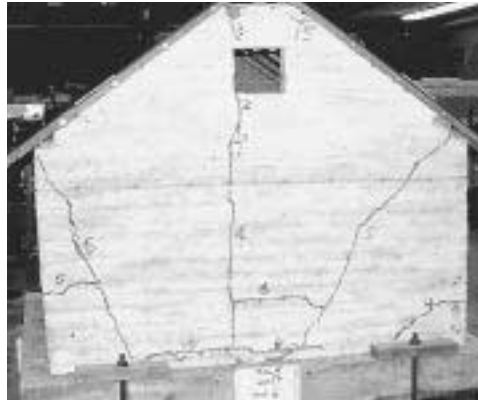
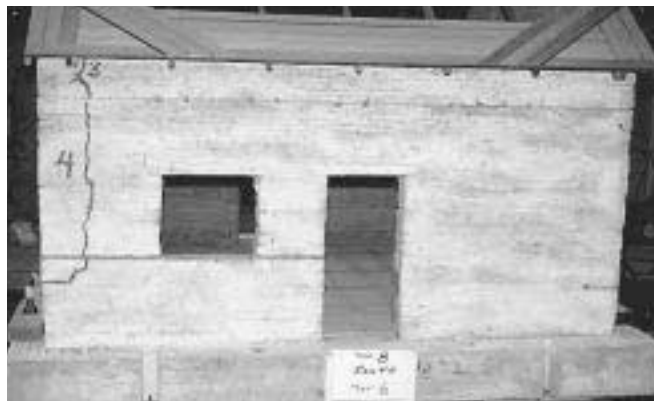
**Figure 5.19**

Model 8, test level VI, showing (a) east wall (out of plane); (b) north wall (in plane); (c) west wall (out of plane); and (d) south wall (in plane). Crack patterns continued to develop in the east and west walls. The west wall sustained additional diagonal cracking at the northern end and a horizontal crack near the center, located at about the level of the end of the center-core rods. The two rods near the center of the wall did not extend to the slab. In the in-plane walls, there were no additional cracks in the south wall, but further cracks appeared in the north wall. The basic crack pattern in each wall was nearly complete except for the lack of damage to the south wall.

The performance of the walls with epoxied center-core elements was the exception to this observation. The epoxied rods acted as effective reinforcements and delayed the appearance of crack damage. Damage to the walls of model 8 (fig. 5.19) and to the walls with epoxied center cores was very slight compared to the full crack development of the walls fitted with vertical straps.

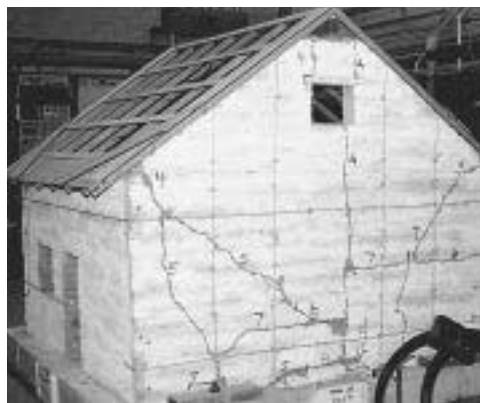
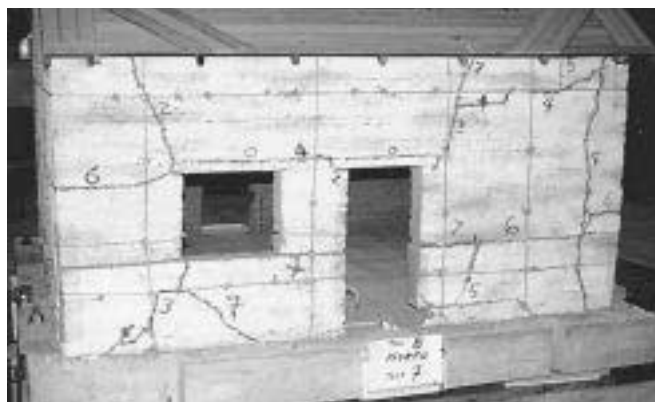
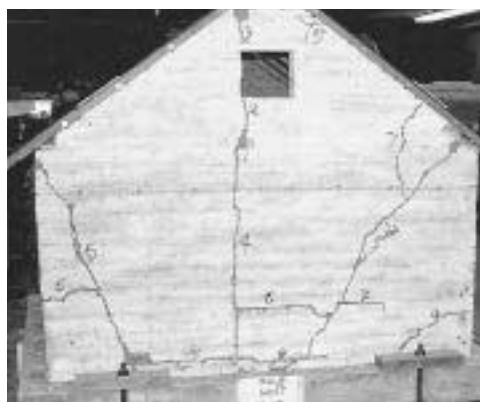
**Figure 5.20**

Model 8, test level VII, showing (a) east wall (out of plane); (b) north wall (in plane); (c) west wall (out of plane); and (d) south wall (in plane). At this point, the building walls had cracked into major sections that allowed them to move dynamically without sustaining substantial additional damage. Minor fragmentation of the wall continued in the north and west walls (straps), and little additional damage developed in the west wall (center core). The center cores in the south wall continued to provide adequate reinforcement that prevented cracks from occurring.

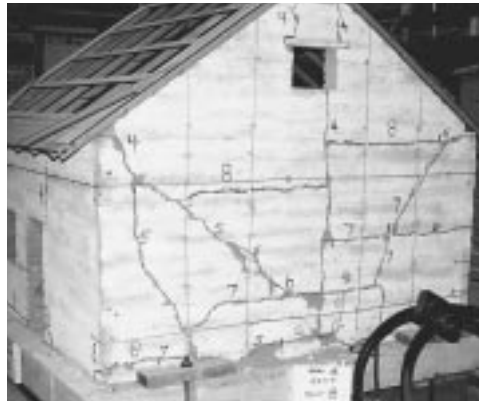
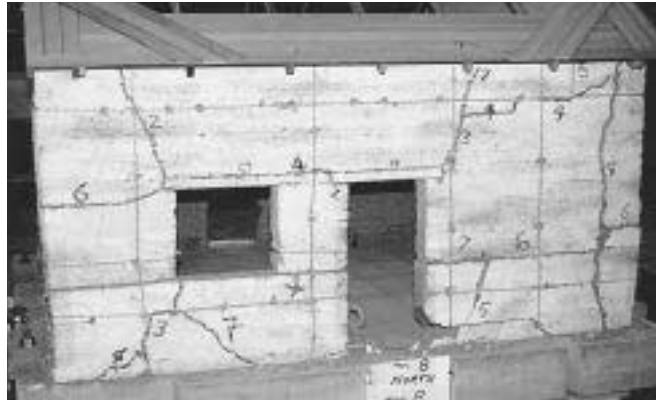
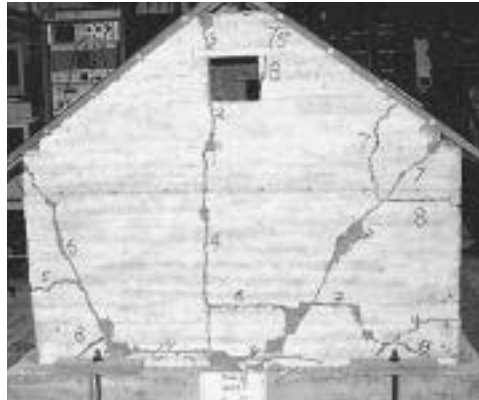
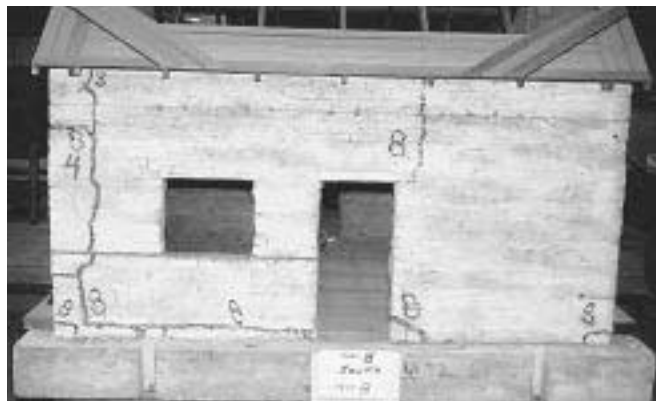
**Figure 5.21**

Model 8, test level VIII, showing (a) east wall (out of plane); (b) north wall (in plane); (c) west wall (out of plane); and (d) south wall (in plane). Several cracks finally developed in the south wall of this model, including a vertical crack at the door and a horizontal crack at the base of the wall below the window. The cracks that had developed in the other three walls remained fairly stable, although offsets of about 0.6 cm (0.25 in.) were observed in the north and east walls.

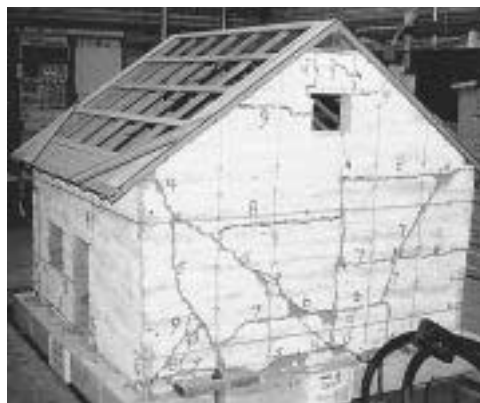
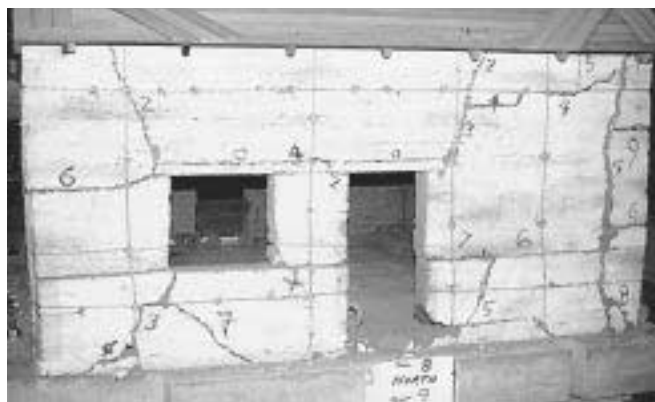
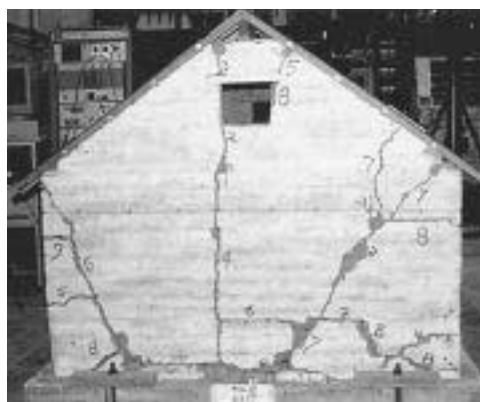
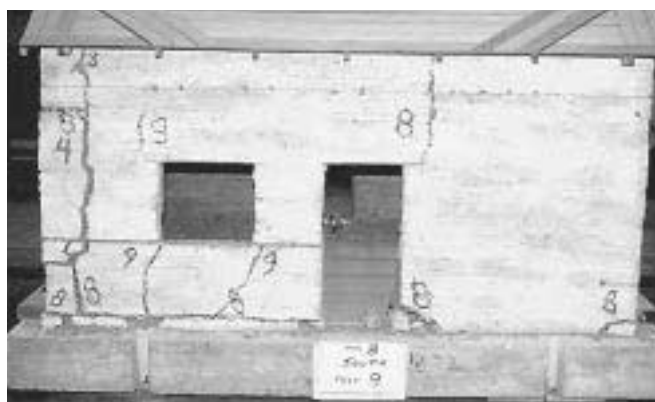
**Figure 5.22**

Model 8, test level IX(1), the first of two tests at this level, showing (a) east wall (out of plane); (b) north wall (in plane); (c) west wall (out of plane); and (d) south wall (in plane). Crack patterns changed little, but the substantial amount of additional spalling at crack edges and corners was indicative of the large motions to which the building was subjected during this test. The center cores in the west wall allowed the formation of major blocks with two center-core rods in each block. Damage to the south wall (with center cores) increased but was considerably less than that observed in the north wall (with straps).

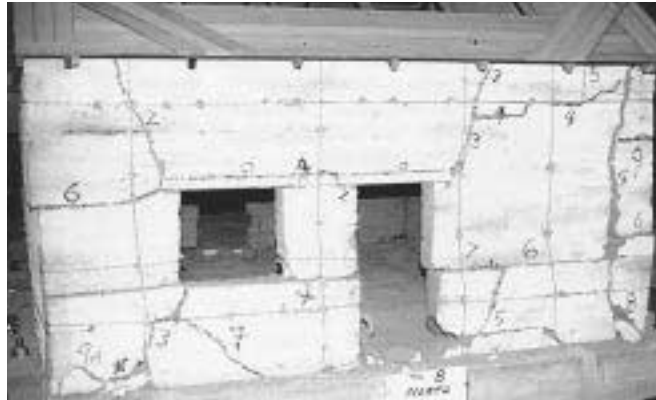
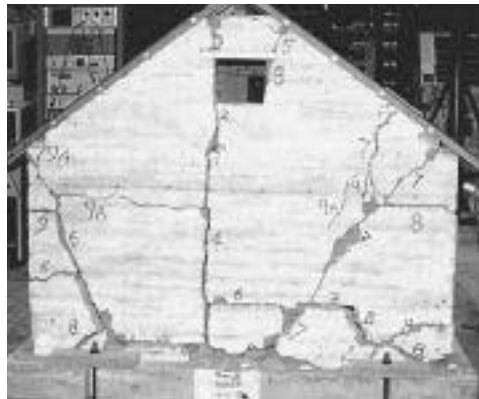
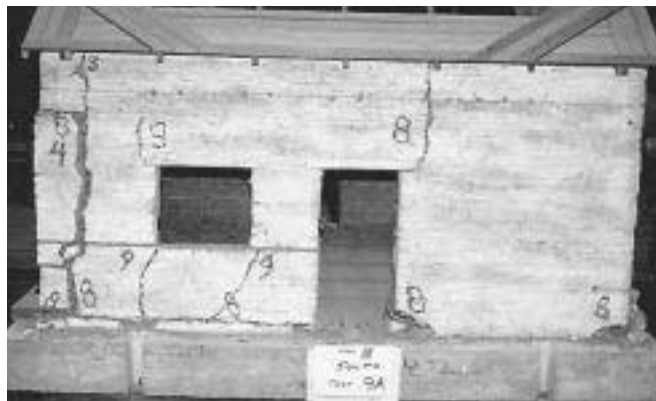
**Figure 5.23**

Model 8, test level IX(2), the second of two tests at this level, showing (a) east wall (out of plane); (b) north wall (in plane); (c) west wall (out of plane); and (d) south wall (in plane). Offsets at existing cracks increased to about 1.25 cm (0.5 in.). Damage to the basic panels in the south wall was still negligible. The walls were beginning to slide at the foundation level.

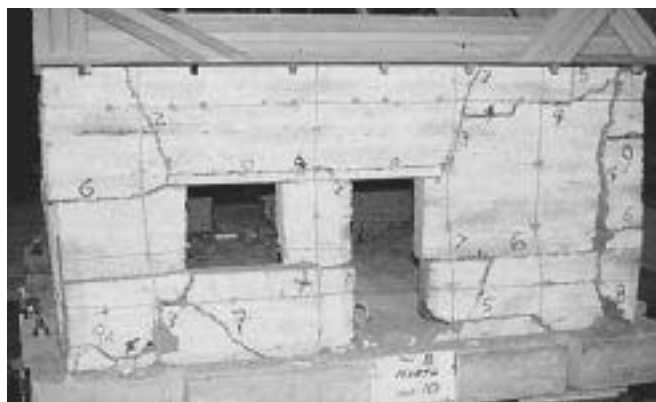
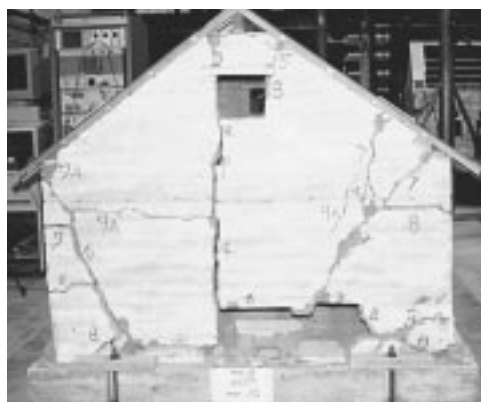
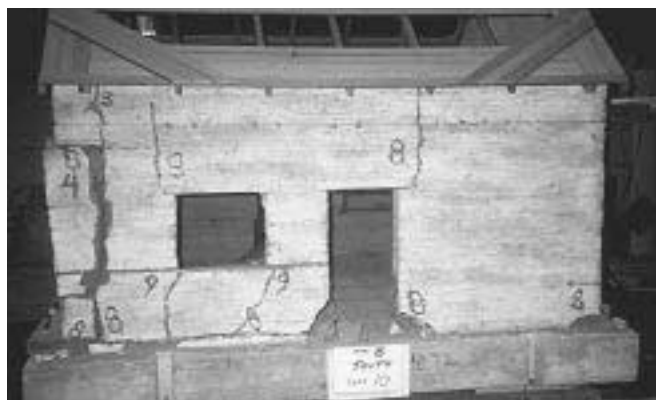
**Figure 5.24**

Model 8, test level X, showing (a) east wall (out of plane); (b) north wall (in plane); (c) west wall (out of plane); and (d) south wall (in plane). Crack pattern remained fundamentally the same, and no new cracks were created. The center-core rods prevented major damage from occurring in the walls in which they were installed. For the most part, cracks formed in the area just outside of the center-core rods. There were no rods or straps in the section at the west end of the south wall, which permitted an offset of more than 1.25 cm (0.5 in.) at that location. The offsets in the east and north walls increased to about 1.8 cm (0.7 in.). The straps did an effective job of maintaining stability but were less effective than center-core rods at controlling damage.

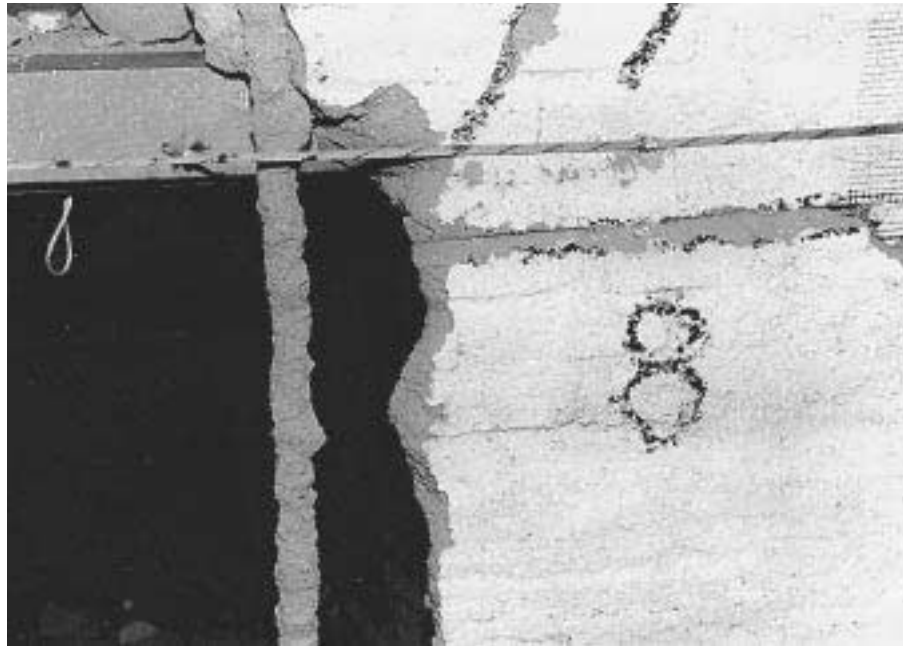
**Figure 5.25**

After test level X was completed, examination of the west wall was undertaken in an attempt to understand more about the effectiveness of the center-core rods. When the adobe material was broken away from around one of the rods (fig. 5.25), the uneven surface that the epoxy formed at the adobe interface was evident. This uneven surface was indicative of the nature of the bonding of the epoxy resin and the fiberglass rod to the adobe wall, with the result that the composite structure acted effectively as a reinforcing rod. It should be noted that there was a small yet visible crack in the adobe at the time the section of wall was removed from the building. In concrete, reinforcing bars do not become effective in tension or flexure until the concrete has cracked. These cracks can be very small and not even visible to the naked eye. Therefore, even though the section of adobe wall was cracked, it did not affect the strength of this “reinforced adobe beam.”

Close-up of center-core rod epoxy after removal of adobe.

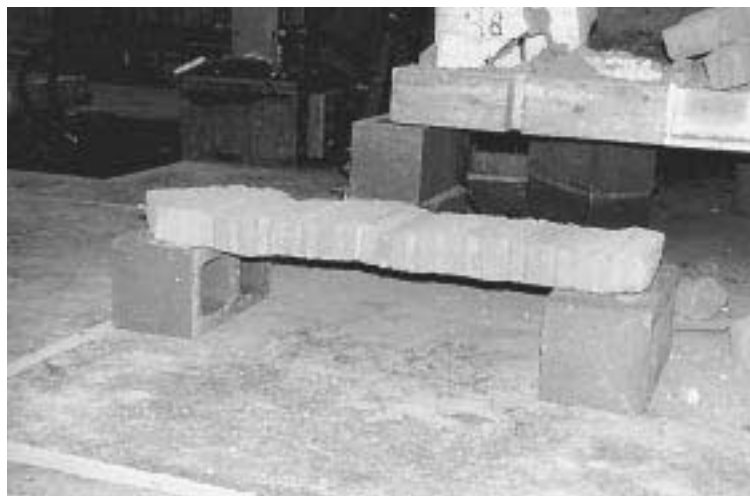
**Figure 5.26**

The section of the west wall was removed from the model and then statically loaded at mid-span with lead blocks until failure occurred (fig. 5.26). A videotape made during the tests showed that the adobe material was crushed when the beam failed. The load at failure was approximately 72.6 kg (160 lb.). Based on calculations similar to those used for analyzing concrete, the capacity of this beam was approximately 124 N-m (1100 in.-lb.). The moment induced by the loading was approximately 136 N-m (1200 in.-lb.). These calculations demonstrate an accurate analytical method for determining the strengthening effects of the fiberglass bars embedded in the adobe wall of the model building.

Section of wall panel containing center-core rod before static-loading test.

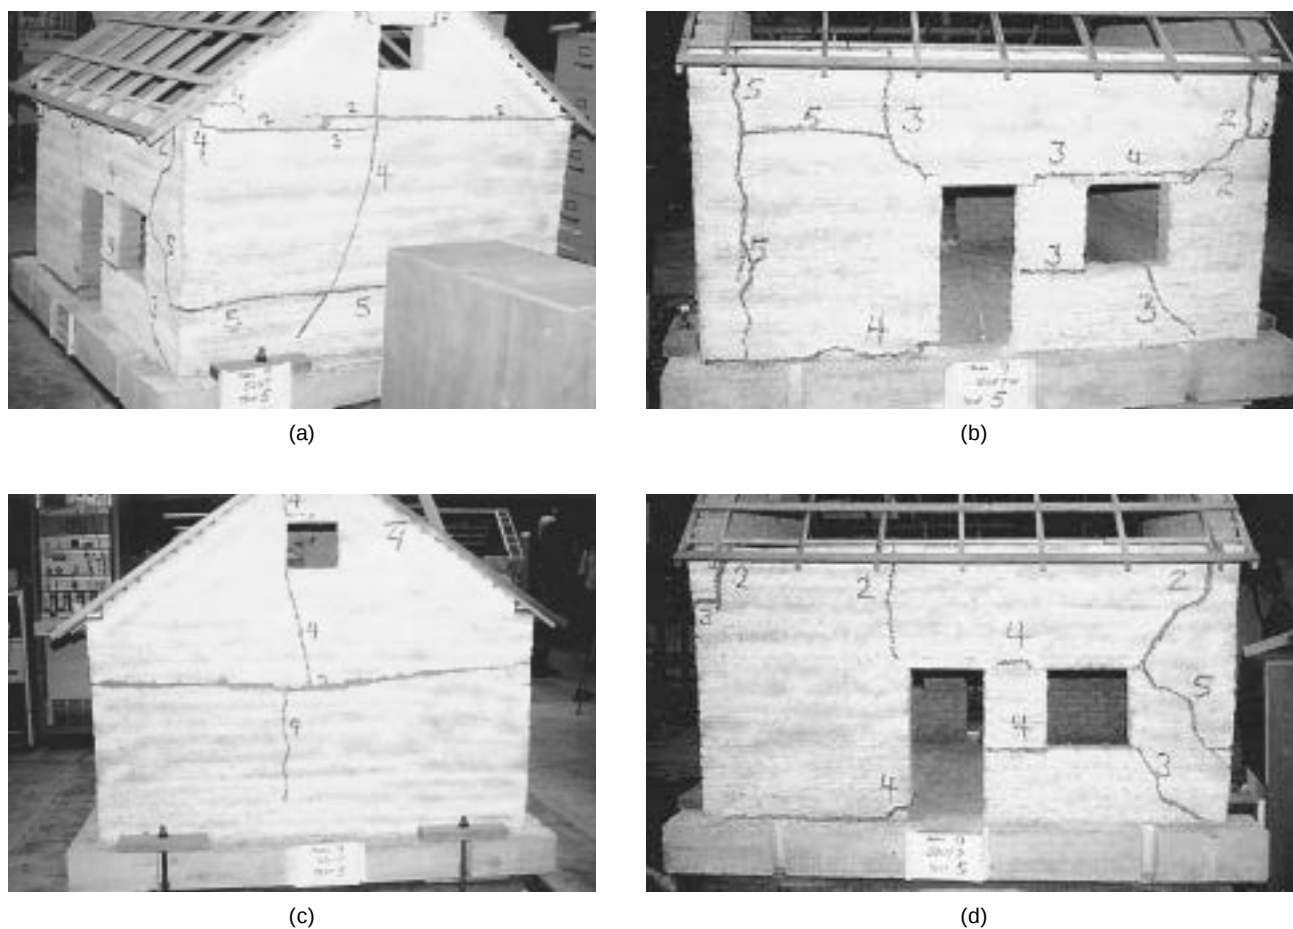
**Figure 5.27**

the fragility of an unretrofitted adobe building. Cracks began during test levels II and III and continued to develop during test level IV. The dynamic motions of the gable-end wall became apparent during test level IV, and the model nearly collapsed during test level V. The roof rafters on both sides of the gable-end walls provided some resistance to the motion of these walls and probably were responsible for the stabilization of the model during test level V (fig. 5.27).

Model 9, test level V, showing (a) east wall (out of plane); (b) north wall (in plane); (c) west wall (out of plane); and (d) south wall (in plane). The dynamic motion of the gable-end walls increased substantially, and the model became nearly unstable. The slight resistance provided by the roof framing may have prevented out-of-plane collapse of the gable-end walls. A permanent offset of approximately 1.9 cm (0.75 in.) perpendicular to the plane of the wall occurred at the center of the upper horizontal crack in the east wall. A few additional cracks developed near the base of the east wall, and the vertical cracks in the west wall continued to extend downward.

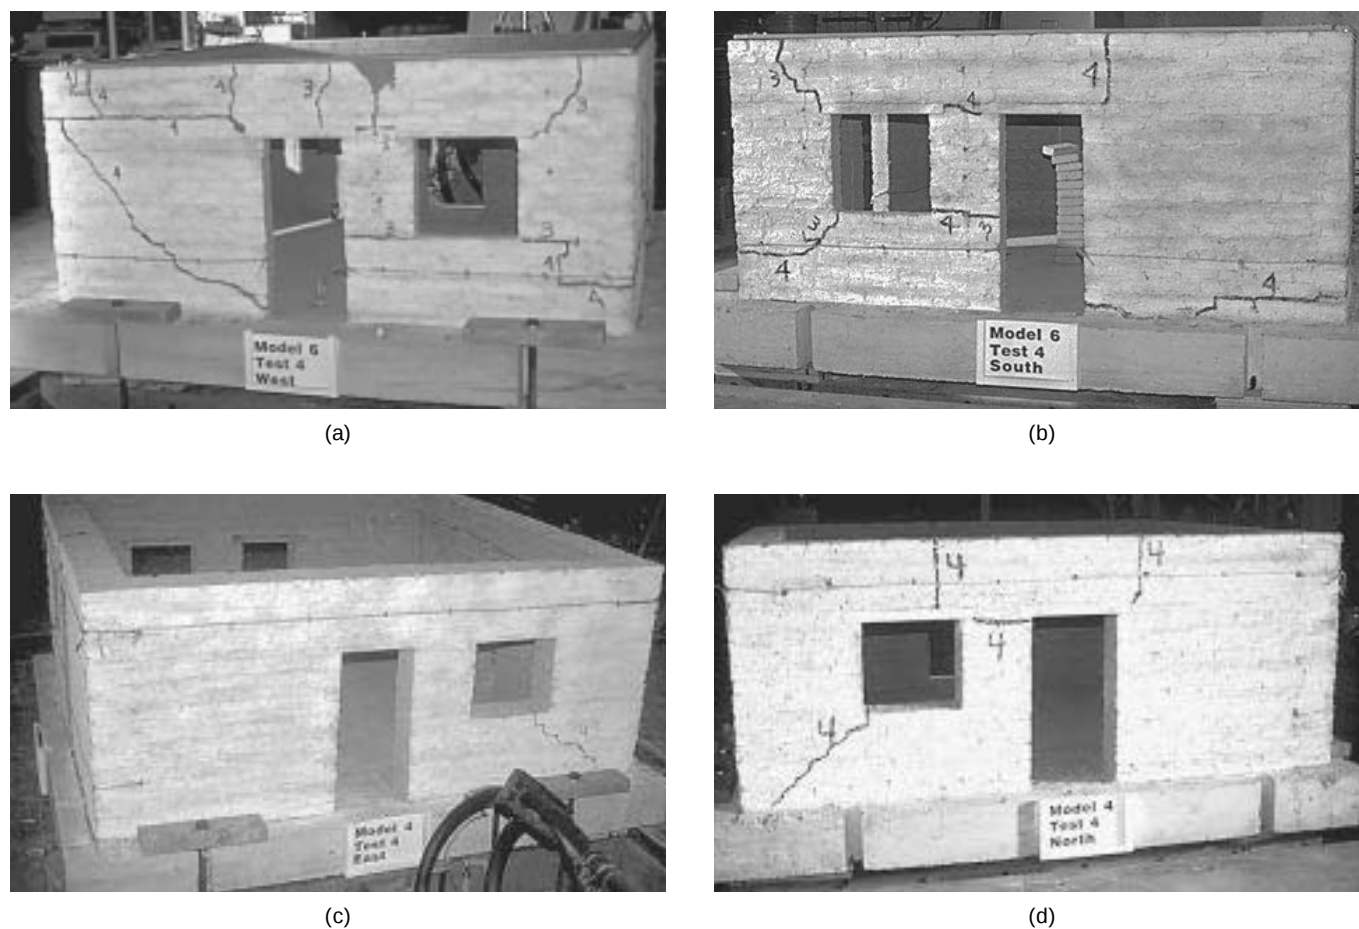
**Figure 6.1**

The test level required to cause damage to out-of-plane walls was one of the greatest differences in the performance of thick and thin walls (fig. 6.1). Thin walls ( $S_L = 11$ ) are shown in figure 6.1a, b, and thick walls ( $S_L = 5$ ) are shown in figure 6.1c, d. As would be expected from an elastic analysis, the crack pattern in the out-of-plane walls (fig. 6.1a) occurred first, followed by cracking in the in-plane walls. Once cracks had developed in the out-of-plane walls, the loads were quickly transferred to the

Comparison of crack initiation after test level IV for thin-walled model 6 ( $S_L = 11$ ), showing (a) west wall, and (b) south wall; and thick-walled model 4 ( $S_L = 5$ ), showing (c) east wall and (d) north wall.

in-plane walls through the attached bond beam, causing cracks in the in-plane walls (fig. 6.1b).

In contrast, the out-of-plane thick walls ( $S_L = 5$ ) suffered very little damage during test level IV, while the in-plane walls suffered cracking at the corners of some of the openings (fig. 6.1c, d). The thick walls had much greater flexural stiffness and strength than the thinner walls and were mostly able to resist the loading with only a minor crack at the bottom of the window opening. The out-of-plane thick walls were strong enough to resist the loading and were sufficiently stiff to transfer the load to the in-plane walls, which suffered damage similar to that of the thin walls. As would be expected from an elastic analysis, the thin walls ( $S_L = 11$ ) were much more susceptible to out-of-plane damage than the thick walls ( $S_L = 5$ ). There was little difference in the initial crack patterns of the in-plane walls.

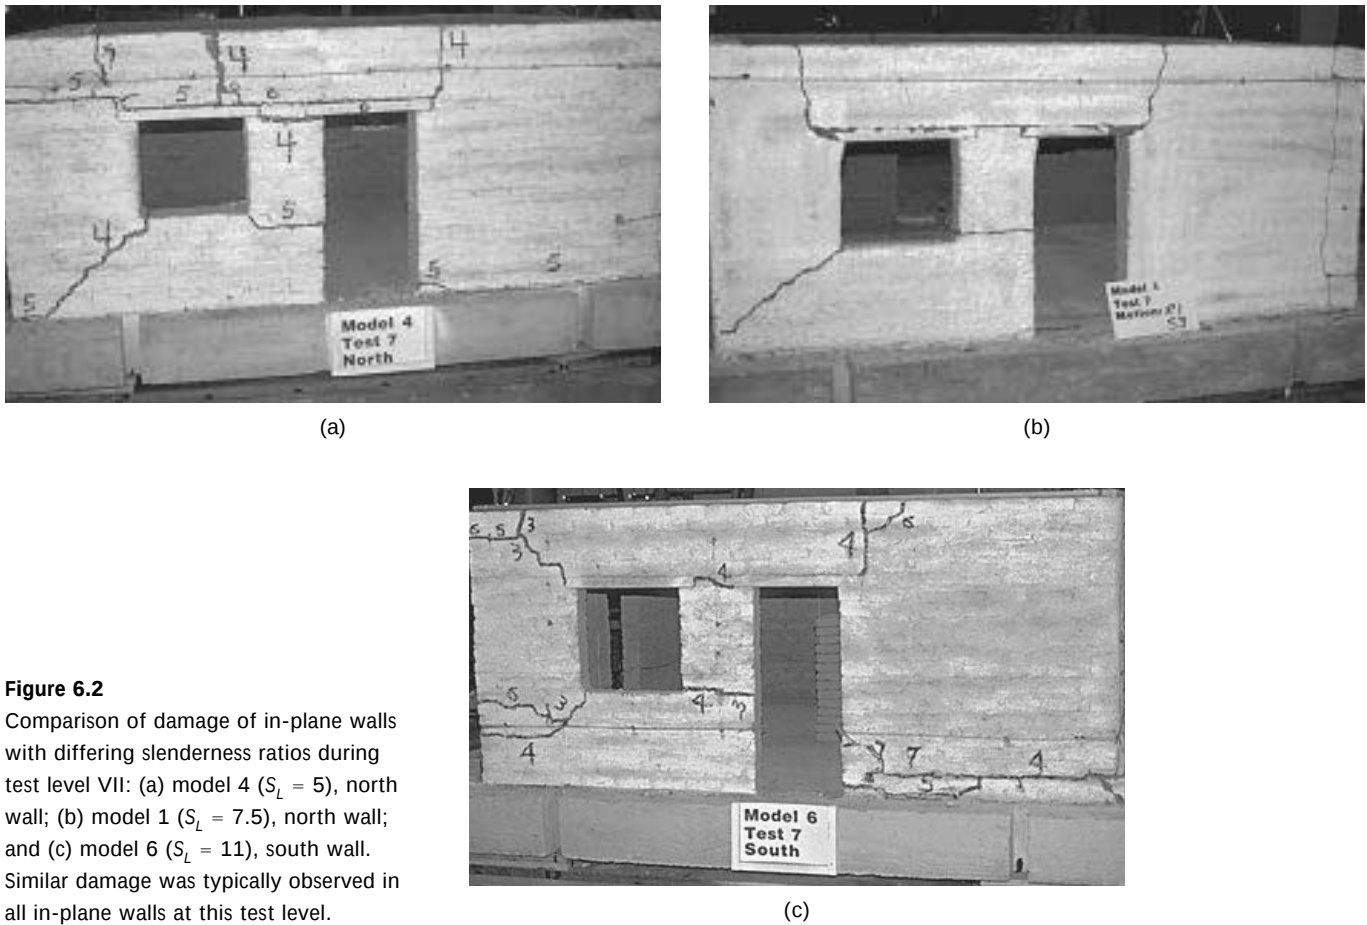
**Figure 6.2**

In general, the level of damage to the in-plane walls was independent of wall thickness. A comparison of in-plane wall damage after test level VII for walls with differing slenderness ratios ( $S_L = 5, 7.5$ , and  $11$ ) is shown in figure 6.2. Damage was similar for each of these walls. The principal damage occurred at the corners of the doors and windows and at the top and bottom of the pier between the door and the window, which was typical of both laboratory and field observations.

Comparison of damage of in-plane walls with differing slenderness ratios during test level VII: (a) model 4 ( $S_L = 5$ ), north wall; (b) model 1 ( $S_L = 7.5$ ), north wall; and (c) model 6 ( $S_L = 11$ ), south wall. Similar damage was typically observed in all in-plane walls at this test level.

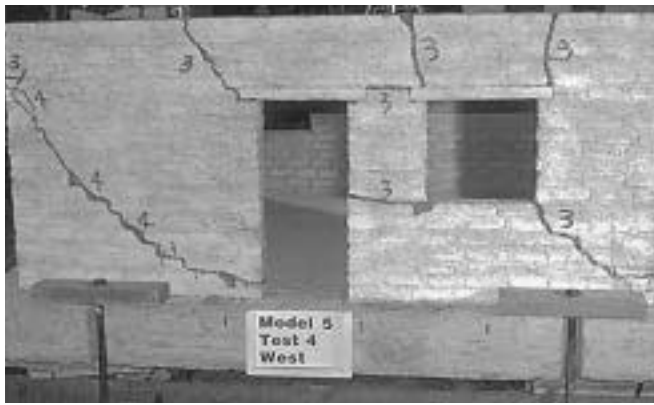
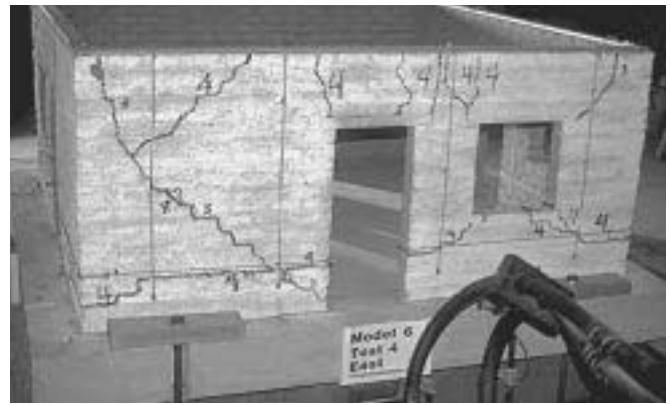
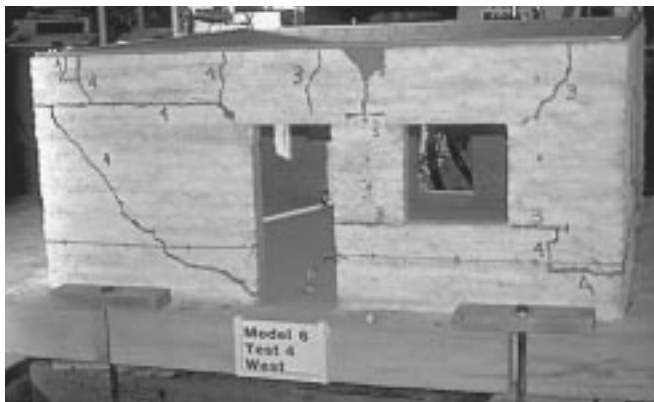
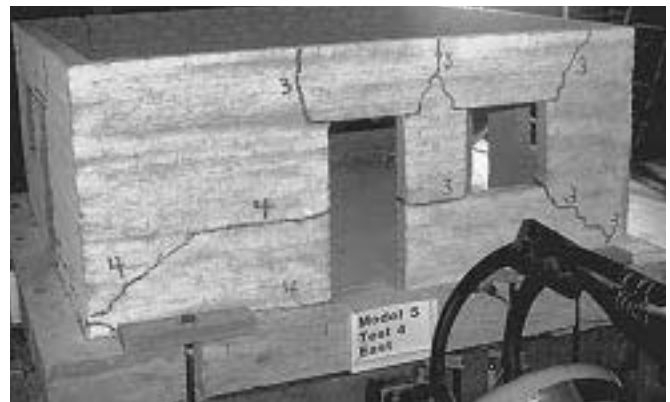
**Figure 6.3**

The crack patterns of corresponding walls were often consistent from one model to the next and in opposite walls of the same building. Nevertheless, there was one difference between similar walls that were subjected to the same input motions. The four walls shown in figure 6.3 were all thin walls ( $S_L = 11$ ). The retrofit measures had a negligible effect on their elastic performance, and the resulting crack patterns had many similarities. The principal motion of the walls was out-of-plane rocking of the center panel, as shown in the whitened area in figure 6.4. In figure 6.3a–c, the crack pattern is nearly the same. This pattern is defined by a crack in the upper left corner of the wall that extends diagonally to the base of the door. From the right side, the crack starts at the upper right corner of the wall and extends through the window opening. However, in figure 6.3d, no major diagonal crack in the large left-hand panel is observed, suggesting that variability in material and construction typically exists in adobe structures, which could account for the difference.

Comparison of crack patterns in out-of-plane walls with the same slenderness ratio ( $S_L = 11$ ) after test level IV:

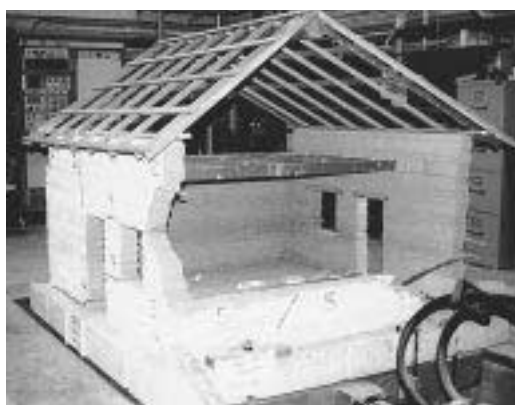
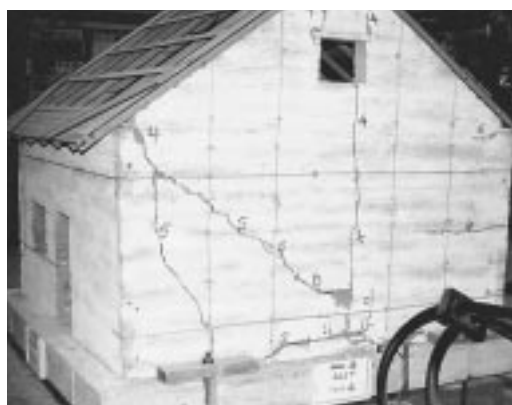
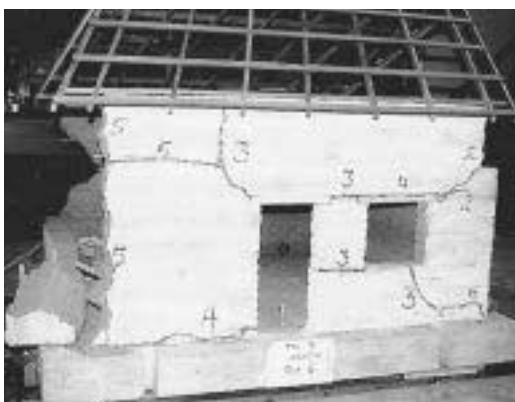
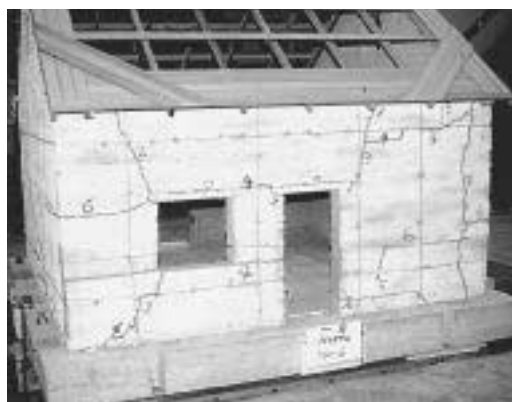
**Figure 6.6**

The effectiveness of the retrofit measures during test level VI is shown by the performance of the tapanco-style buildings, as illustrated in figure 6.6. Unretrofitted gable-end walls, tested out of plane, collapsed during test level VI (fig. 6.6a). The retrofitted gable-end walls suffered crack damage, but the model was very stable (fig. 6.6b). Damage to the in-plane unretrofitted walls was similar (fig. 6.6c), and those in the retrofitted structure (fig. 6.6d) suffered some additional cracks not observed in the unretrofitted model. Presumably, these were due to the additional load transferred through the partial diaphragms and upper horizontal straps.

Comparison of tapanco-style control model 9 and retrofitted model 8 after test level VI: (a) east wall of model 9 (unretrofitted) vs. (b) east wall of model 8 (retrofitted); and (c) north wall of model 9 (unretrofitted) vs. (d) north wall of model 8 (retrofitted).

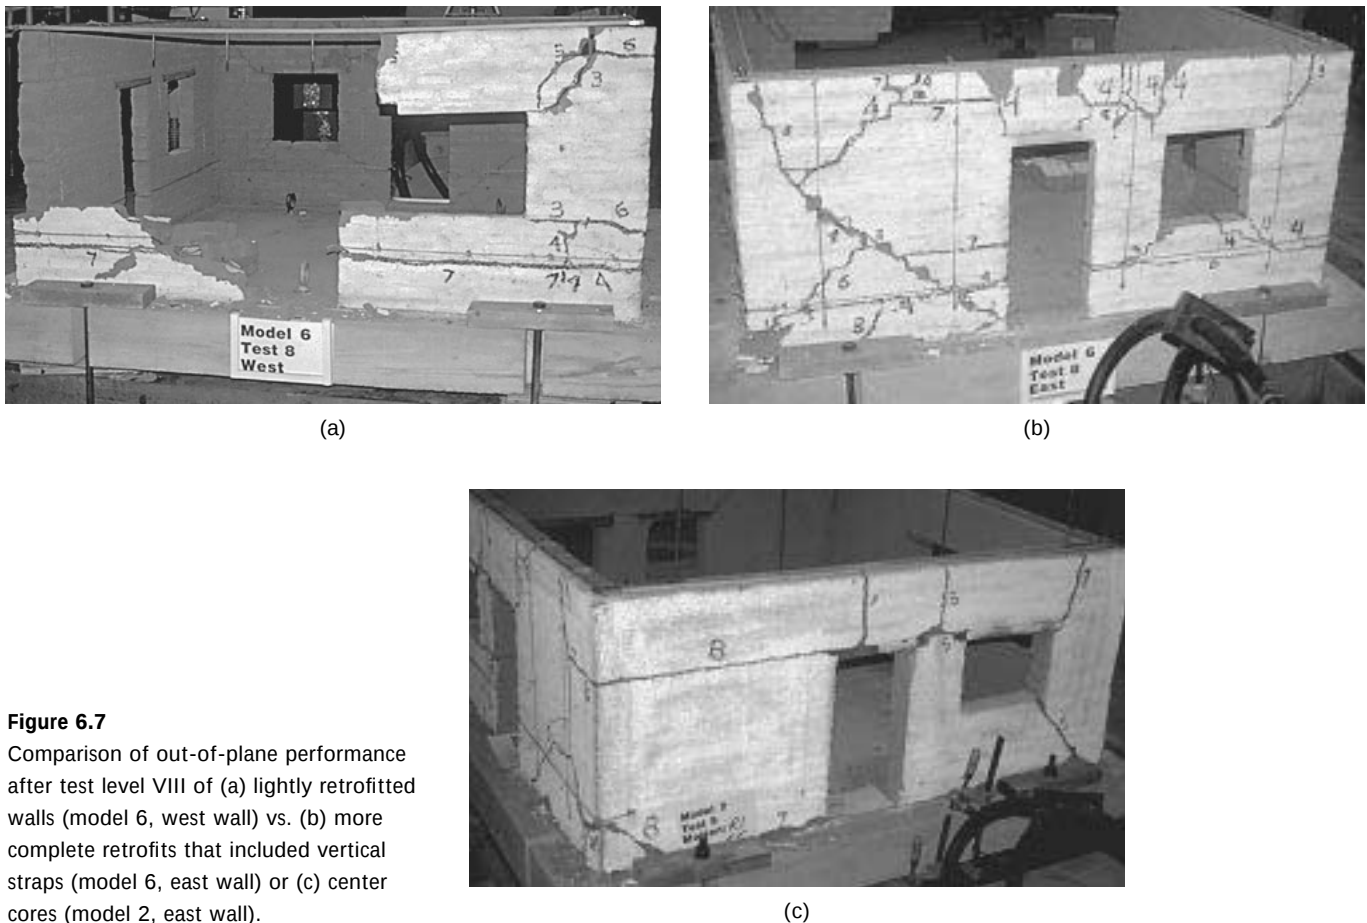
**Figure 6.7**

The light retrofit system used on the thin south and west walls of model 6, which included a bond beam and vertical local ties, was adequate to withstand the motions of test level VII, but the out-of-plane wall collapsed during test level VIII (fig. 6.7a). By comparison, the opposite walls of the same model were stable during this test (fig. 6.7b), a result that can be attributed to the effectiveness of the vertical straps. Similarly, moderately thick walls with a bond beam and center-core rods also behaved well during test level VIII (fig. 6.7c).

Comparison of out-of-plane performance after test level VIII of (a) lightly retrofitted walls (model 6, west wall) vs. (b) more complete retrofits that included vertical straps (model 6, east wall) or (c) center cores (model 2, east wall).

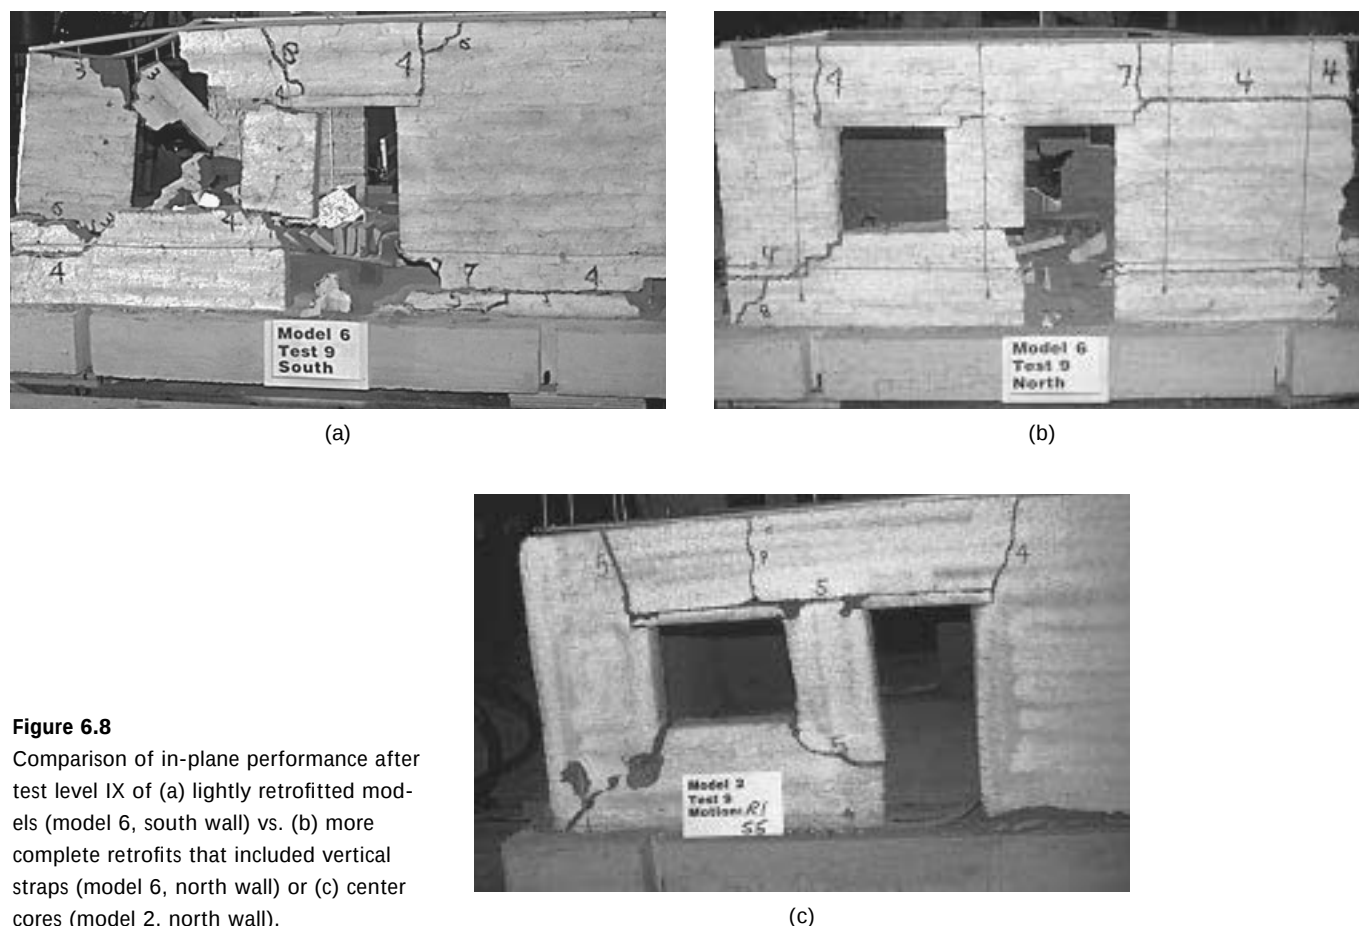
**Figure 6.8**

Test level IX was even more of a challenge to some of the lightly retrofitted model buildings. A large section of the in-plane thin wall with bond beam and local ties collapsed during this test (fig. 6.8a). Again, the

Comparison of in-plane performance after test level IX of (a) lightly retrofitted models (model 6, south wall) vs. (b) more complete retrofits that included vertical straps (model 6, north wall) or (c) center cores (model 2, north wall).

The addition of vertical straps instead of local ties improved the performance of the thin walls. The condition of the thin wall with a bond beam and vertical straps after test level IX is shown in figure 6.8b; the cracked wall is still stable and generally in good condition. The condition of the two in-plane walls shows the difference between the use of local ties (fig 6.8a) and the use of vertical straps (fig. 6.8b). Good behavior was also observed in the moderate walls with a bond beam and center cores during test level IX (fig. 6.8c).

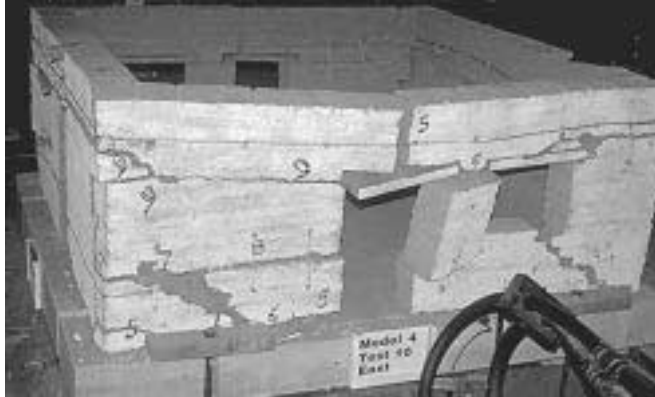
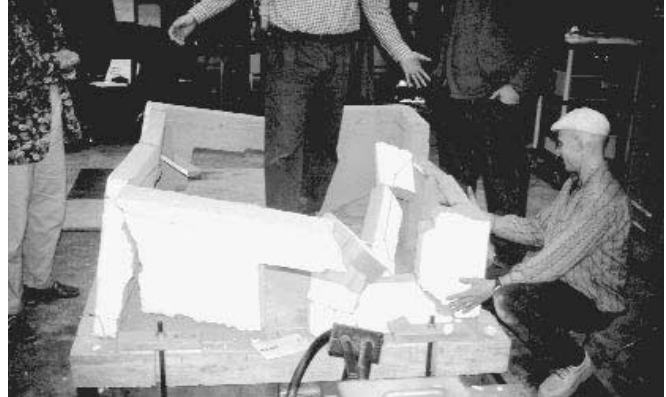
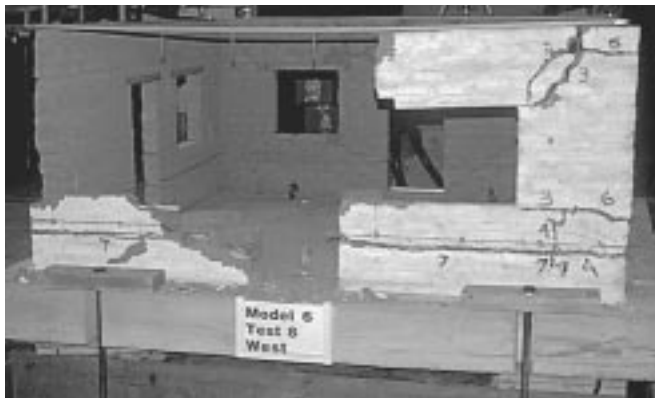
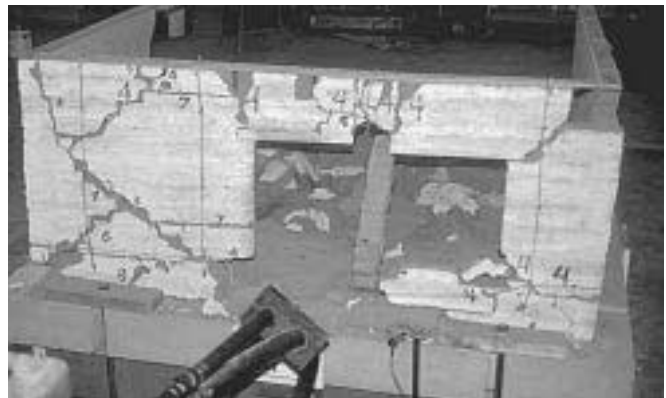
**Figure 6.9**

Comparison of out-of-plane wall performance in lightly retrofitted models after partial collapse: (a) model 4 ( $S_L = 5$ ), east wall, test level X; (b) model 1 ( $S_L = 7.5$ ), east wall, test level X; (c) model 6 ( $S_L = 11$ ), west wall, test level VIII; and (d) model 6 ( $S_L = 11$ ), east wall, test level X.

The performance of a thin wall with a bond beam and local ties showed that modest improvements to the retrofit systems on a thin-walled building still may not be sufficient. The out-of-plane walls collapsed during test levels VIII and IX, respectively (fig. 6.9c, d). These two walls had a bond beam, lower horizontal straps, and local ties in critical locations.

The other two walls of the same model behaved considerably better with the addition of vertical straps. Nevertheless, during test level X, the out-of-plane east wall lost the pier between the door and window even with the vertical strap (fig. 6.9d). This type of damage was not observed in other buildings with thicker walls when vertical straps or center-core rods were installed.

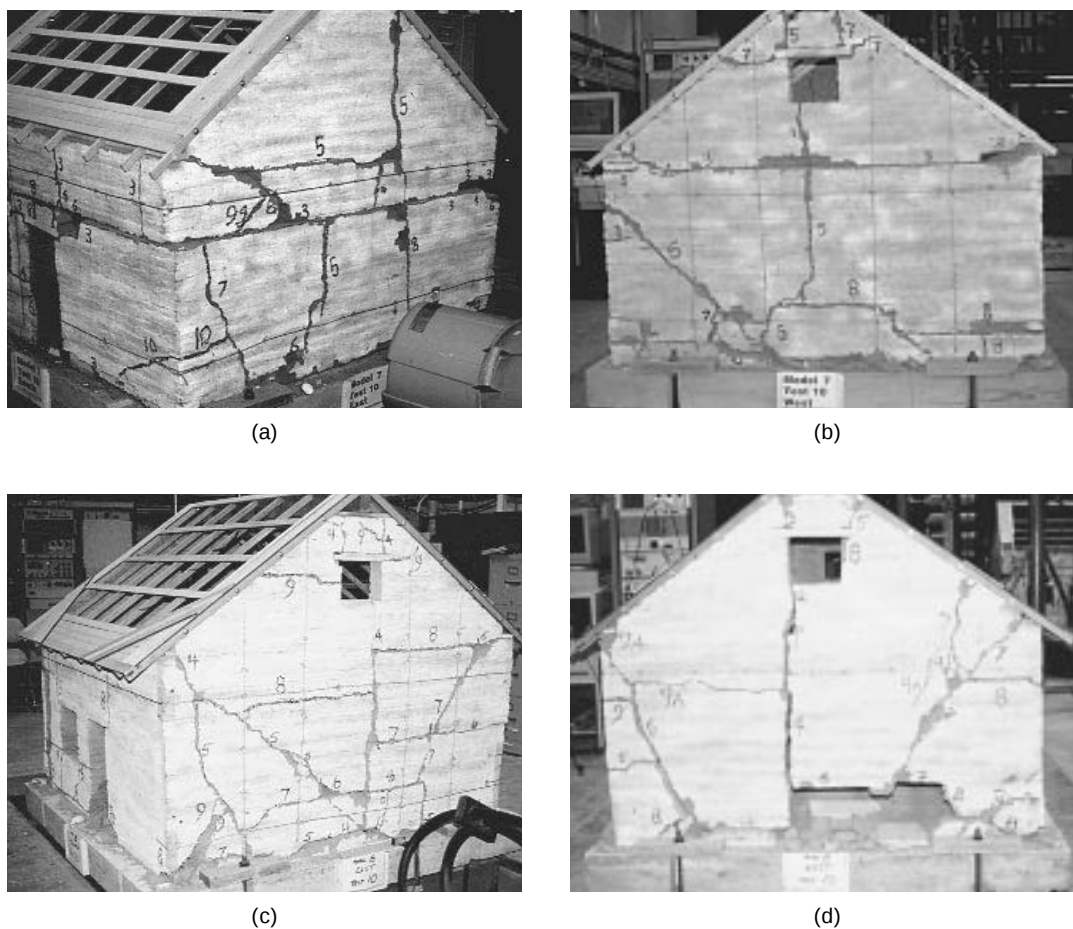
**Figure 6.10**

Comparison of the out-of-plane wall performance of tapanco-style models with differing retrofit systems after test level X: (a) model 7, east wall; (b) model 7, west wall; (c) model 8, east wall; and (d) model 8, west wall.

Vertical straps provided additional restraint that minimized the extent of dynamic and permanent crack offsets. In model 7, the performance of the west wall (fig. 6.10b) was somewhat better than that of the east wall as a result of the vertical straps that provided restraint for block movements along horizontal and diagonal cracks.

The retrofit system used on model 8 ( $S_L = 7.5$ ) was modified slightly to try to decrease the amount of offset at horizontal cracks. The east wall (fig. 6.10c) had vertical straps, and the wall crossties were spaced closely together to limit the relative displacement between adjacent blocks. The displacements in the gable-end wall were limited to 1.25–1.9 cm (0.5–0.75 in.) in the model domain, which was an improvement over the

The performance of the west wall of model 8 showed the extent to which center-core rods can reduce the offset across cracks during out-of-plane ground motions (fig. 6.10d). This wall had center-core rods that extended from the top to almost the base of the wall. Most of this wall was retrofitted with epoxied center-core rods and sustained minimal crack damage. There were no measurable offsets across center-core rods. Extensive damage to this wall occurred near the base in the area where the center-core rods did not extend. Most of the energy was dissipated in the areas outside of the center-core rods. If the center-core rods had extended into the foundation, there may have been additional damage in the upper part of the wall since there would have been no clear area for energy dissipation.
