# Seismic Stabilization of Historic Adobe Structures

**Final Report of the Getty Seismic Adobe Project**

**E. Leroy Tolles**

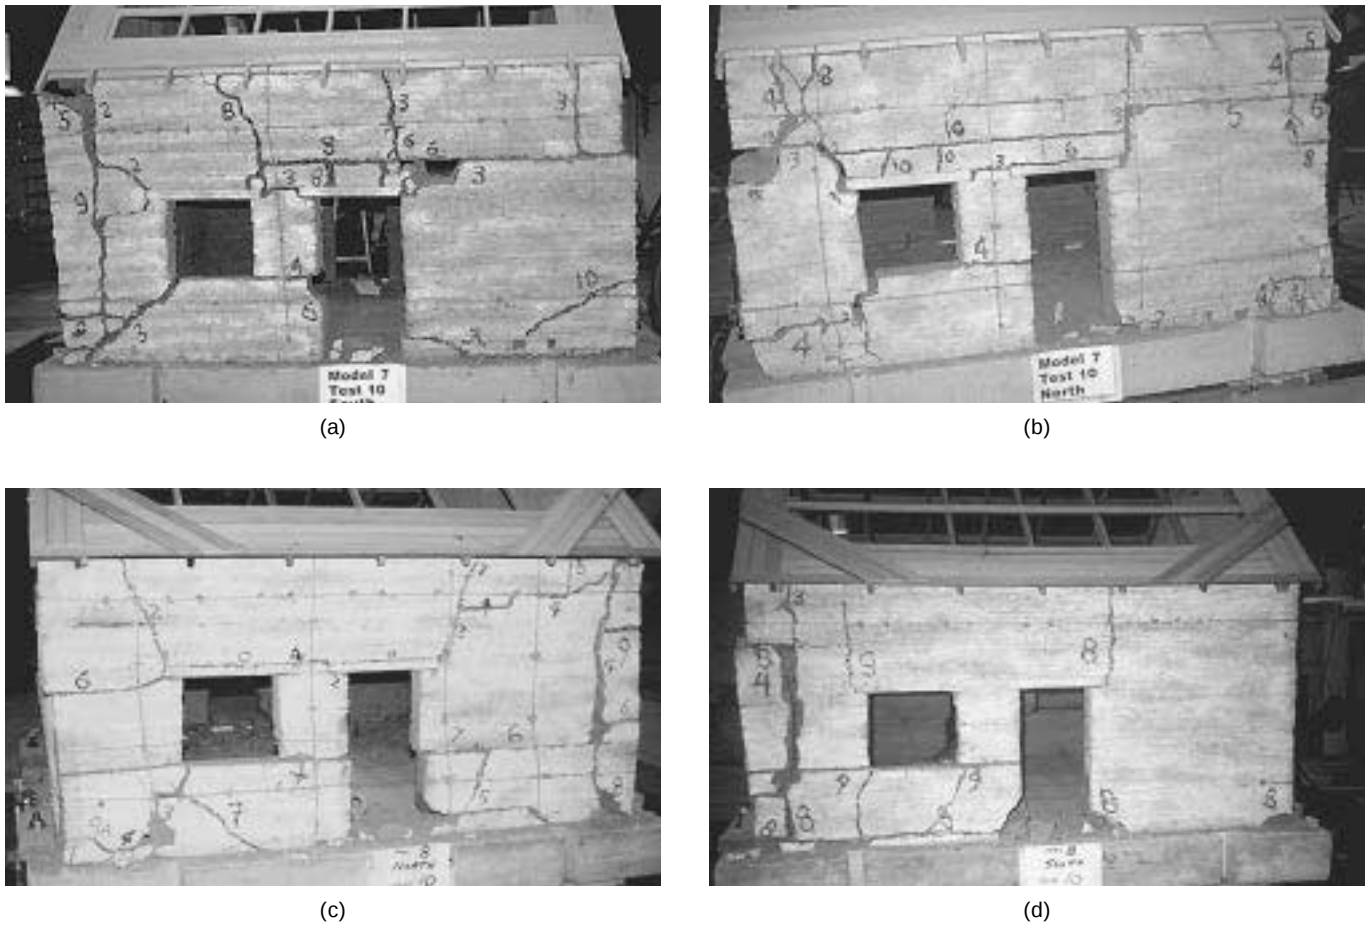
**Figure 6.11**

Comparison of the in-plane wall performance of tapanco-style models with differing retrofit systems after test level X: (a) model 7, south wall; (b) model 7, north wall; (c) model 8, north wall; (d) model 8, south wall.

In the in-plane direction, center-core rods were also most effective at preventing permanent offsets. Figures 6.10 and 6.11 show the damage to the retrofitted tapanco-style models at the end of the testing sequence. In general, the cracks opened to approximately 1.9 cm (0.75 in.) in each of the walls except where epoxied center-core rods were installed. The horizontal straps restrained the development of permanent offsets in the walls but still allowed displacements of the blocks. Stiffer straps may have been used to provide greater restraint against damage, but two factors would need to be taken into account: (1) a failure plane might develop just above the strap that would permit slippage, or (2) the strap may dig into the adobe material and loosen, even with a stiffer strap. To try to control the latter, a wire-mesh screen was added at the exposed corners. The straps were still able to dig into the adobe at the through-wall holes. Minimal damage was observed in the in-plane wall of model 9, where the vertical center-core rods were used (fig. 6.11d).

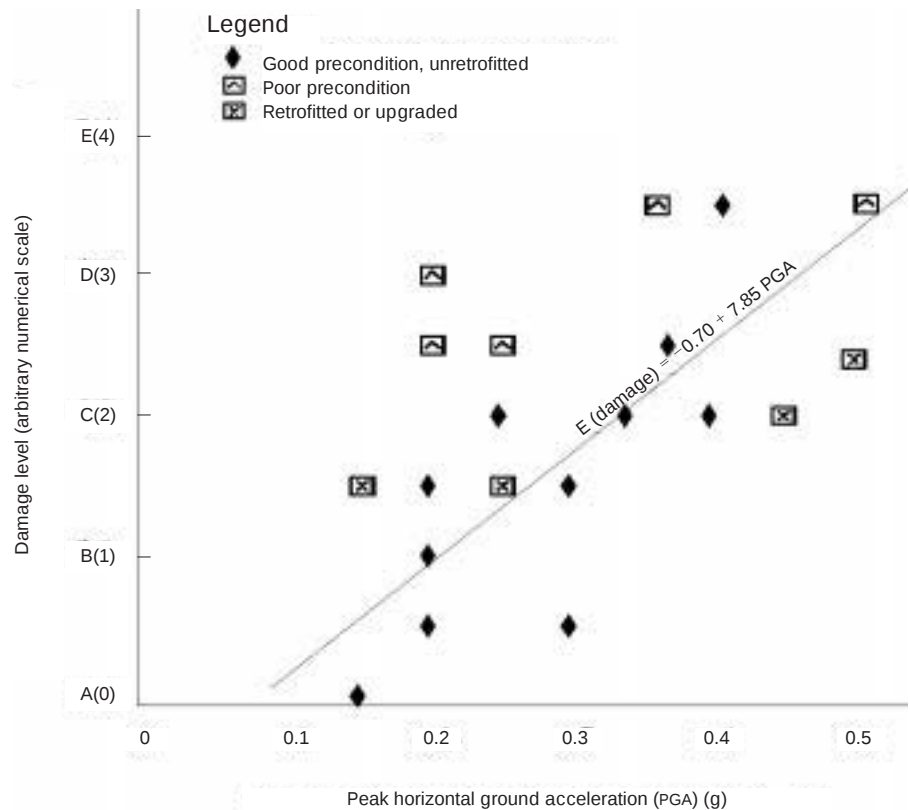
**Figure 6.12**

Figure 6.12 shows the relationship between the PGA level and damage for well-maintained historic adobes. Ground acceleration in the range of 0.1 g to 0.2 g PGA seems to be required to initiate damage in such buildings. At this level of ground motion, cracks begin to form at door and window openings and at the intersections of perpendicular walls. At the Southern California adobe sites studied where PGA was in this range, the Miguel Blanco Adobe, San Marino, was undamaged; the Purcell House, San Gabriel, was slightly damaged; the Plaza Church, Los Angeles, was also slightly damaged; and the Centinela Adobe, Los Angeles, experienced slight to moderate damage. These adobes were well maintained and had not been reinforced or retrofitted.

Observed damage level vs. peak horizontal ground acceleration for historic adobe buildings after the 1994 Northridge earthquake.

earthquake damage are found above the expected damage line for well-maintained adobes, indicating that severe damage can be expected for buildings in poor condition. Even for ground motions of moderate intensity (0.1–0.2 g), poorly maintained buildings are likely to suffer substantial damage.

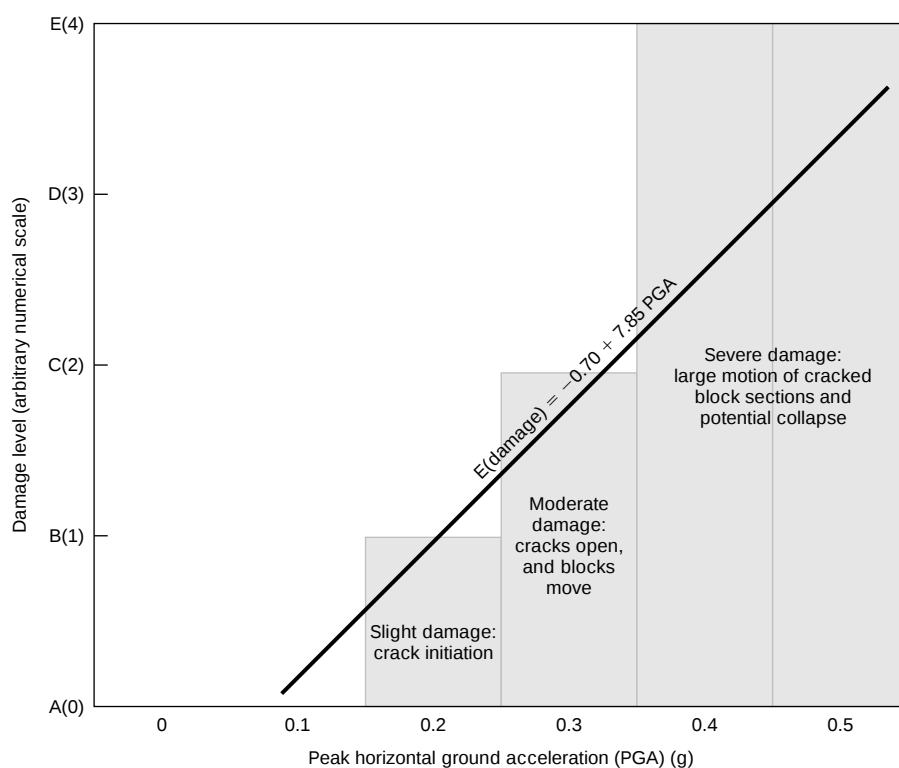
**Figure 6.13**

Damage level vs. peak horizontal ground acceleration for historic adobe buildings after the 1994 Northridge earthquake.

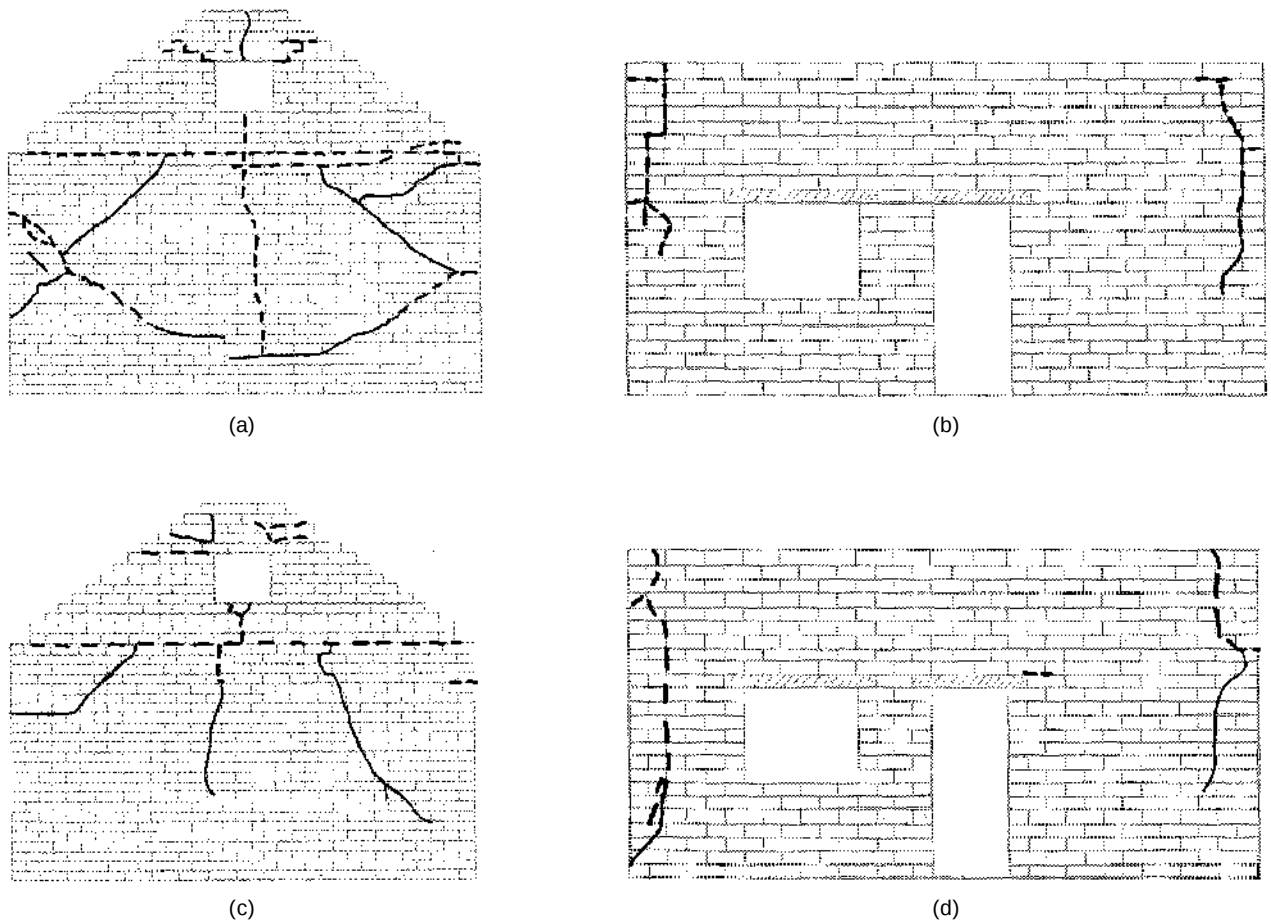
**Figure 8.3**

Diagram of model 10, test VI, crack patterns on (a) east wall; (b) north wall; (c) west wall; and (d) south wall.

During test VI (figs. 8.3 and 8.4), the out-of-plane motions of the gable-end walls were significant, with peak displacements of nearly 16.5 cm (6.5 in.). Cracks developed more fully during this test and completed the principal crack patterns for the out-of-plane walls. The patterns that occurred in the east and west walls were different due to the variability in the adobe masonry and the asymmetry of the ground motions. Spalling continued along the major cracks. Without the restraint of the roof system, the gable-end walls would have had a tendency toward instability. Minimal restraint was required to significantly affect the out-of-plane dynamics of thick walls.

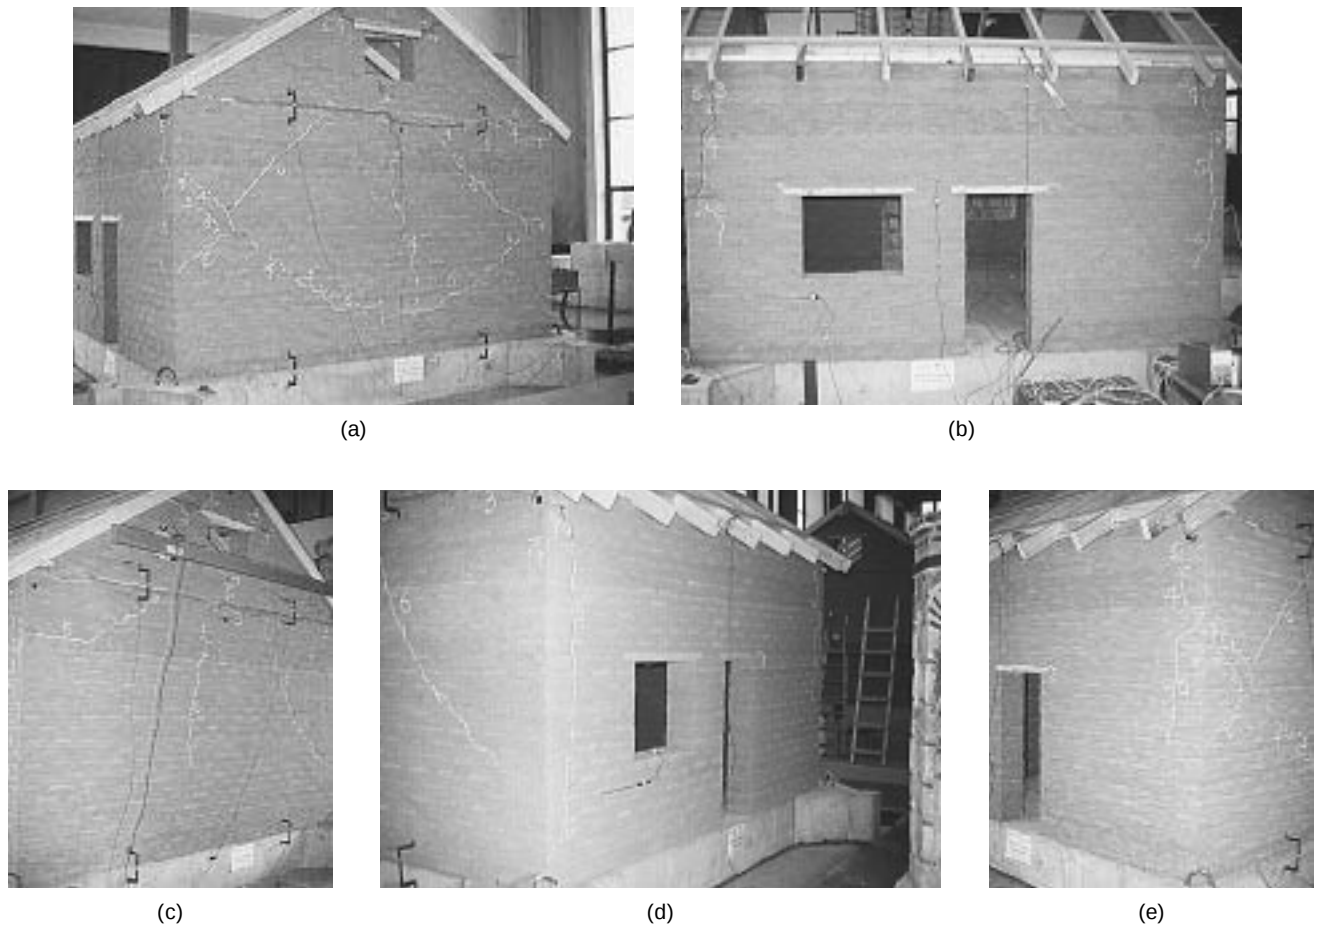
**Figure 8.4**

Photographs of model 10, test VI, crack patterns on (a) east wall; (b) north wall; (c) west wall; (d) south wall, west side; and (e) south wall, east side.

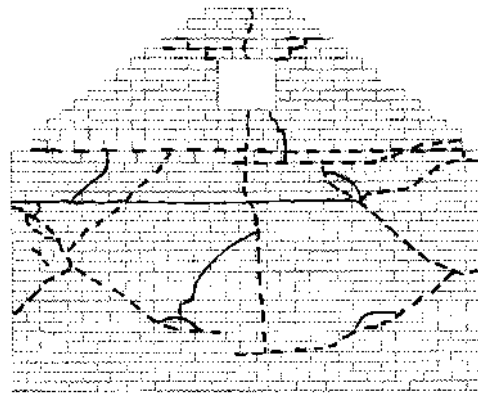
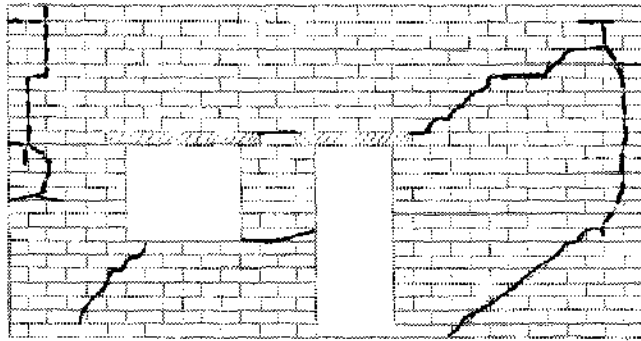
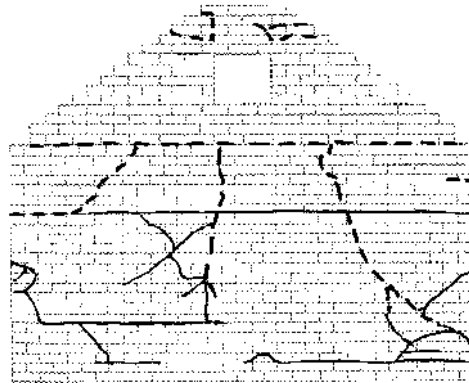
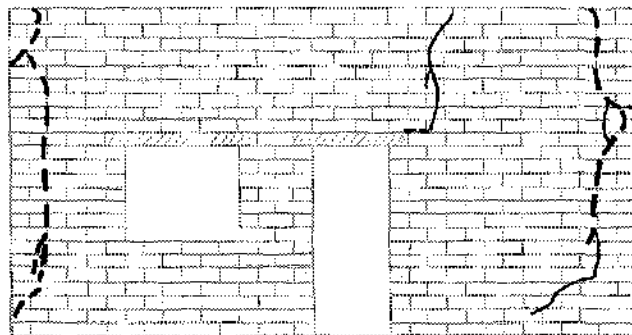
**Figure 8.5**

During test VII (figs. 8.5 and 8.6), the out-of-plane motions were very great and caused cracking and popping noises in the wood framing of the roof. The out-of-plane walls would very likely have overturned had it not been for the restraint provided by the roof framing system. Spalling continued along the major cracks. Diagonal cracks

developed during test VII in the north wall (fig. 8.5b). This was the first test during which typical diagonal in-plane cracks developed; there were no similar in-plane cracks in the south wall. The out-of-plane displacement of the west gable-end wall was 23.6 cm (9.3 in.) during test VII.

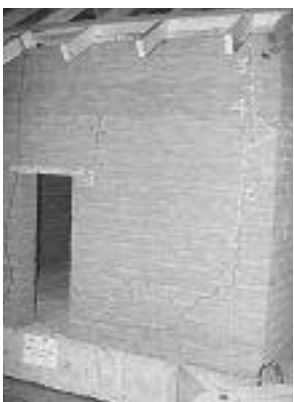
**Figure 8.6**  
Photographs of model 10, test VII, crack patterns on (a) east wall; (b) north wall; (c) west wall, south side; (d) south wall, west side; and (e) south wall, east side.

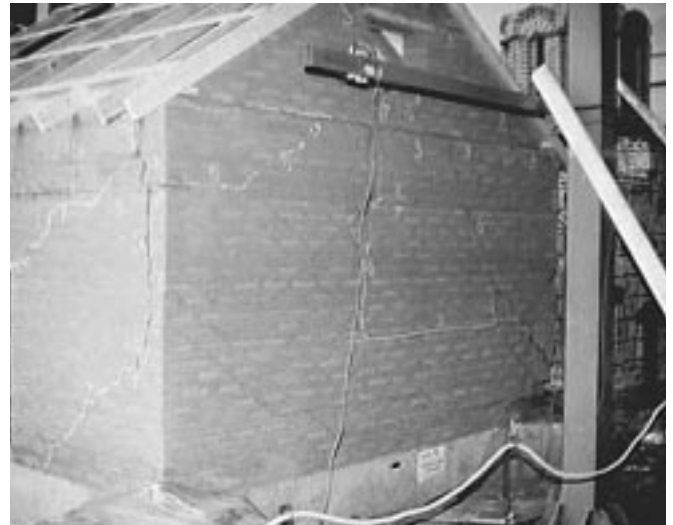
During test VIII (fig. 8.7), the east wall collapsed from the center of the wall rather than overturning due to restraint by the roof system. Test VIII lasted only about 3 seconds because the programmed table accelerations exceeded the capacity of the earthquake simulator. Due to the short length of the test, little additional damage occurred in the other walls of the building. The overturning failure mode occurs by rotation about the lowest horizontal crack, and the maximum displacement occurs at the top of the wall (fig. 8.8a). This type of collapse is referred to as “mid-height, out-of-plane collapse” (fig. 8.8b).

Model 10, test VIII, showing (a) east wall collapse; and (b) crack patterns in north-west corner.

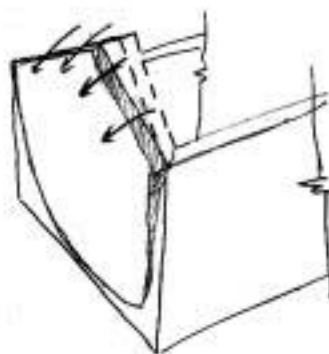
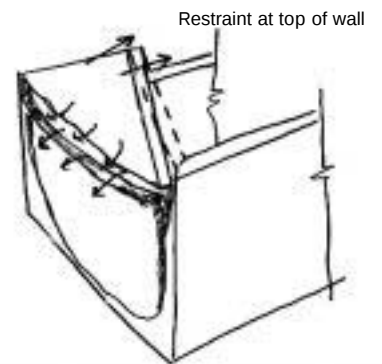
Drawings of out-of-plane modes of failure, illustrating (a) typical overturning failure as the wall rotates about its base; and (b) mid-height, out-of-plane collapse observed in the east wall of model 10. The latter mode of collapse occurred due to the restraint provided by the roof system at the top of the wall.

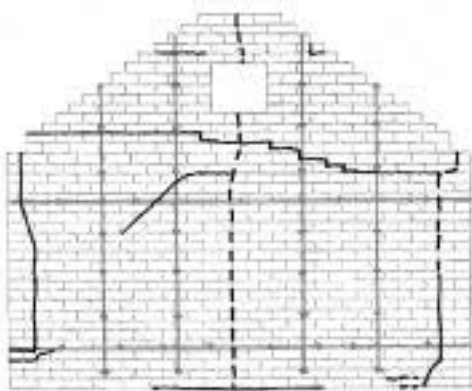
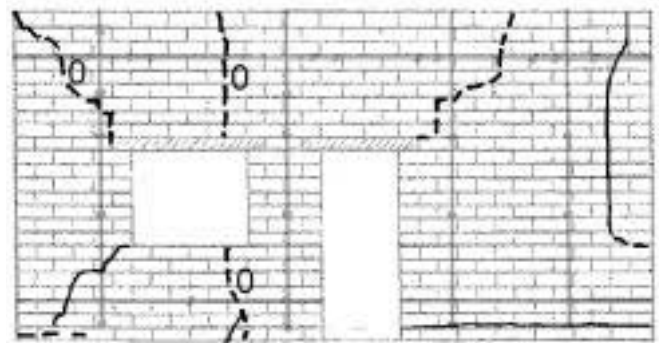
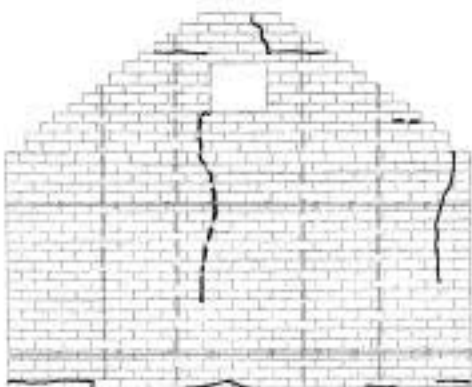
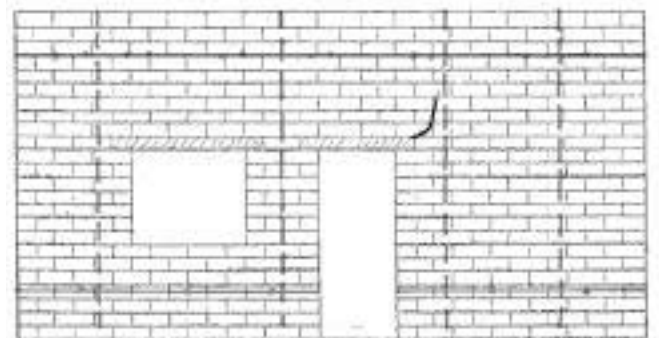
Diagrams of model 11, test V, crack patterns on (a) east wall; (b) north wall; (c) west wall; and (d) south wall. Earlier cracks are marked with zeros and dashed lines.

New crack damage did not develop until test IV or propagate until test V. The location of the crack damage after test V is shown in figure 8.10. Damage to the two out-of-plane walls was similar in some respects to that in model 10 but different in others, indicating the influence of the retrofit strategies. The vertical straps used on the west walls were not stiff enough to prevent or change the development of crack damage in the wall. The strap system affected only the dynamic performance after cracks had developed. As a result, the crack pattern in the east out-of-plane, gable-end wall consisted of both vertical and horizontal cracks similar to those

The in-plane north wall with vertical and horizontal straps developed additional cracks during both tests IV and V (fig. 8.10b). These cracks occurred earlier than in the in-plane walls of model 10 for two reasons: (1) some cracks existed before the testing began, and (2) the retrofit system resulted in higher forces being transferred to the in-plane from the out-of-plane walls. More than likely, both factors contributed to greater cracking in the north wall of model 11 compared to the north wall of the unretrofitted model 10.

The south wall with vertical center-core rods suffered little damage. A minor crack began at the upper right corner of the in-plane south wall but appeared to stop when the crack reached the epoxy-anchored, center-core rods.

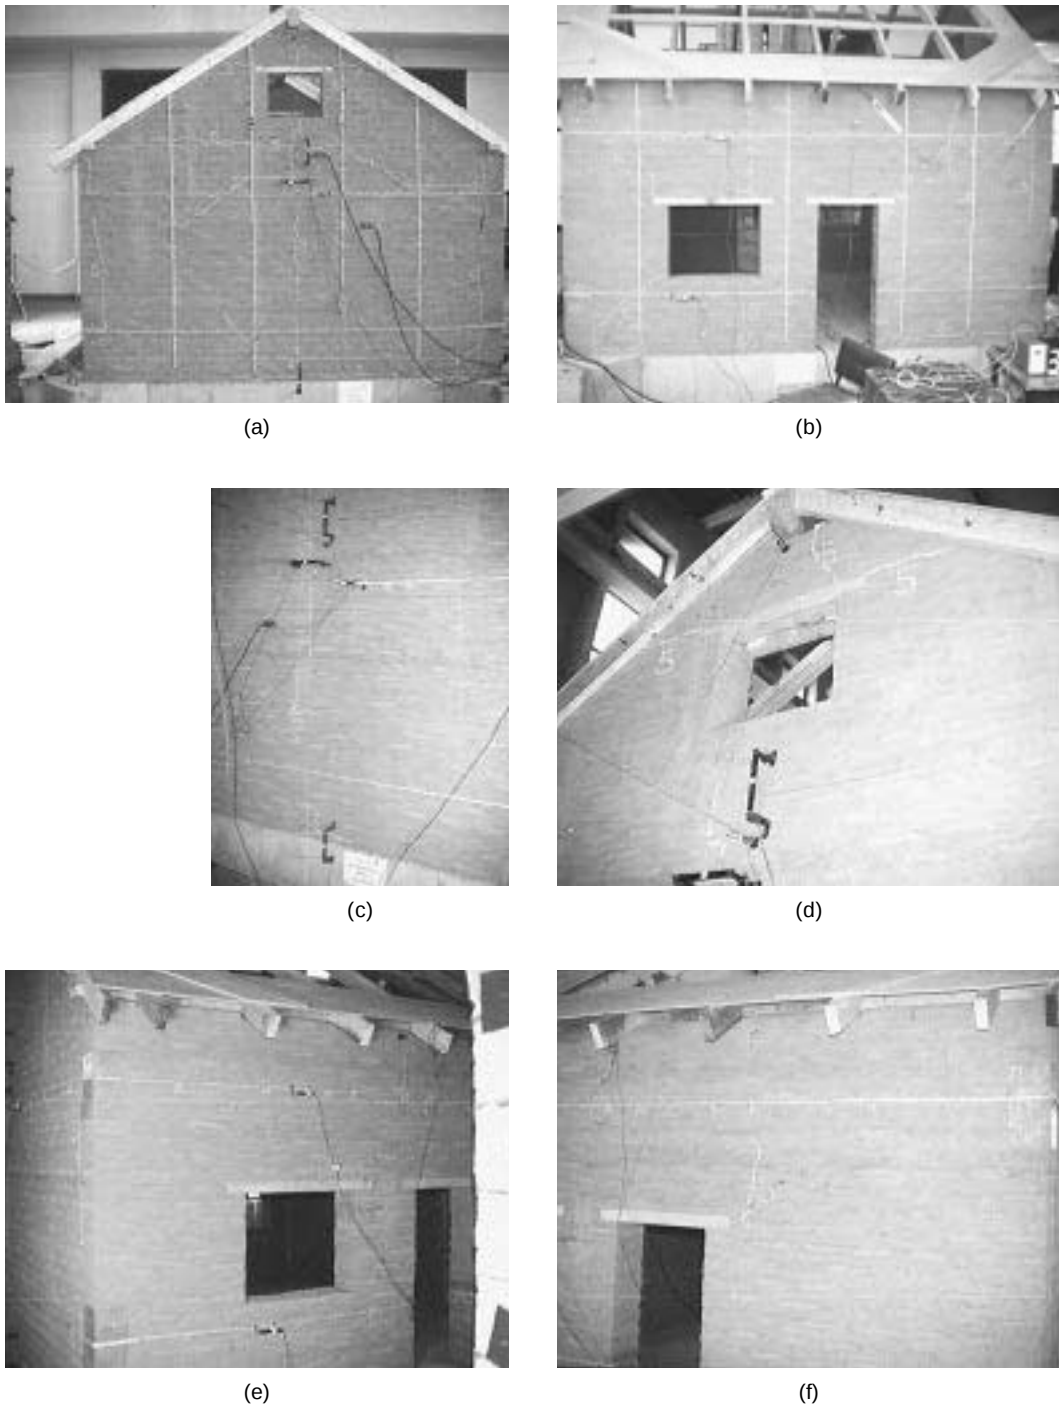
**Figure 8.11**

In viewing the dynamic tests, the cracks that developed during tests IV and V were relatively minor in terms of the amount of displacement that occurred in the out-of-plane walls. In the photographs of figure 8.11, it is difficult to discern the locations of the cracks because they were highlighted with chalk only, and no spalling had occurred around the cracks. Not until test VI did larger displacements develop and spalling become significant.

Photographs of model 11, test V, crack patterns on (a) east wall; (b) north wall; (c) west wall; (d) west wall gable; (e) south wall, west side; and (f) south wall, east side.

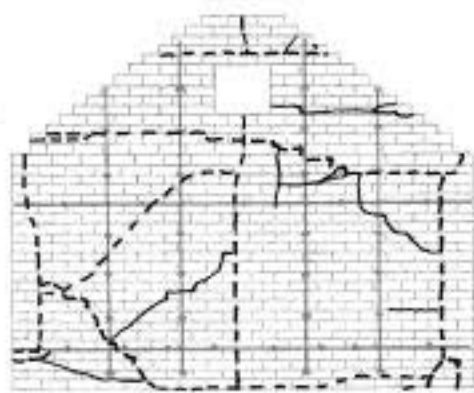
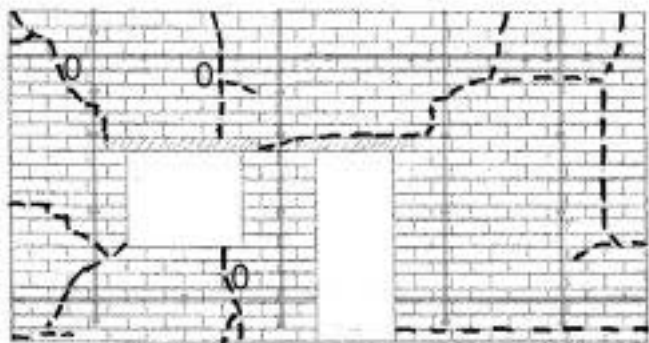
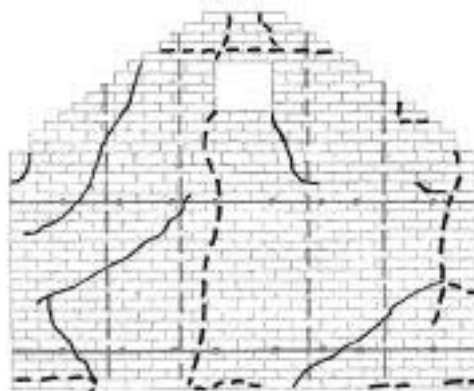
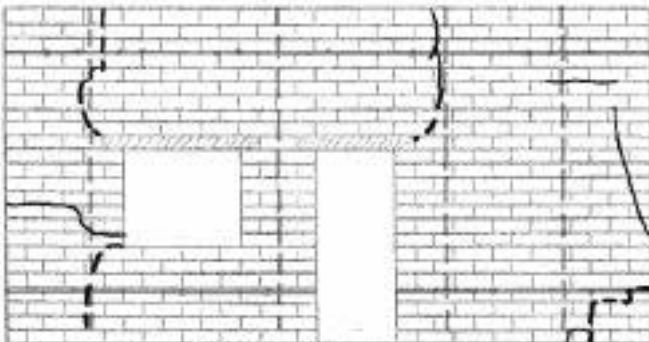
During the strong ground motions of tests VI–VIII, all of the retrofit measures on the building became significant with regard to the performance of model 11. The walls with vertical straps, both in-plane and out-of-plane, sustained much higher levels of damage than the walls with the vertical center cores. The drawings and photographs of model 11 after test VII are shown in figures 8.12 and 8.13.

Test VII was informative because of the significant difference in the behavior of the two sets of walls. The north and east walls with vertical straps suffered large displacements, spalling, and significant off-

The extent of damage to the north and east walls contrasts sharply with the low level of damage in the south and west walls. Spalling continued, with large cracks opening on the east and north walls and permanent offsets at several cracks. The dynamic motions of the east gable-end wall were very great, causing relatively large loads to develop in the vertical and horizontal straps.

**Figure 8.12**  
Diagram of model 11, test VII, crack patterns on (a) east wall; (b) north wall; (c) west wall; and (d) south wall.

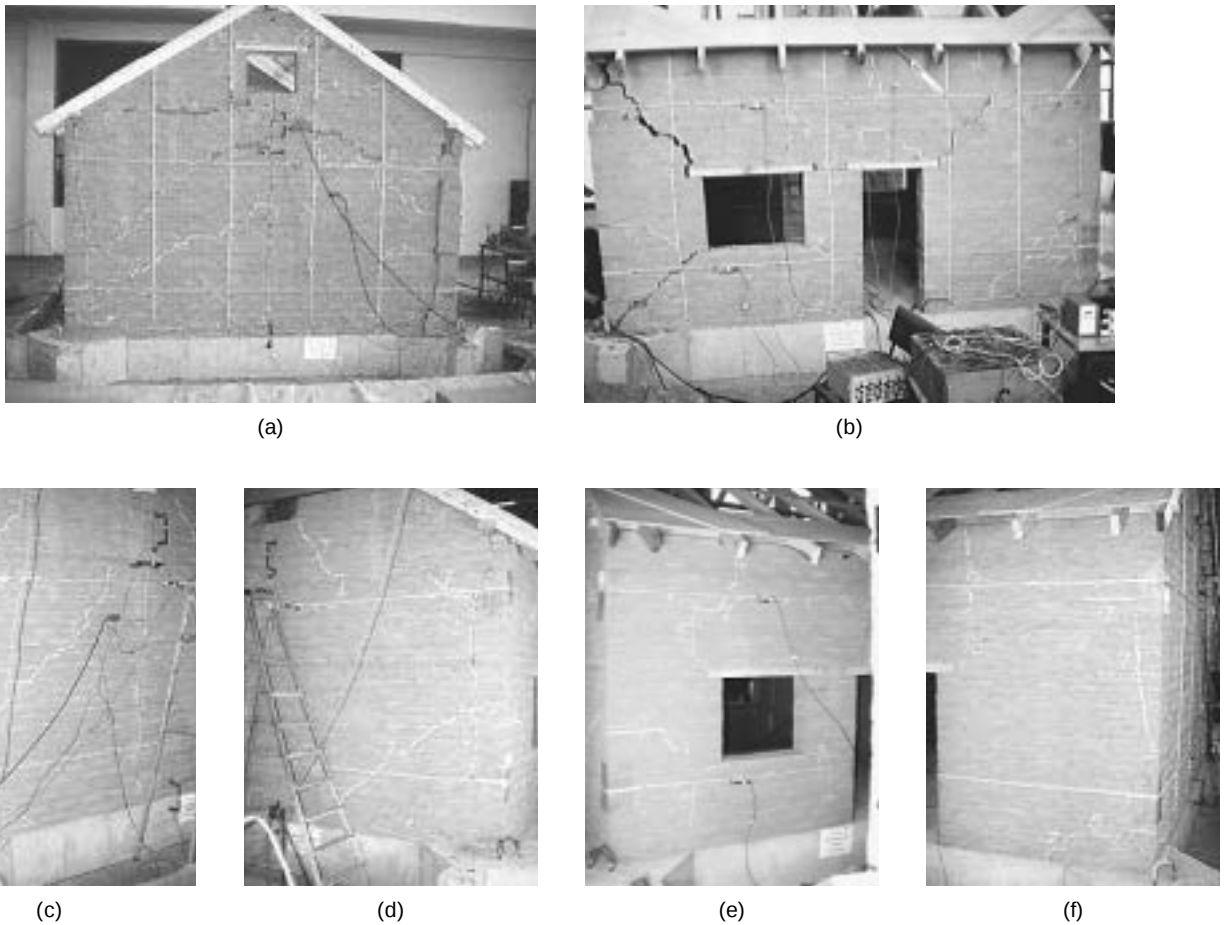
**Figure 8.13**

Photographs of model 11, test VII, crack patterns on (a) east wall; (b) north wall; (c) west wall gable; (d) west wall, south side; (e) south wall, west side; and (f) south wall, east side.

The most significant damage may have been the displacement of the block at the east end of the north wall (fig. 8.13b). The section of the wall defined by the diagonal cracks at the upper and lower left corners of the window created a cracked wall section along which the permanent displacements continued to grow as the tests proceeded, beginning with test VII. The crack at the top of this panel developed a permanent displacement of approximately 3.8 cm (1.5 in.) during this test, and significant loads were applied to both the upper and lower horizontal straps. The load on the upper strap was great enough to result in a secondary horizontal crack that developed just below this strap. This section of wall was difficult to restrain because it continued to move downward and out along the lower diagonal crack. Gravity and dynamic motions continually moved this section outward. In this type of damage, a diagonal crack at the end of a wall section creates a condition in which damage progressively worsens during continued earthquake motions and may eventually lead to catastrophic failure.

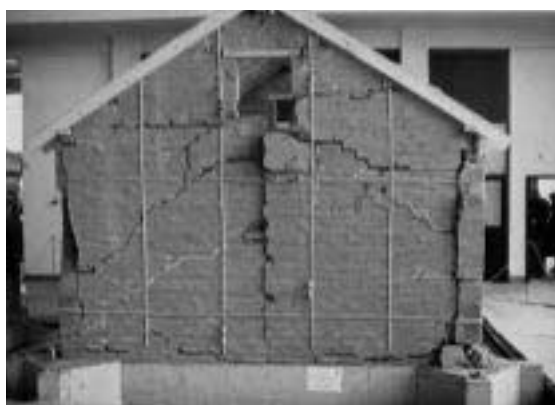
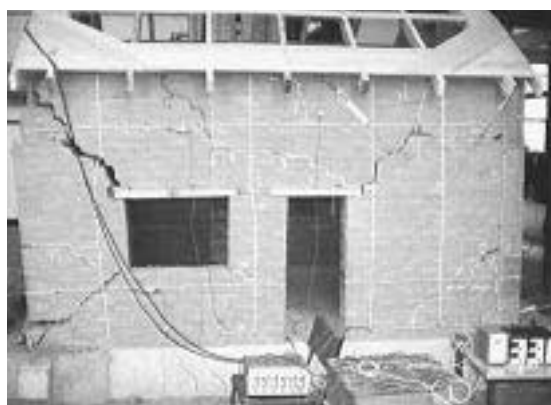
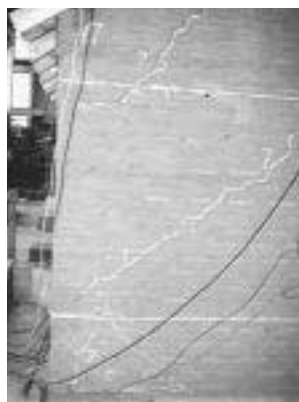
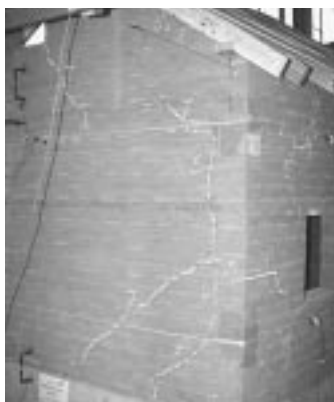
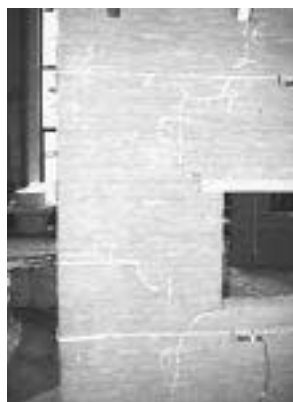
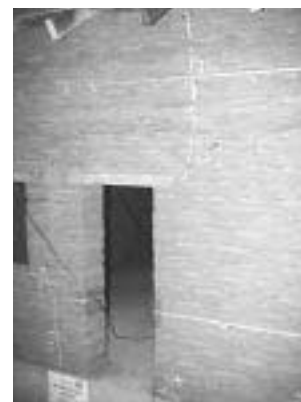
**Figure 8.14**

Model 11, test VIII\*, crack patterns on (a) east wall; (b) north wall; (c) west wall, south side; (d) west wall, north side; (e) south wall, west side; and (f) south wall, east side.

The east gable-end wall suffered significant additional damage during test VIII\*. A small block just below the window was dislodged (see fig. 8.14a), and the offsets at the cracks in the center were nearly 7.6 cm (3 in.). Although large dynamic displacements occurred during the test, the wall never appeared to have been close to collapse.

Damage to the north wall continued to worsen, with additional cracks at the upper right corner of the door opening. The large offset at the cracked wall section on the left (east) end of the wall became slightly greater, but the tension in the upper and lower straps was sufficient to prevent considerably larger displacements from occurring at this location.

The west and south walls continued to perform very well. The crack pattern generally remained stable, and no significant spalling occurred. There were no offsets at any of the cracks in these walls, again demonstrating the effectiveness of the center-core rods.

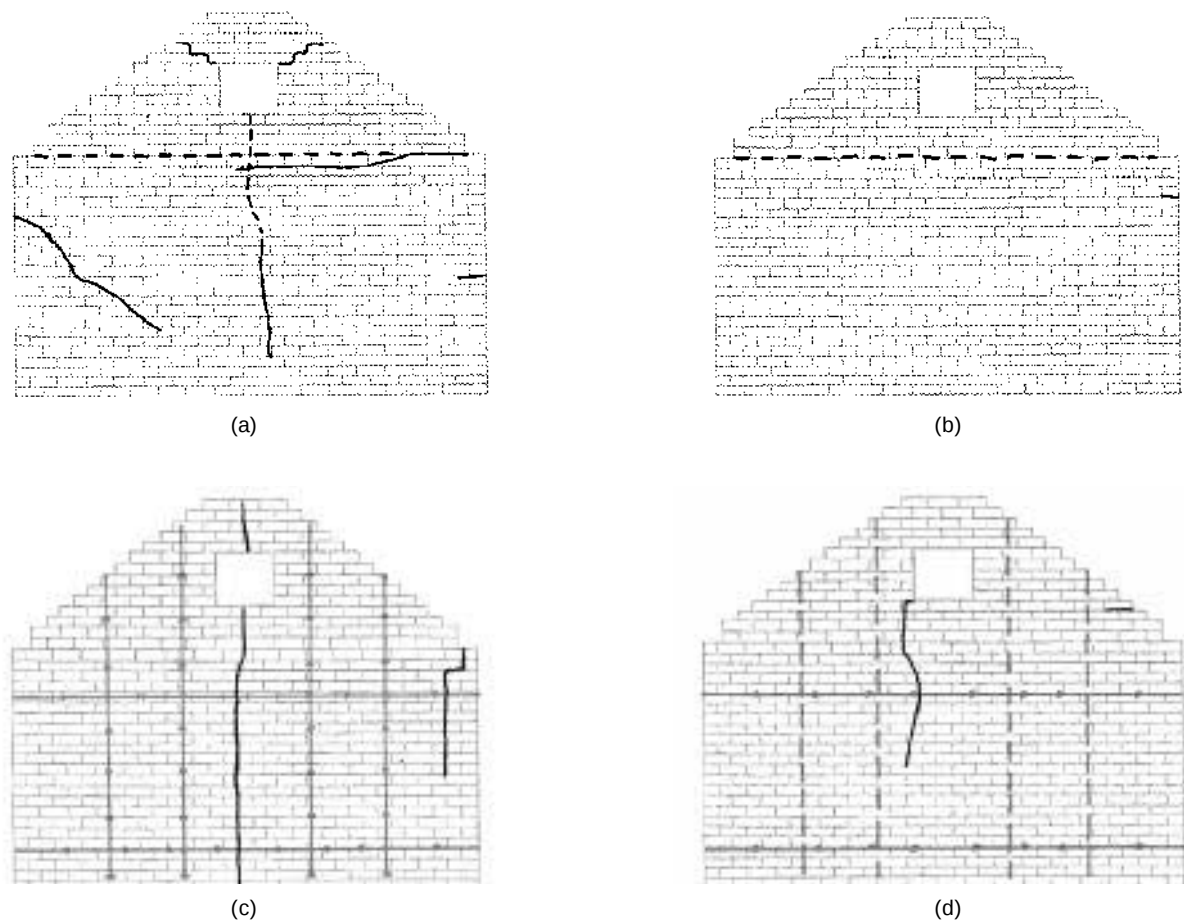
**Figure 8.16**

Crack development of the out-of-plane walls during moderate-level tests was affected by the retrofit system. The stiffness of the roof diaphragm was sufficient to prevent horizontal cracks from occurring in both the east and west gable-end walls of model 11 during test IV, whereas both walls of model 10 developed horizontal cracks during test III (fig. 8.16). Vertical cracks developed during test IV in both retrofitted and unretrofitted models.

Comparison of crack patterns after test IV in out-of-plane walls for (a) model 10, unretrofitted east wall; (b) model 10, unretrofitted west wall; (c) model 11, retrofitted east wall; and (d) model 11, retrofitted west wall. Solid lines indicate cracks that occurred during test IV; dashed lines indicate cracks that typically occurred during test III.

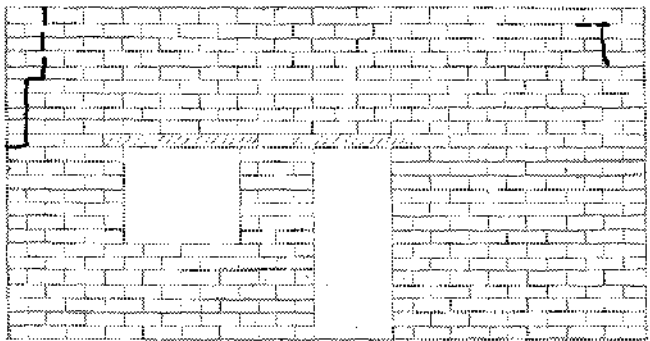
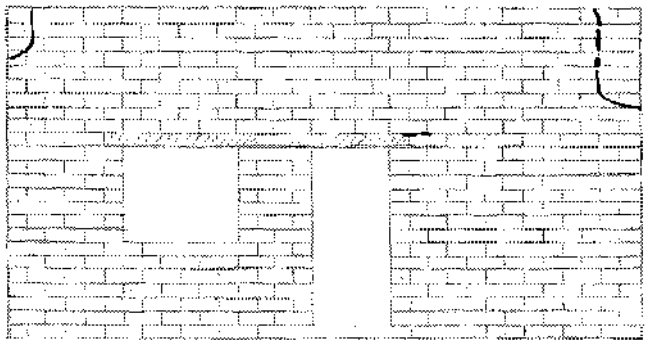
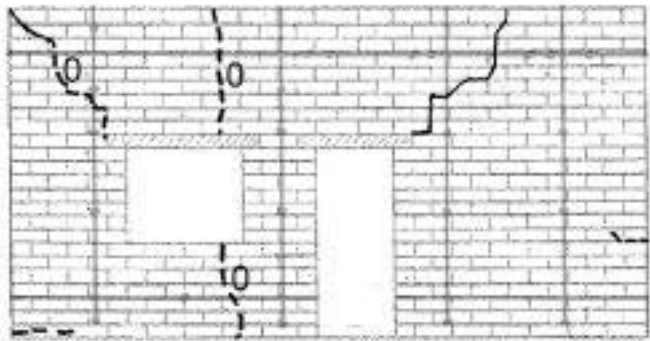
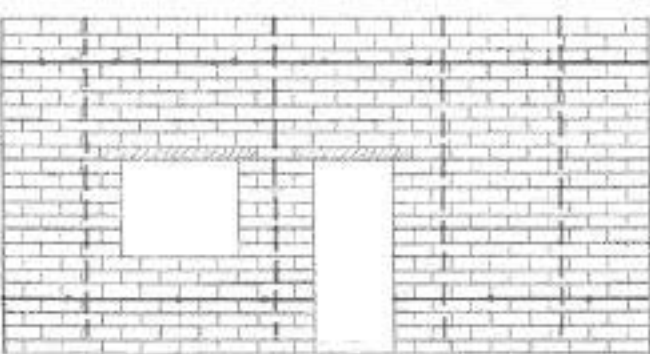
pull-out forces exerted on them by the gable-end walls. The gable-end walls were beginning to pull away from the in-plane walls, which led to crack damage in the upper corners of the in-plane walls (fig. 8.17a, b). The in-plane walls of model 11 did not develop these cracks because of restraint on the dynamic motions of the out-of-plane walls provided by the diaphragms.

In the in-plane walls of the retrofitted model, the only crack that developed during test IV was the diagonal crack that extended from the upper right corner of the doorway in the north wall of model 11 (fig. 8.17c). This crack occurred because the wall already had sustained crack damage and was subjected to greater loads from the roof and floor diaphragms, which transferred loads from the out-of-plane walls to the in-plane walls. It is not possible to determine the extent to which each of these factors contributed to the development of these cracks. During test V, a small in-plane crack also developed at the upper right corner of the doorway in the south wall (fig. 8.19d). This crack turned upward and terminated when it intersected the vertical center-core bar. Nevertheless, the development of a shear crack in the south wall indicated that the loading in the in-plane walls of the retrofitted model was greater than the loading in the corresponding walls of the unretrofitted model.

**Figure 8.17**  
Comparison of crack patterns after test IV in the in-plane walls for (a) model 10, unretrofitted north wall; (b) model 10, unretrofitted south wall; (c) model 11, retrofitted north wall; and (d) model 11, retrofitted south wall. Solid lines indicate cracks that occurred during test IV; dashed lines indicate cracks that typically occurred during test III; cracks labeled “O” occurred before the start of the test series.

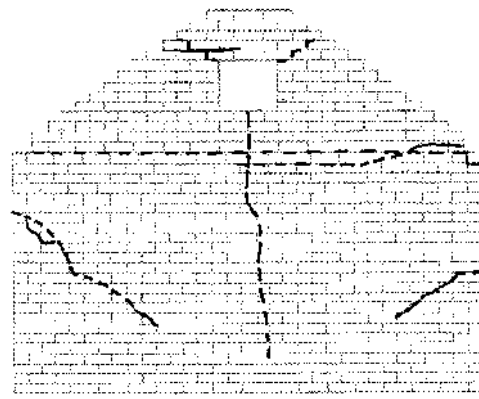
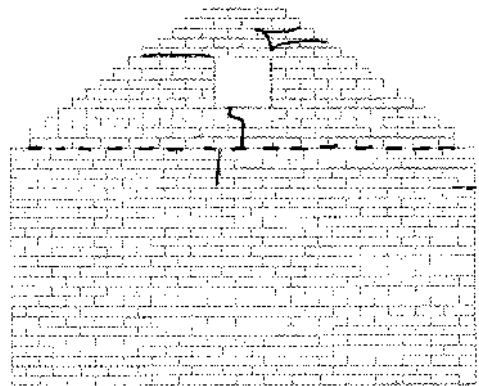
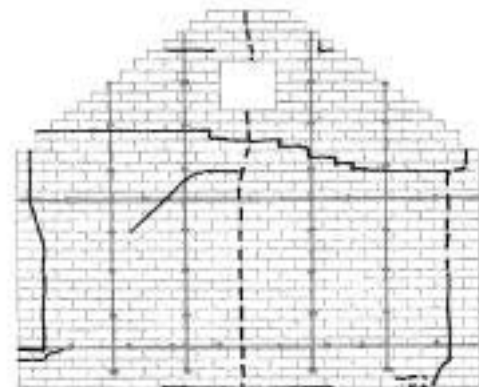
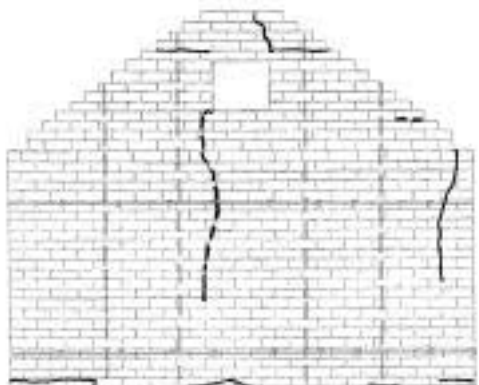
**Figure 8.18**

Crack damage to the out-of-plane walls continued to worsen during tests V and VI as shown in figures 8.18 and 8.20, respectively. During test V, a horizontal crack developed in the east wall of model 11

Comparison of crack patterns after test V  
in out-of-plane walls for (a) model 10,  
unreinforced east wall; (b) model 10,  
unreinforced west wall; (c) model 11,  
reinforced east wall; and (d) model 11,  
reinforced west wall.

(fig. 8.18c). The roof system restrained the top of the wall, but the vertical straps were not able to prevent this type of damage. The crack damage to the east wall of models 10 and 11 was similar though not identical (fig. 8.20a, c). The vertical and horizontal strap system had no significant effect on the elastic behavior and crack development; it had an observable effect only after cracks had developed and displacements were large. Nevertheless, the effect of the strapping system is very significant. Stiffness of the roof diaphragm affected all phases of dynamic performance.

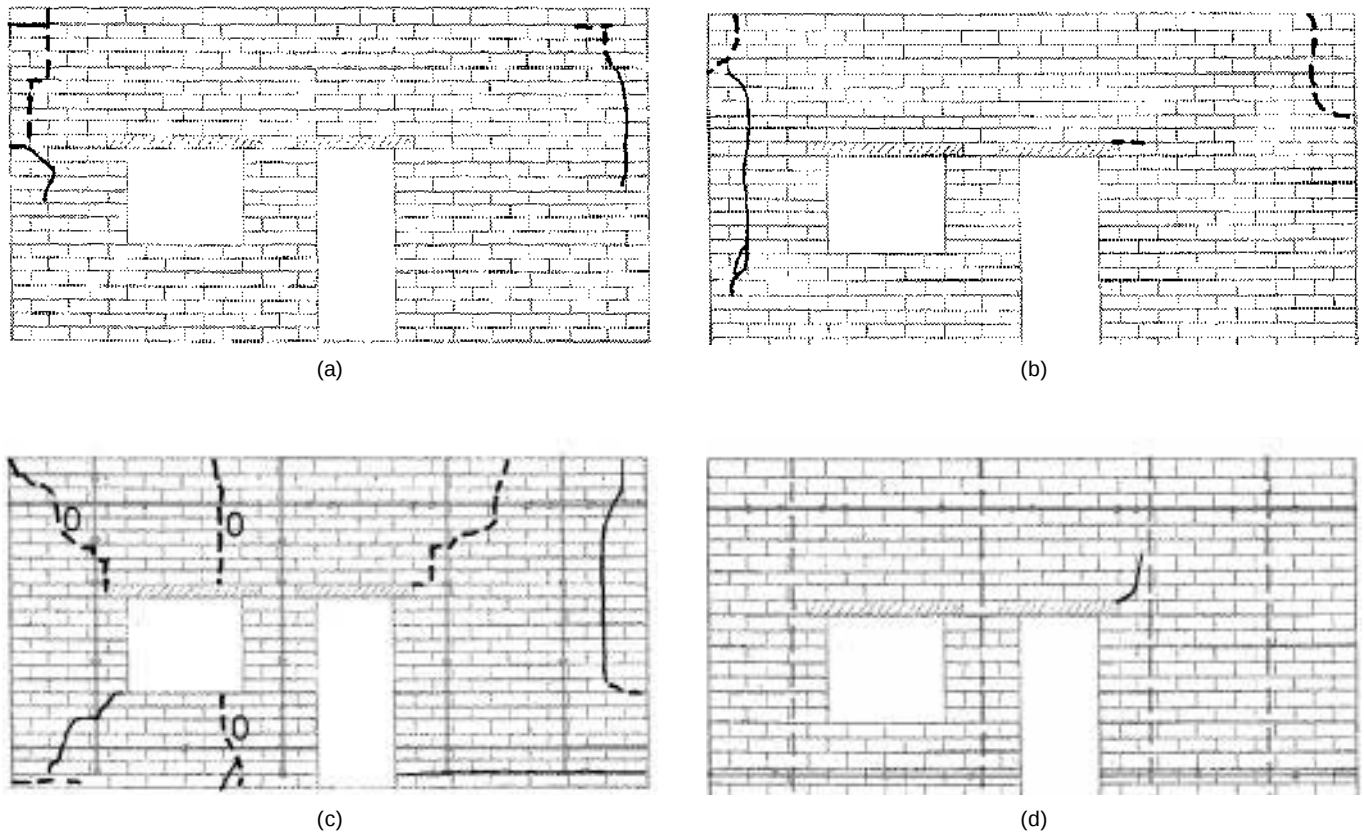
**Figure 8.19**

Comparison of crack patterns after test V in the in-plane walls for (a) model 10, unretrofitted north wall; (b) model 10, unretrofitted south wall; (c) model 11, retrofitted north wall; and (d) model 11, retrofitted south wall.

Crack damage to the in-plane walls continued to progress in both walls of model 11 during tests V and VI (figs. 8.19 and 8.21). In model 11, the damage to the north wall worsened considerably, whereas the crack damage to the south wall propagated to the reinforcing bars, where the cracks terminated. In model 10, crack damage was limited to the ends of the walls and was caused by tensile stresses, not in-plane shear stresses. The differences in behavior are due largely to the additional loading that resulted from the anchorage to the roof and floor diaphragms.

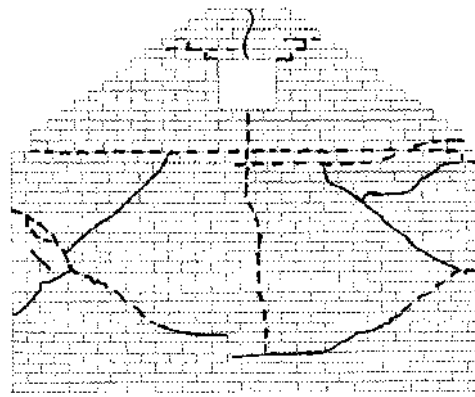
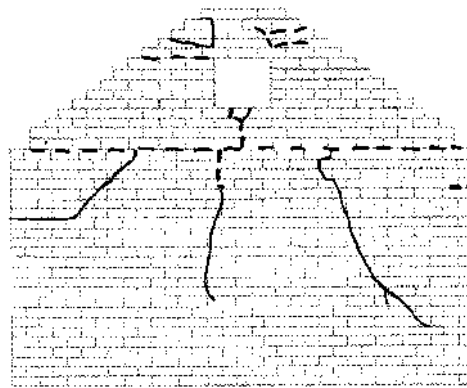
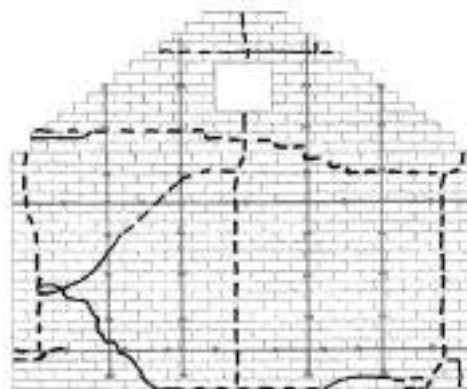
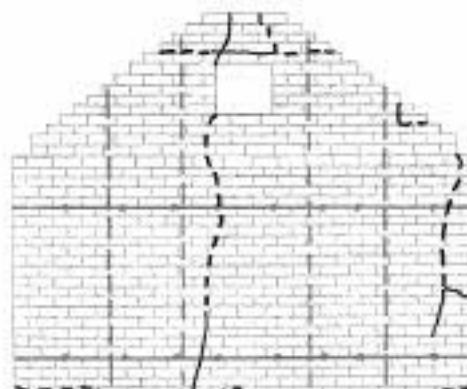
**Figure 8.20**

The crack damage to the west wall of model 11 shows the significant effect of the center-core rods. Through test VI (fig. 8.20), the only long cracks in the west wall were the vertical crack at the center of the wall and the vertical crack on the right (south) side of the wall. Other cracks in the wall were small and not significant. The center-core rods prevented the development of any horizontal or diagonal cracks through test VI.

Comparison of crack patterns after test VI in out-of-plane walls for (a) model 10, unretrofitted east wall; (b) model 10, unretrofitted west wall; (c) model 11, retrofitted east wall; (d) model 11, retrofitted west wall.

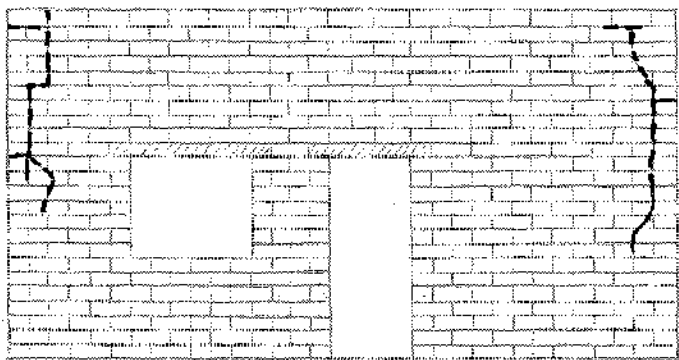
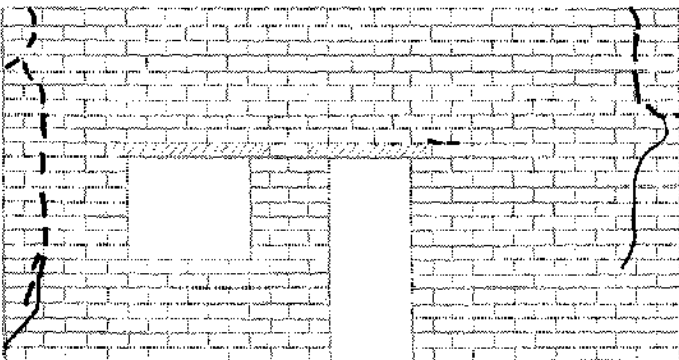
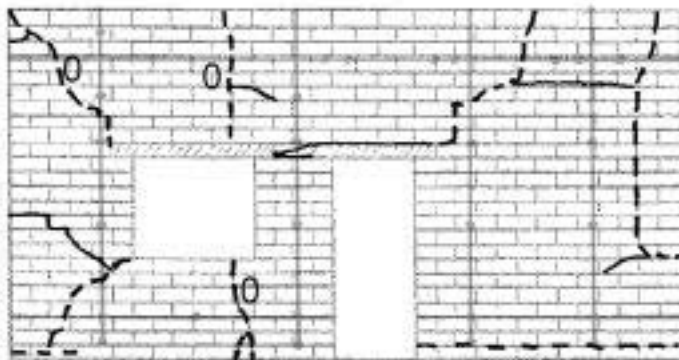
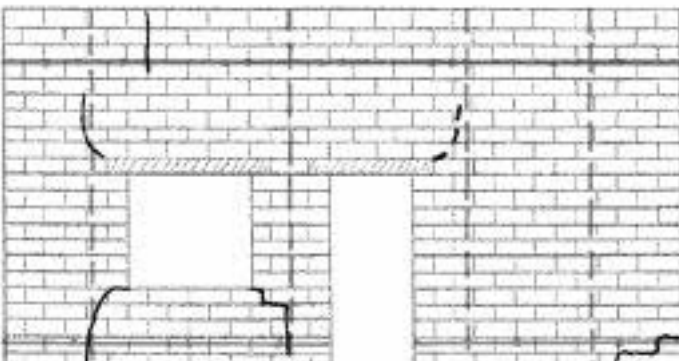
**Figure 8.21**  
Comparison of crack patterns after test VI in the in-plane walls for (a) model 10, unreinforced north wall; (b) model 10, unreinforced south wall; (c) model 11, retrofitted north wall; and (d) model 11, retrofitted south wall.
