# Seismic Stabilization of Historic Adobe Structures

**Final Report of the Getty Seismic Adobe Project**

**E. Leroy Tolles**

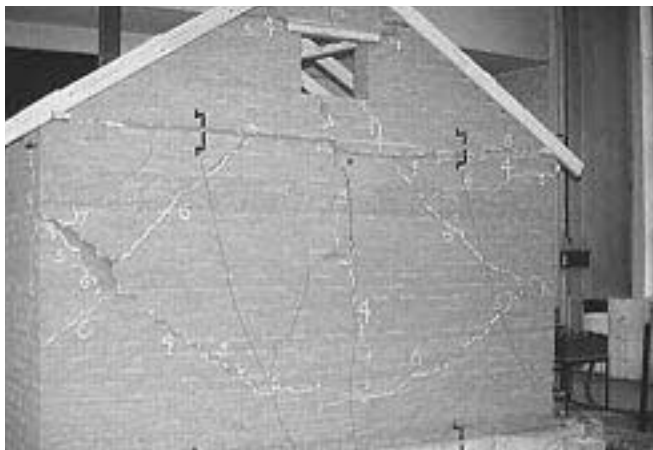
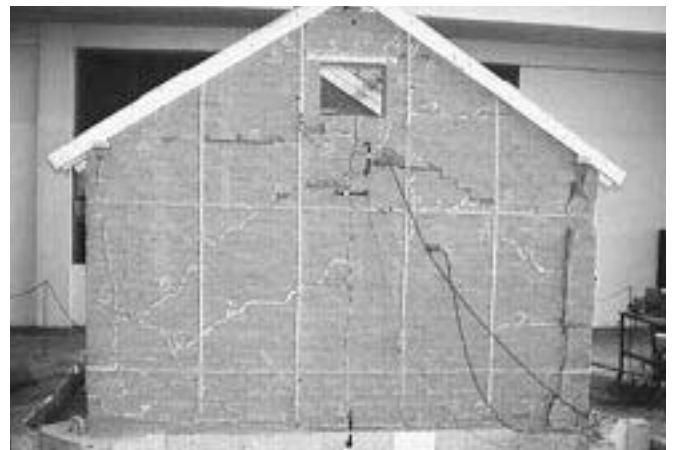
**Figure 8.26**

Photographs of the damage to each wall after test VII appear in figures 8.26–8.29. Crack patterns are shown in figures 8.30 and 8.31. Damage to the out-of-plane walls was significant after test VII in both walls of model 10 and in the east wall of model 11 (fig. 8.30a–c). Although the crack pattern was somewhat different, the extent of the cracks and the amount of spalling was similar in both models. The vertical straps had little effect on the extent of damage; their principal purpose was to reduce damage progression and prevent instability. The extent of damage to the west wall of model 11 was the least of all four walls because of the ductility and strengthening provided by the center-core rods (fig. 8.27).

Comparison of damage to the east walls for (a) model 10 and (b) model 11 after test VII.

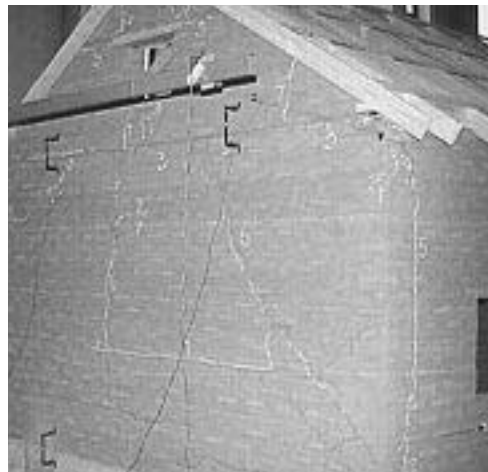
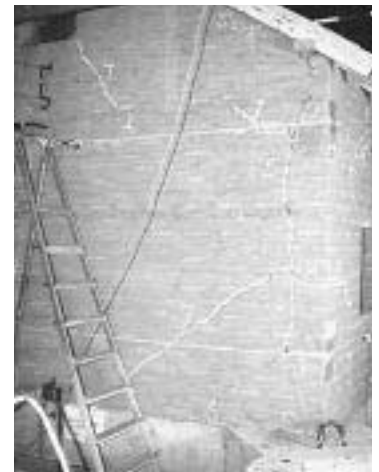
**Figure 8.27**

Comparison of damage to the west walls for (a) model 10 and (b) model 11 after test VII.

The center-core system used on the west wall of model 11 performed extremely well. The condition of the wall after test VII is shown in figure 8.34. Although the full crack patterns developed during tests VI, VII, and VIII\*, the wall was stabilized by the center-core rods. There were no large cracks, offsets, or spalling on this wall; despite the cracks, the wall remained in very good condition.

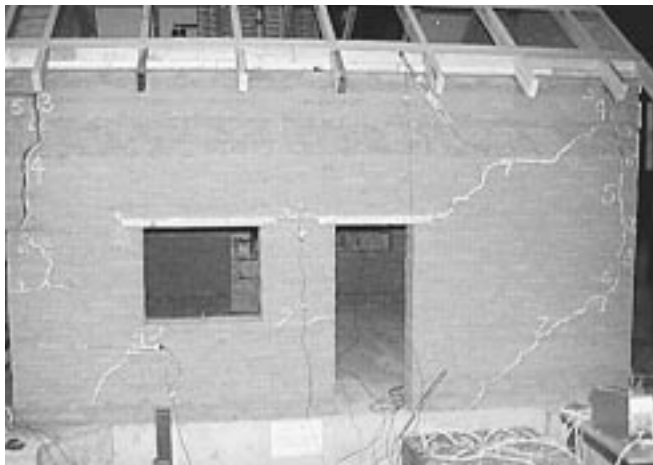
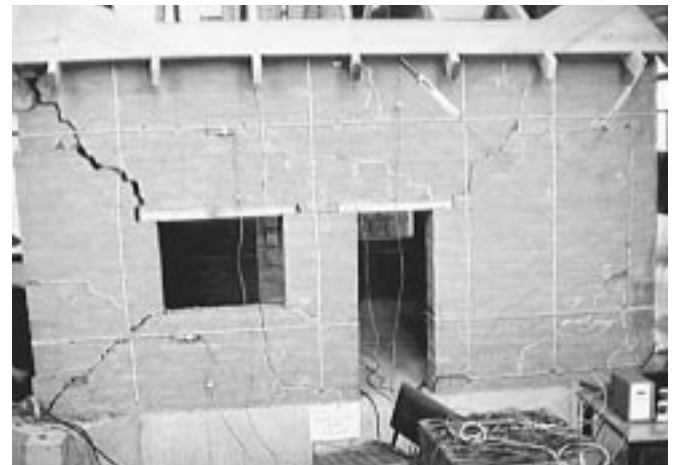
**Figure 8.28**

During the severest tests, additional cracks developed in the in-plane north and south walls (figs. 8.28, 8.29, and 8.31). For the most part, the crack damage in these walls was relatively minor. One exception was the section to the east side of the window at the end of the north wall of model 11, where diagonal cracks developed at the top and bottom

corners of the window. The section was bounded by two large cracks and was not restrained by an adjacent wall. The lower diagonal crack provided a slip plane for this block. Movements along the slip plane were aided by the dynamic motions of the shaking table and gravity. This type of damage has been observed both in the laboratory and in the field and represents a common condition that needs to be addressed by a complete retrofit system. The center-core rod near the southeast corner (fig. 8.29d) was effective in anchoring this section. Shear cracks began to develop in this corner that were similar to the crack at the northwest corner; the center-core rods prevented the full propagation of the upper and lower cracks. Even if the cracks had propagated more fully, the center-core rod would have acted as a dowel pin across the joint and greatly limited the amount of offset that could occur at this location.

Comparison of damage to the north walls for (a) model 10 and (b) model 11 after test VII.

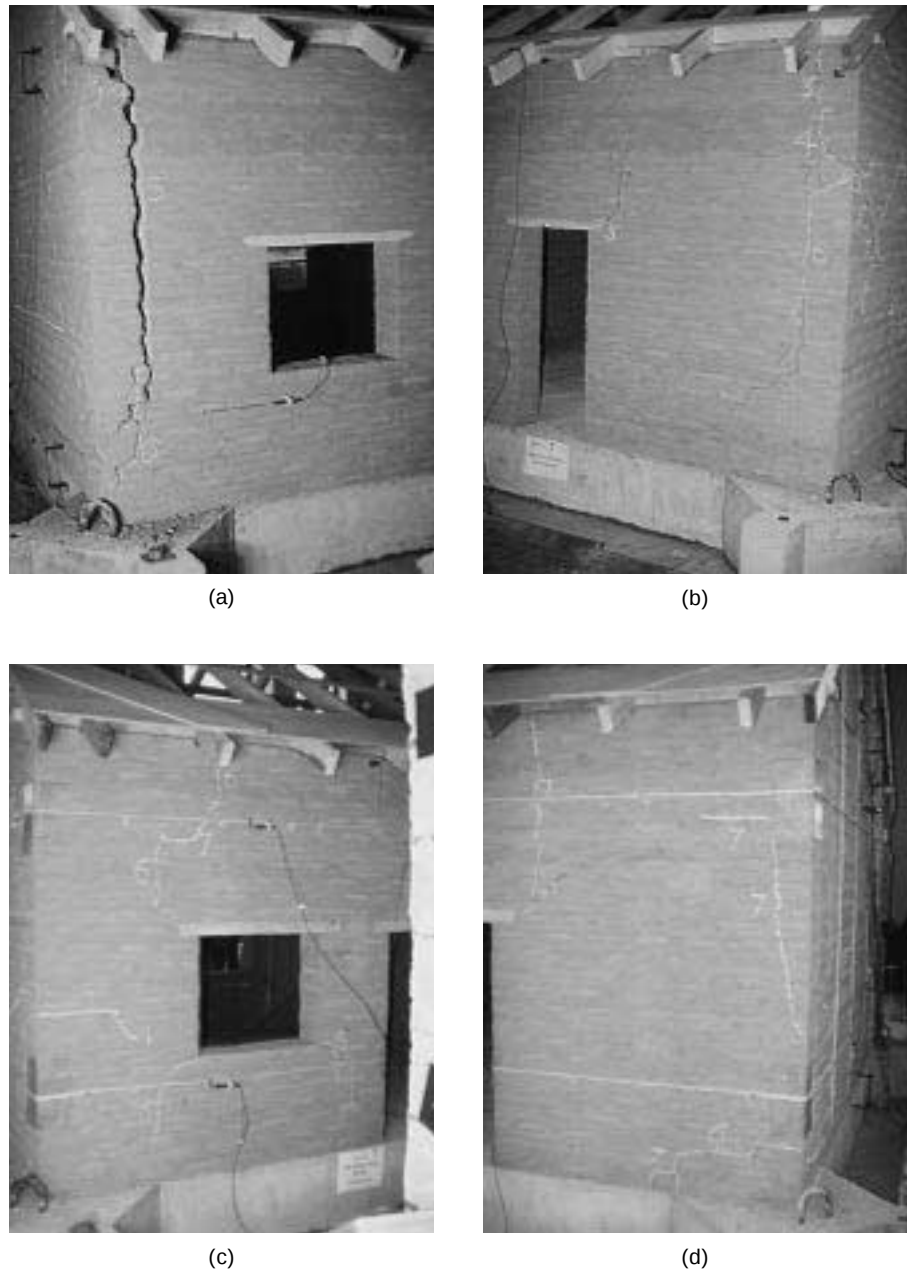
**Figure 8.29**

A second exception to the minor damage of in-plane cracks occurred in the south wall of model 10, as illustrated in figure 8.29a. The crack shown on the left in this photograph is a tension failure caused by the out-of-plane motions of the west wall and is not a typical shear crack.

Comparison of damage to the south walls for models 10 and 11 after test VII, showing (a) model 10, south wall, west side; (b) model 10, south wall, east side; (c) model 11, south wall, west side; and (d) model 11, south wall, east side.

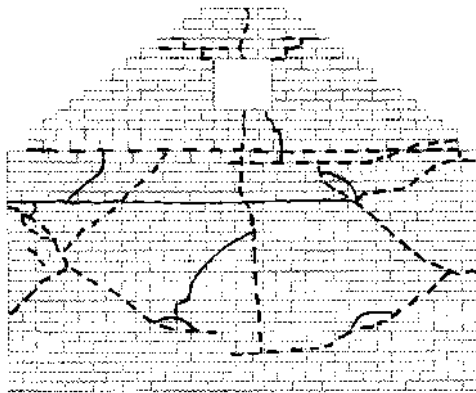
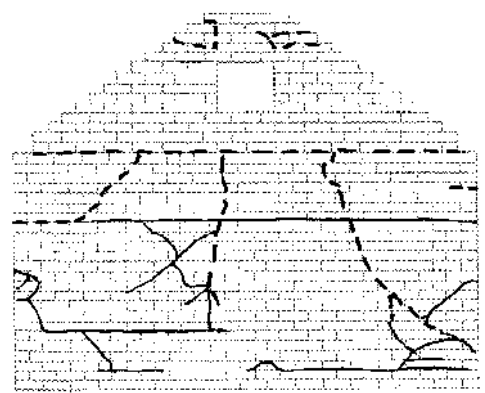
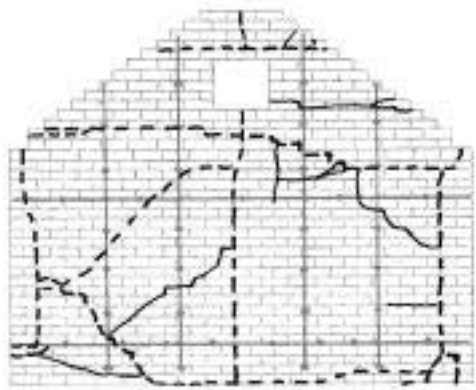
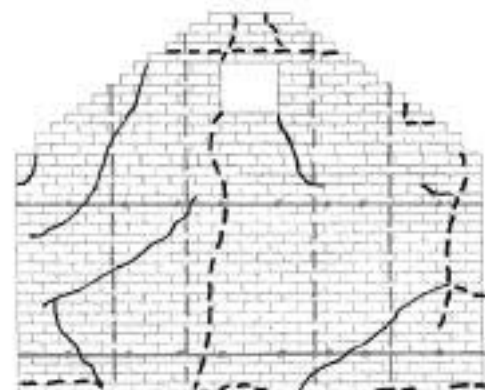
**Figure 8.30**

In the out-of-plane walls, full crack development occurred during tests V (PGA = 0.23 g) and VI (PGA = 0.27 g). (Fig. 8.30 shows crack patterns in these walls after test VII.) Full crack development did not occur in the in-plane walls, except perhaps in the north wall of model 11 after test VIII\*. (Fig. 8.31 shows crack patterns in these walls after test VII.) Full crack development is the point at which all the edges of the major sections of a wall are defined by cracks. A drawing of the crack pattern in the out-of-plane east wall of model 11 after test VI is shown in figure 8.32a. The major cracked sections or “blocks” of this wall are labeled B1 through B5. Each section is bounded by a free surface or by a crack on all four sides. Despite the increased intensity of the table motion in test VII, the only major crack that developed was the one that split B4 into two sections (fig. 8.32b). Once cracks developed,

Comparison of crack patterns after test VII in the out-of-plane walls for (a) model 10, unretrofitted east wall; (b) model 10, unretrofitted west wall; (c) model 11, retrofitted east wall; and (d) model 11, retrofitted west wall.

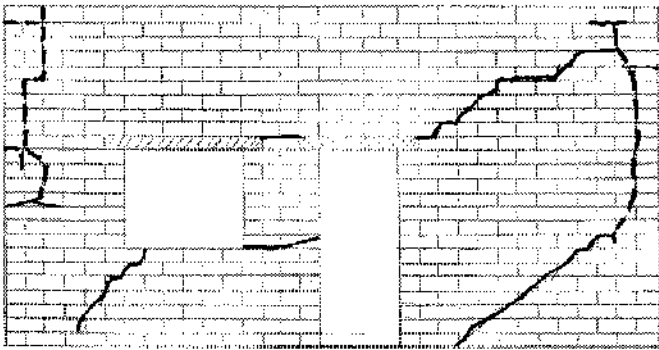
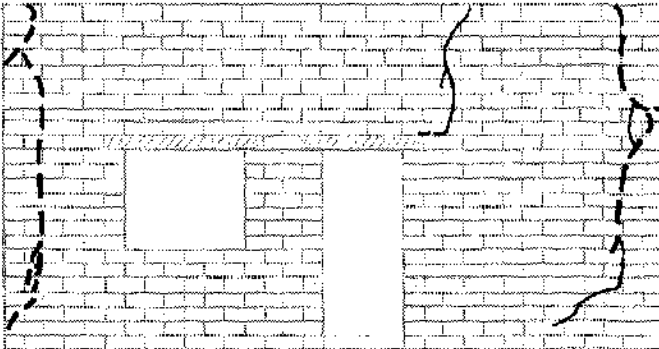
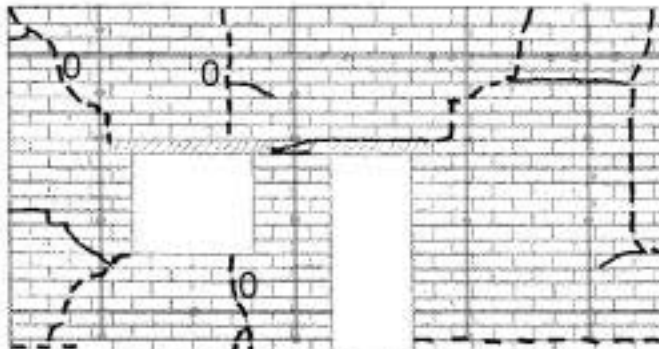
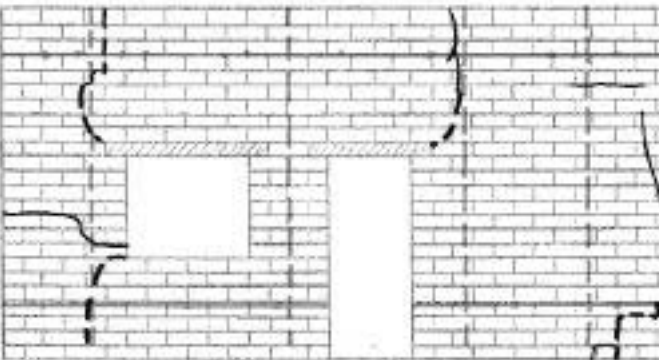
**Figure 8.31**  
Comparison of crack patterns after test VII in the in-plane walls for (a) model 10, unreinforced north wall; (b) model 10, unreinforced south wall; (c) model 11, retrofitted north wall; and (d) model 11, retrofitted south wall.

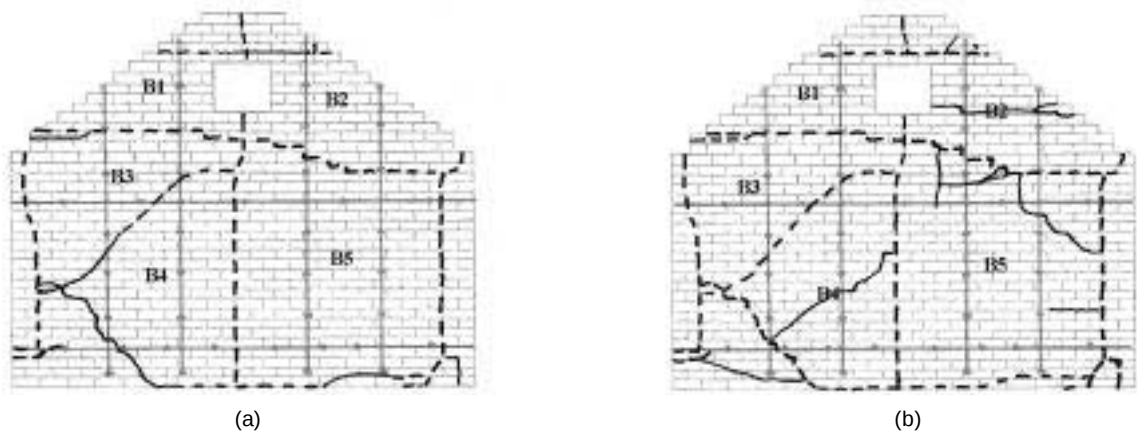
**Figure 8.32**

Crack pattern development in east wall of model 11 (a) after test VI and (b) after test VII. During test VI, the wall cracked into five major sections, or blocks, labeled B1 through B5. During test VII, three of the major blocks remained intact, but B2 and B4 each cracked into two sections.

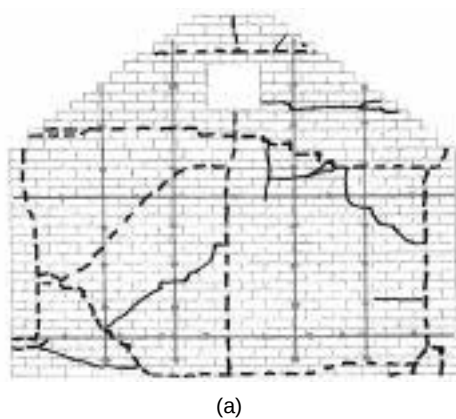
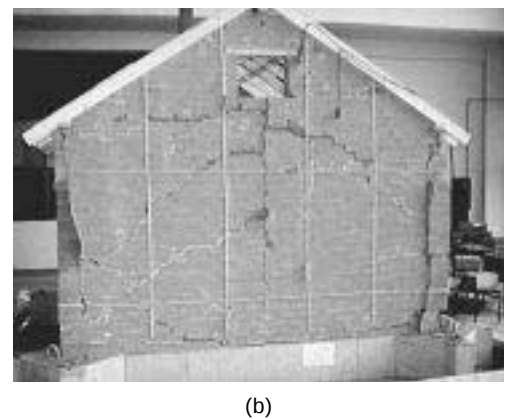
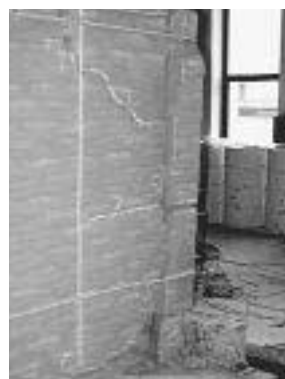
**Figure 8.33**

The strapping system used on the east wall of model 11 was effective in providing wall stability. A drawing of the crack pattern after test VII and photographs showing the condition of the walls are presented in figure 8.33. Cracks and spalling were significant, and an offset of almost 5.1 cm (2 in.) occurred at the northeast corner (fig. 8.33c).

Damage to model 11, east wall (retrofitted with vertical straps) after test VII, shown in (a) diagram of crack pattern, with vertical lines indicating position of straps; (b) photograph of strapped wall; and (c) detail of north side of wall.

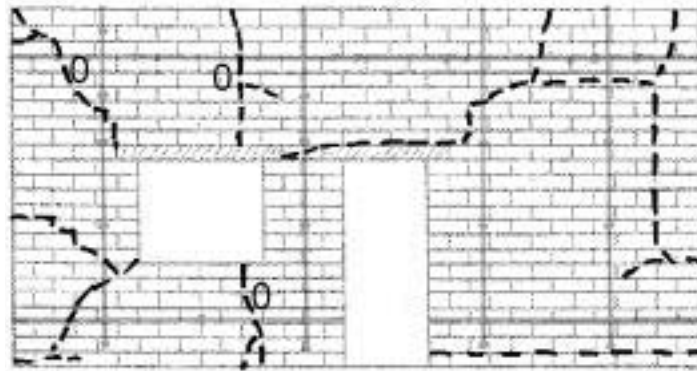
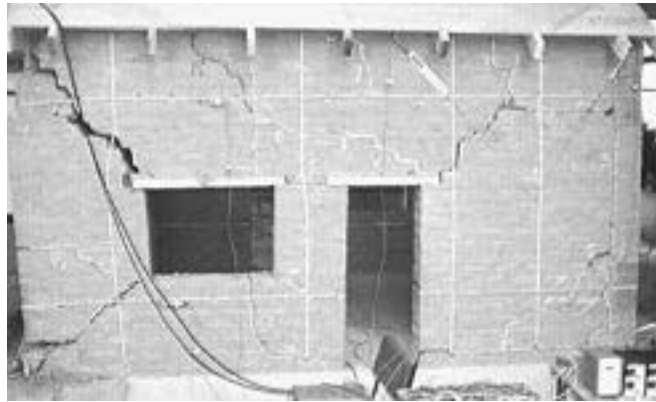
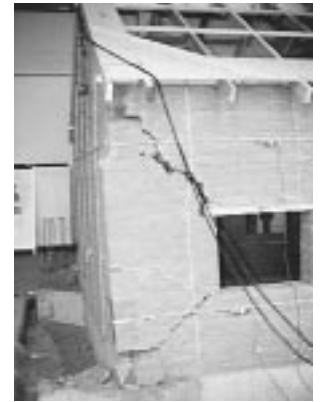
The strapping system of model 11 was not effective in controlling the in-plane diagonal cracking at the east end of the north wall (fig. 8.35). The upper and lower straps were highly stressed, which resulted in some damage to the adjacent adobe. Nevertheless, the straps continued to perform well throughout the testing program. Some additional retrofit measures need to be installed to minimize this type of damage, which could lead to the collapse of the corner section of the wall.

Damage to model 11, north wall (retro-fitted with vertical straps), shown in (a) diagram of crack pattern after test VII; (b) photograph after test VIII\*; and (c) detail of east side of wall after test VIII\*.

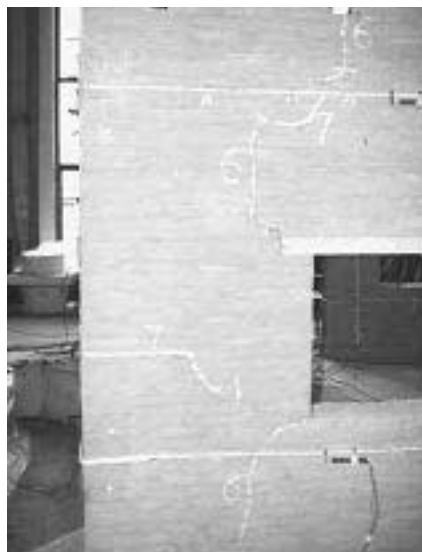
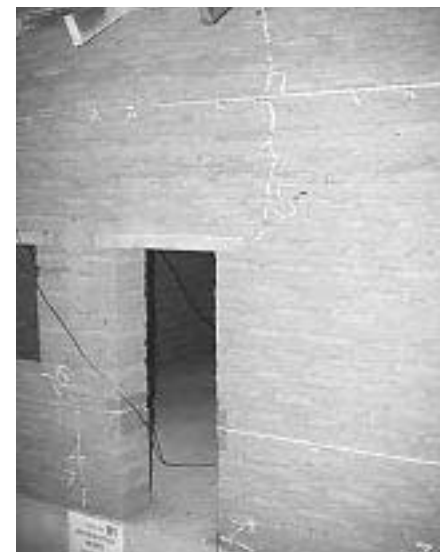
**Figure 8.36**

The center-core elements in the south wall of model 11 were extremely effective in controlling the initiation and progression of crack damage (fig. 8.36). Three of the cracks that started at the corners of the openings in the wall were arrested when they reached the center-core rods. In the later tests, the cracks continued to progress but never became very large.

Damage to model 11, south wall (retro-fitted with center-core rods) after test VIII\*, showing (a) west side and (b) east side of wall.

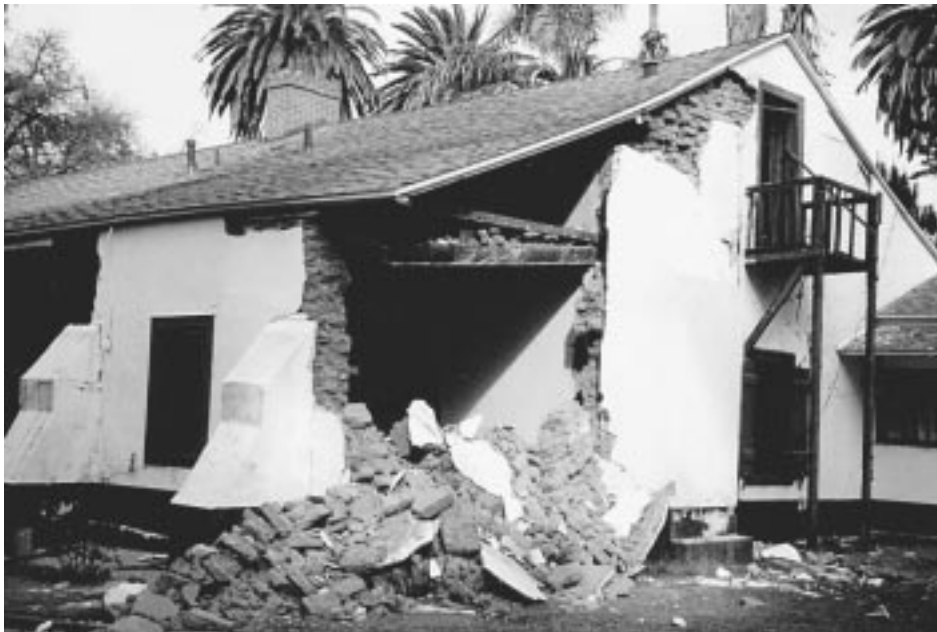
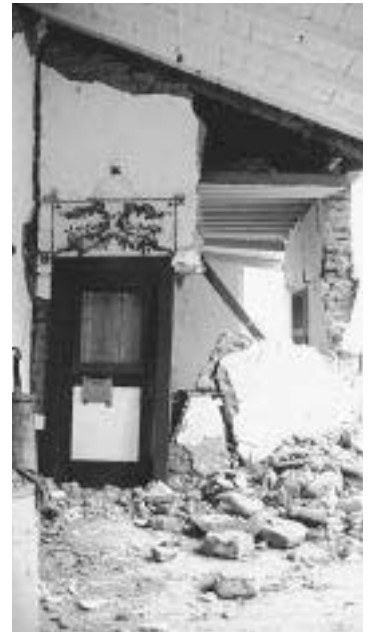
**Figure 9.1**

Ramona's room, Del Valle Adobe at Rancho Camulos, Piru, California, after the 1994 Northridge earthquake, showing (a) southeast corner of building and (b) west wall of room. Buttresses on the south wall prevented the total collapse of that wall.

In many locations, the walls had pulled away from the ceiling joists, and damage to the walls further reduced their ability to support the joists. Three major physical conditions—water damage, preexisting cracks, and material weakness—influenced the performance of the Del Valle Adobe during the Northridge earthquake. The most significant was moisture damage. There had been water damage to the lower adobe walls and foundation in several locations. Repeated wet/dry cycling has resulted in deteriorated and weakened adobe at the base of many walls. To hide the moisture damage, the lower section of the adobe walls had been covered in many areas with large concrete patches, which forced the water to rise even higher in the walls.
